**Cold Store / Cold Room Thermographic Inspection**

**SAMPLE REPORT**

**Pixel Thermographics Ltd**

<b>Cold Store / Cold Room Thermographic Inspection SAMPLE REPORT</b>	<b>Date:</b>
---	--	--------------

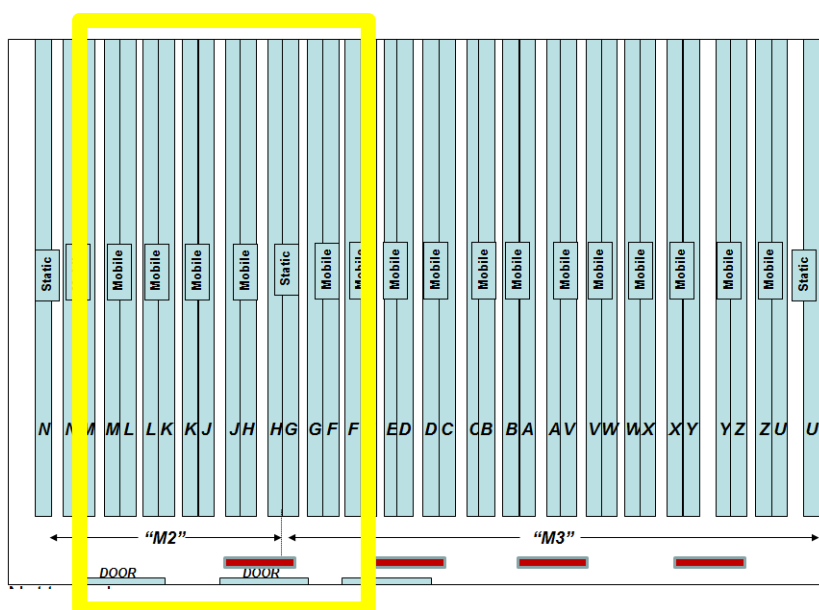
- Areas of the cold store roof were identified where water ingress appears to have entered the roof insulation structure. This results in reduced insulating performance in these areas.
- General temperatures in the cold store in front of the access doors appear to be warmer due to warm air ingress from the continual use of the doors by the trucks. The diagram below shown the general area where higher surface temperatures were noted (highlighted in yellow):

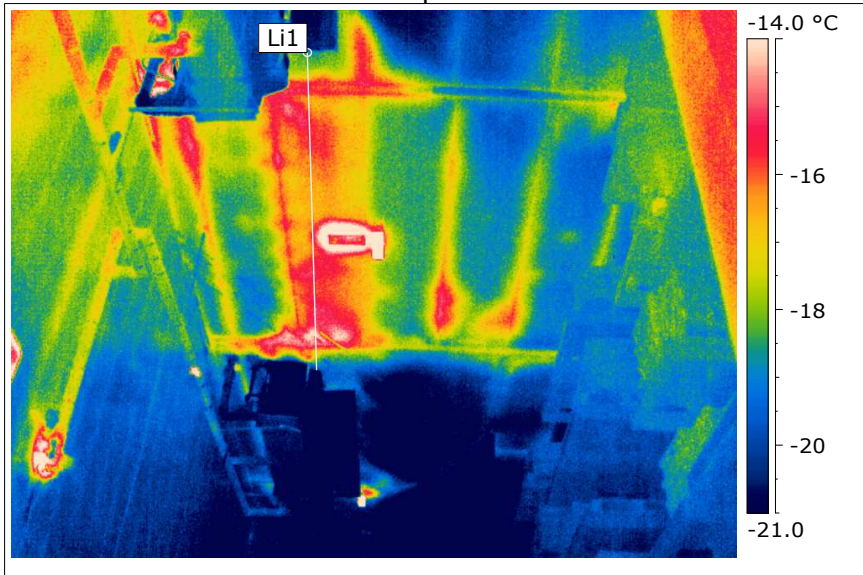
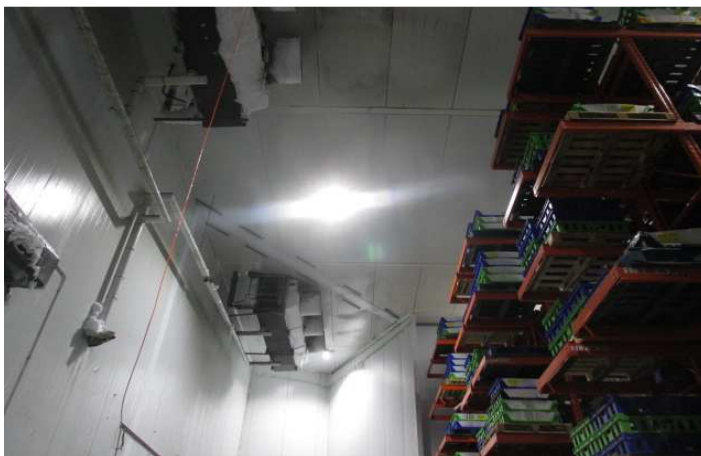
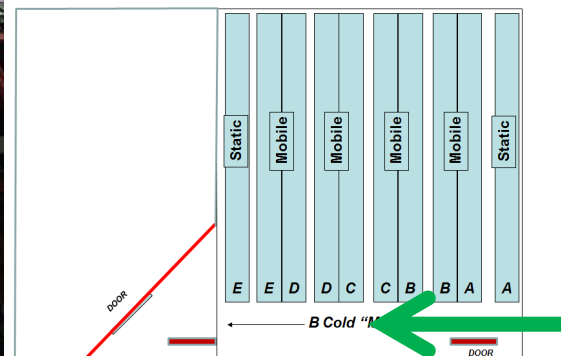
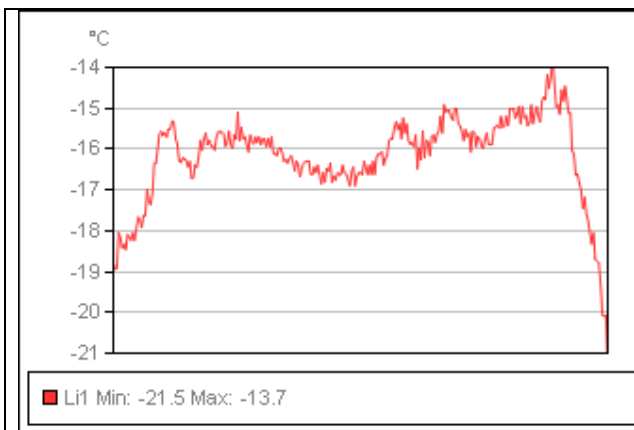
Area: B Store - Roof Between Evaporators 5 & 6

Water ingress suspected within roof insulation resulting in ineffective insulation performance in this area.

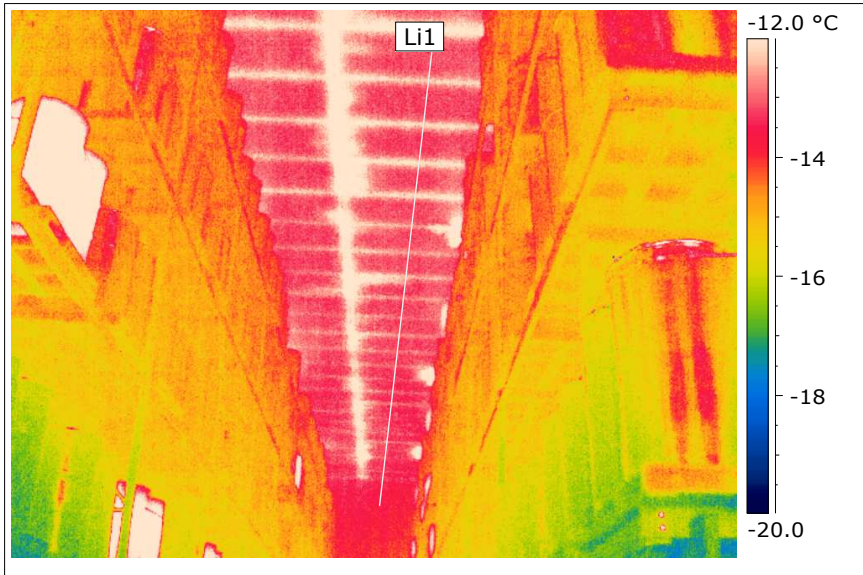
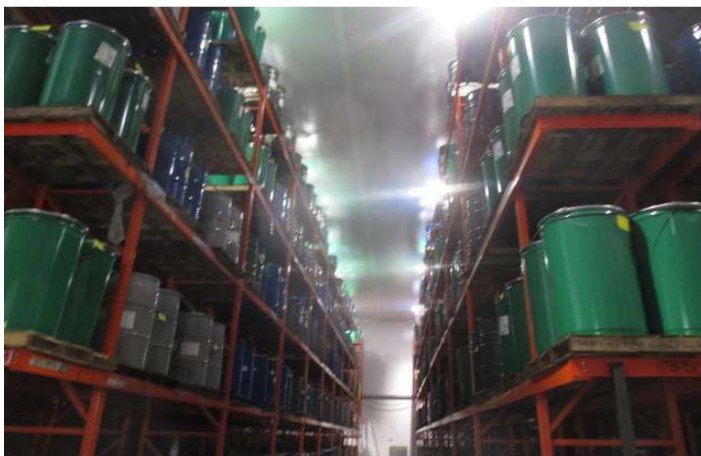
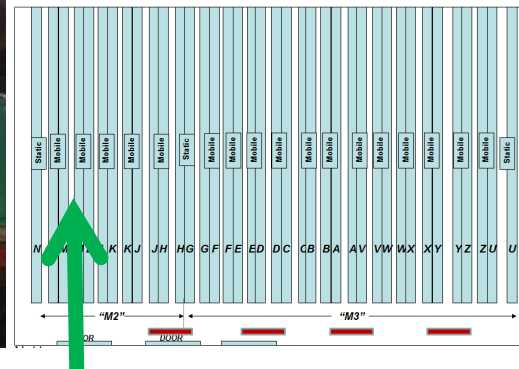
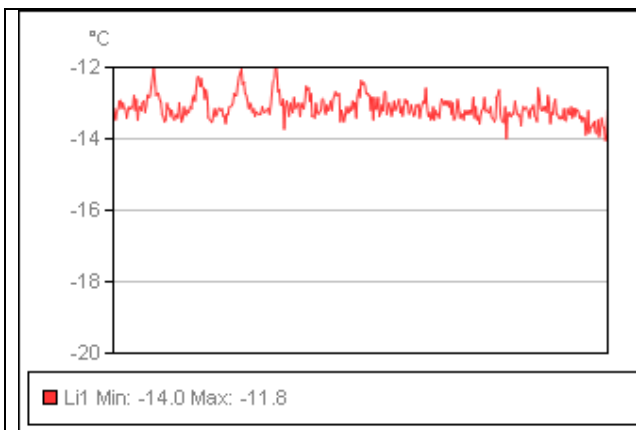
Area: A Store - Roof - Aisle M

It was noted that general surface temperatures in this area of the store appeared higher than other parts of the store.

It appears that the continual use of the entry doors in this area by trucks results in warm air ingress.

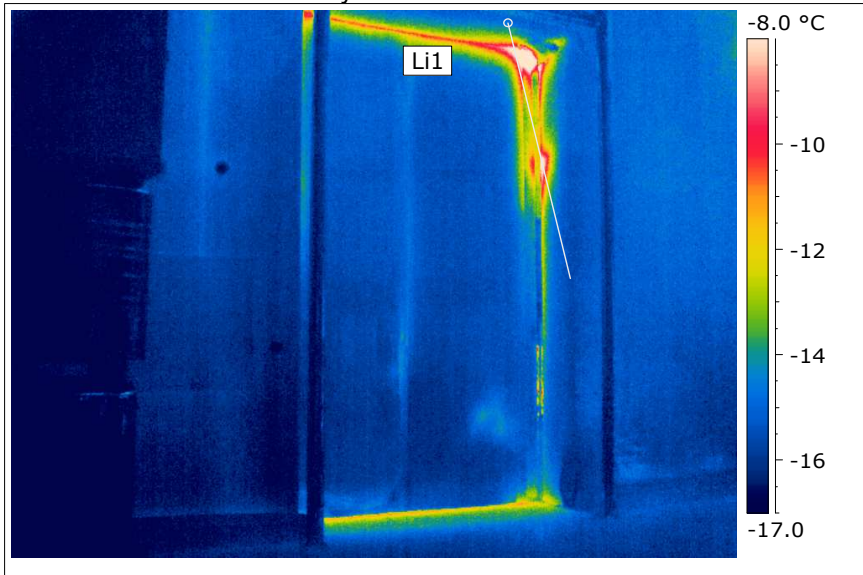
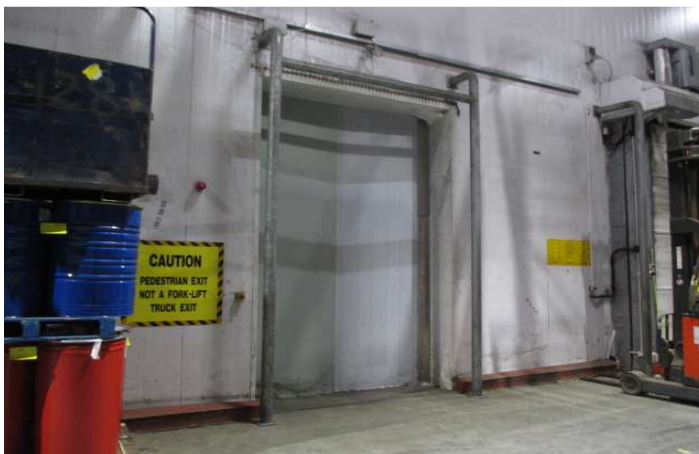
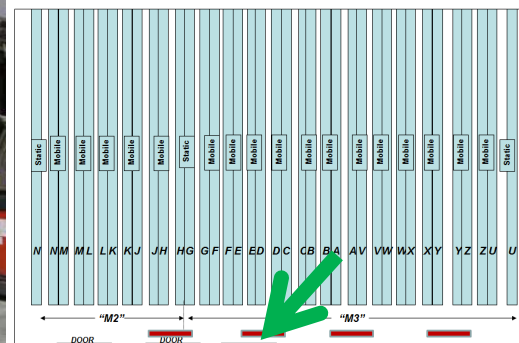
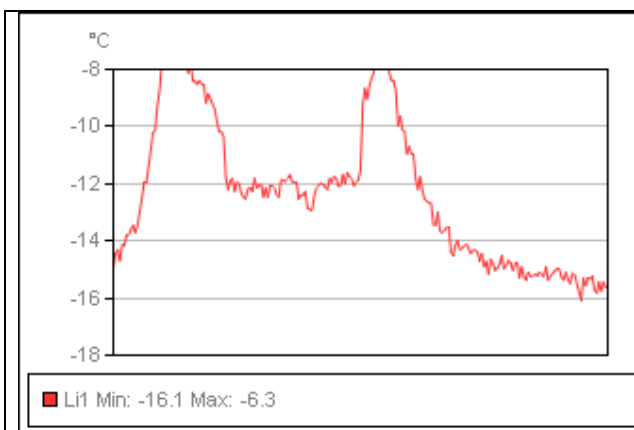
Area: A Store - Old Doorway

Warm air ingress noted in various parts of this old door.

Recommendation is to add further sealant / insulation to help prevent this ingress.

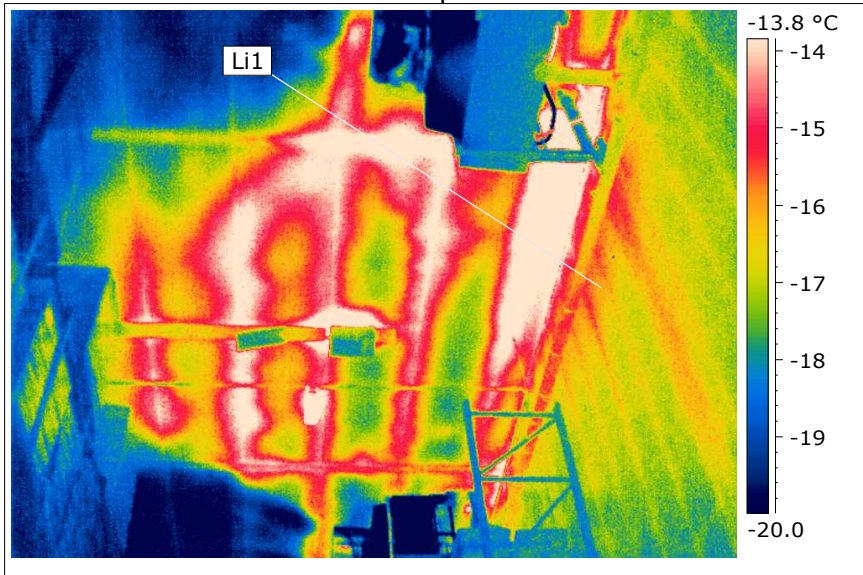
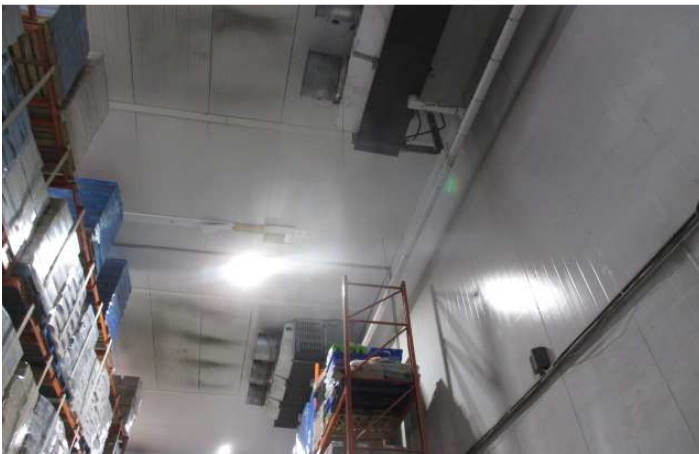
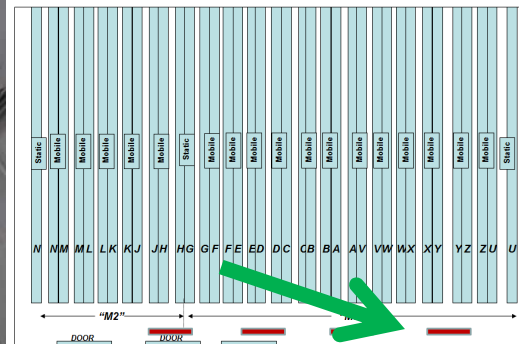
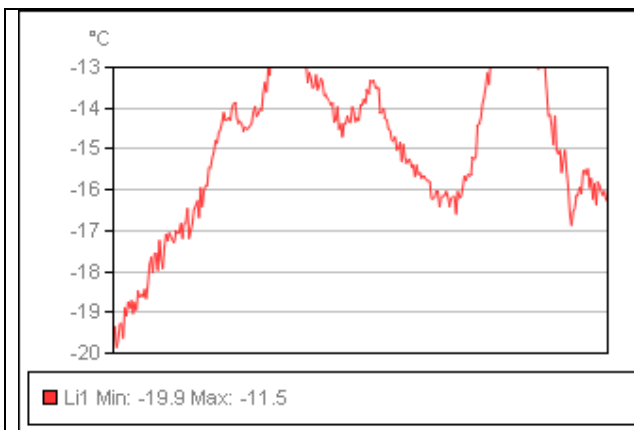
Area: A Store - Roof - Between Evaporators 1 & 2

Water ingress suspected within roof insulation resulting in ineffective insulation performance in this area.

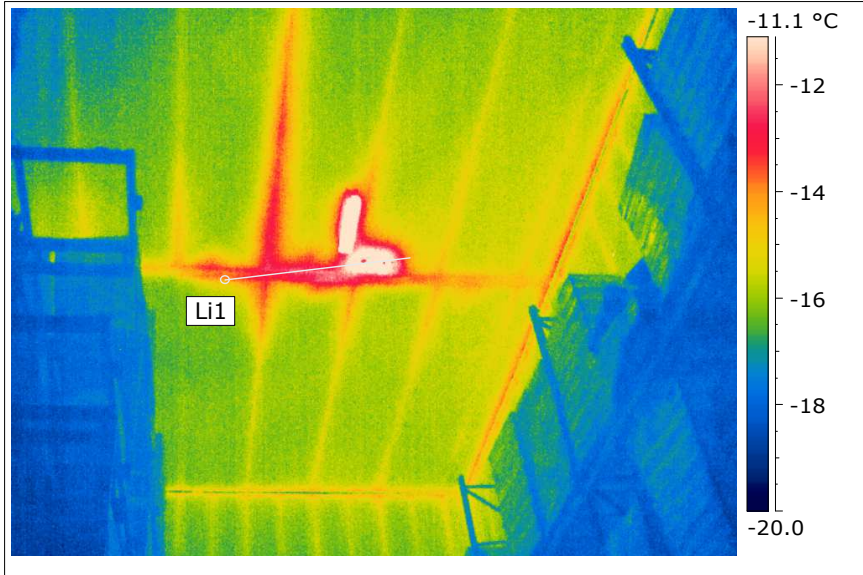
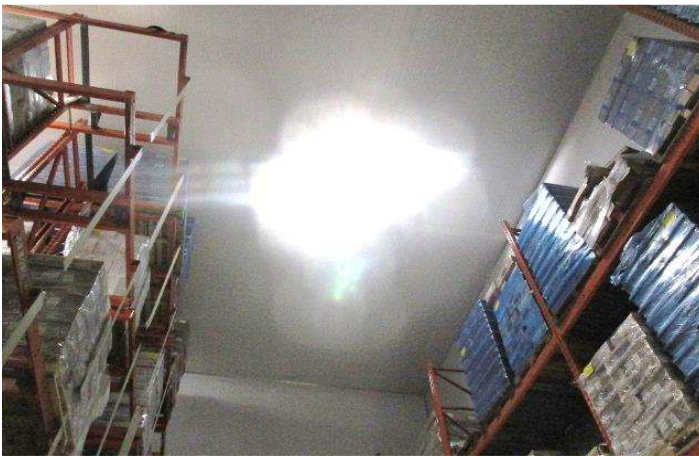
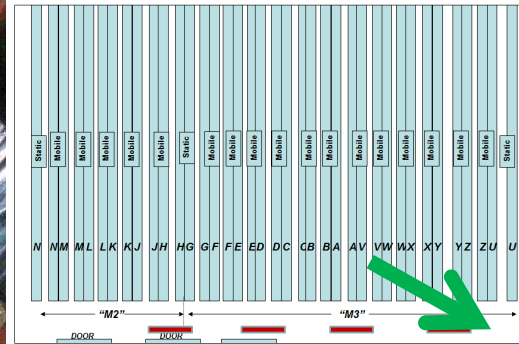
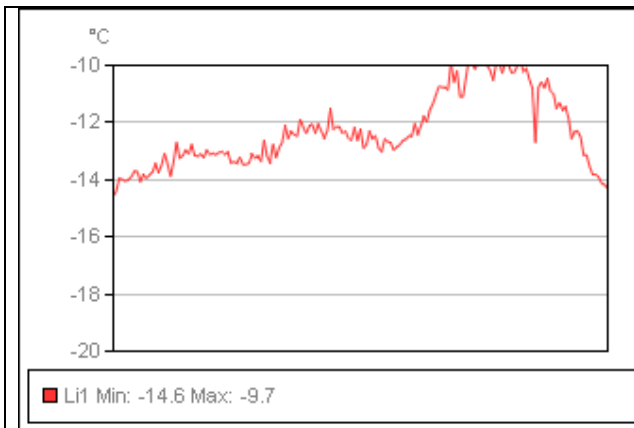
Area: A Store - Roof - Roof Above Entrance Aisle Z

Water ingress suspected within roof insulation resulting in ineffective insulation performance in this area.

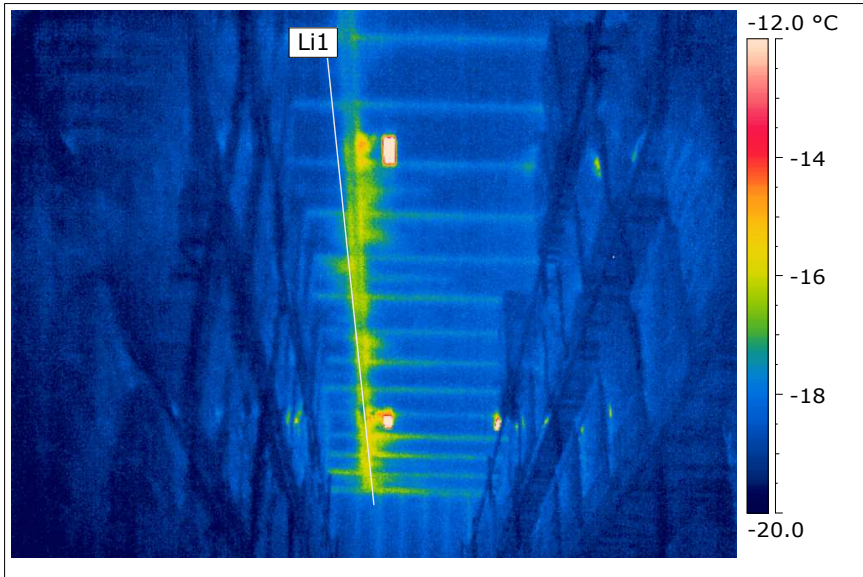
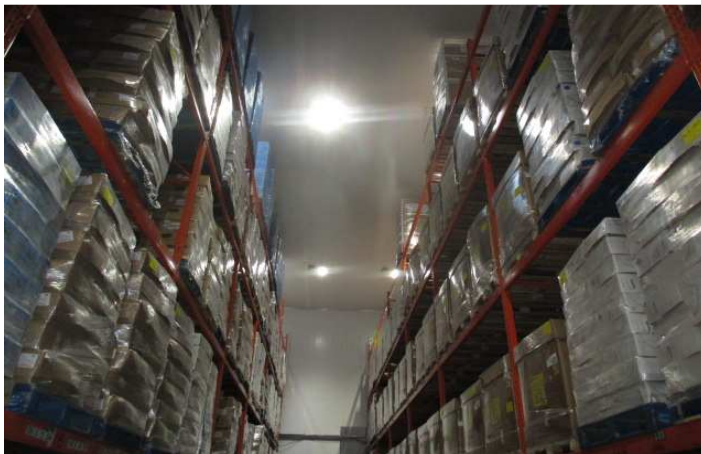
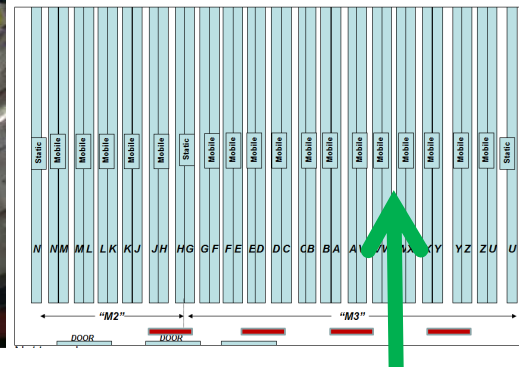
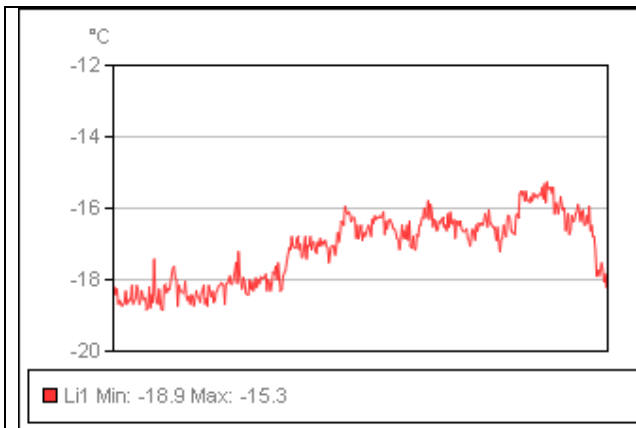
Area: A Store - Roof - Aisle Q

Water ingress suspected within roof insulation resulting in slight reduction in insulation performance in this area.

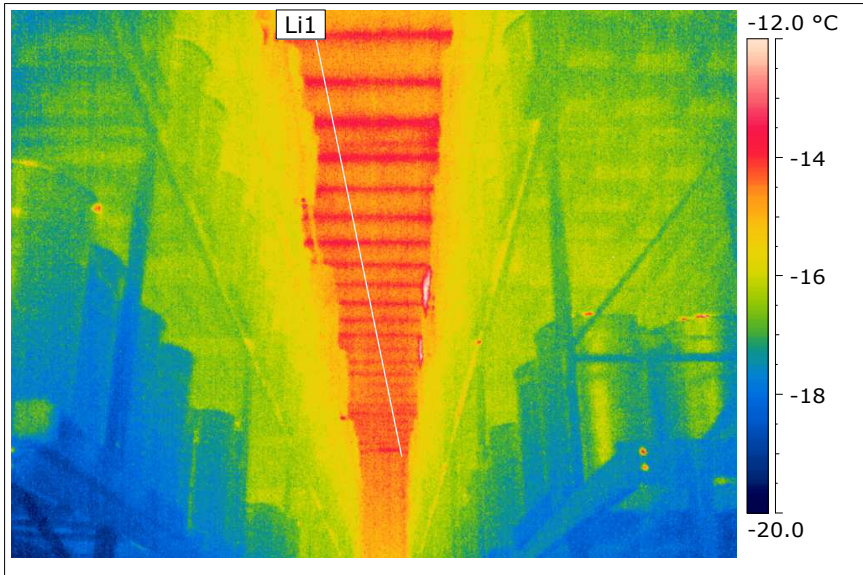
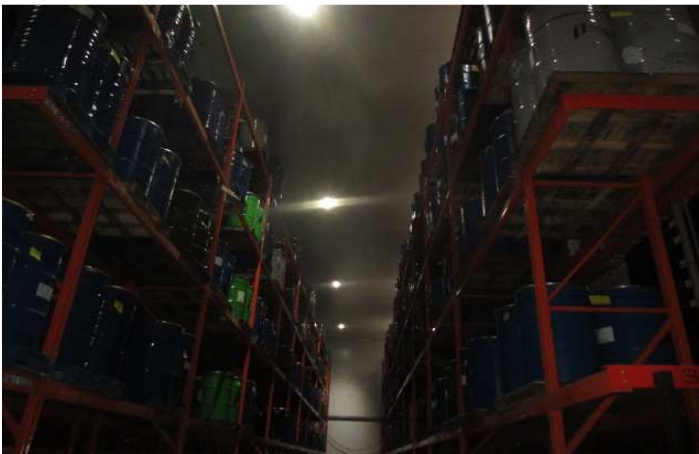
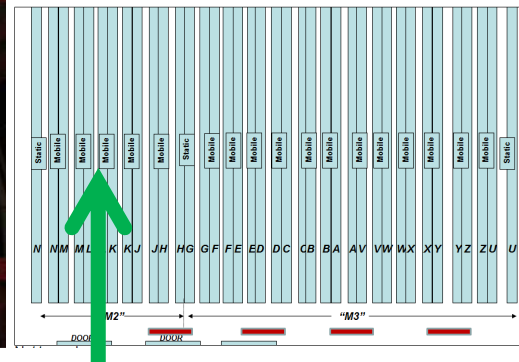
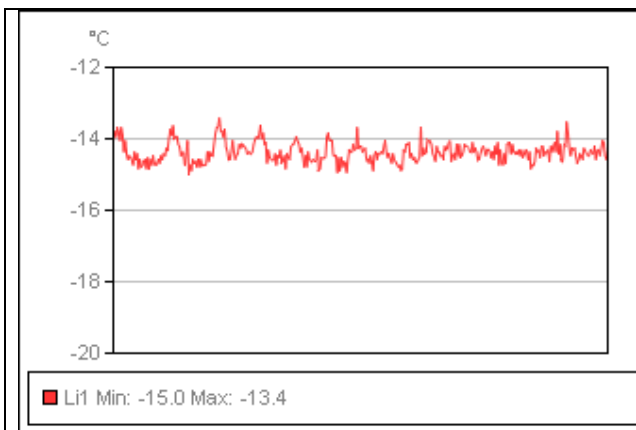
Area: A Store - Roof - Aisle L

It was noted that general surface temperatures in this area of the store appeared higher than other parts of the store.

It appears that the continual use of the entry doors in this area by trucks results in warm air ingress.

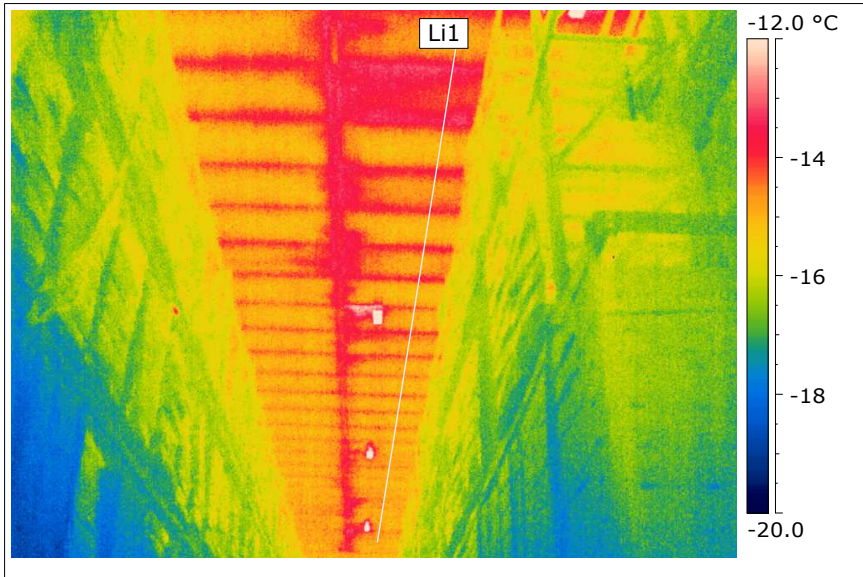
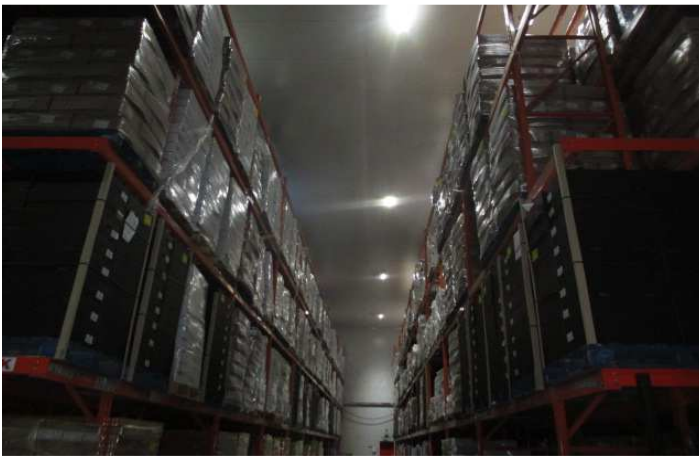
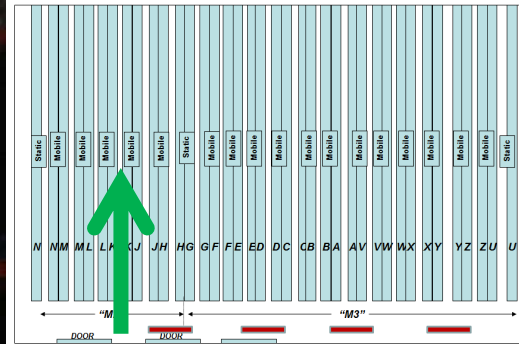
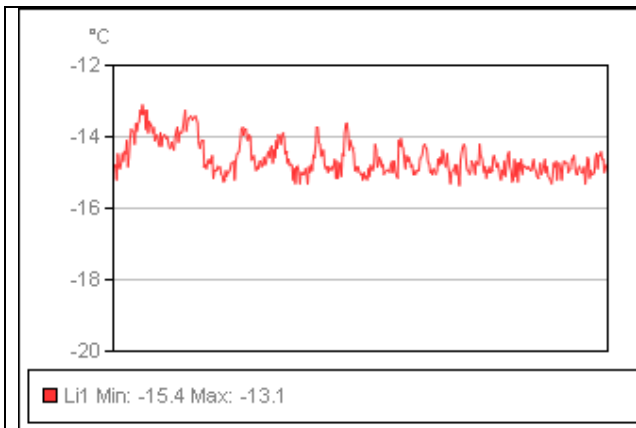
Area: A Store - Roof - Aisle K

It was noted that general surface temperatures in this area of the store appeared higher than other parts of the store.

It appears that the continual use of the entry doors in this area by trucks results in warm air ingress.

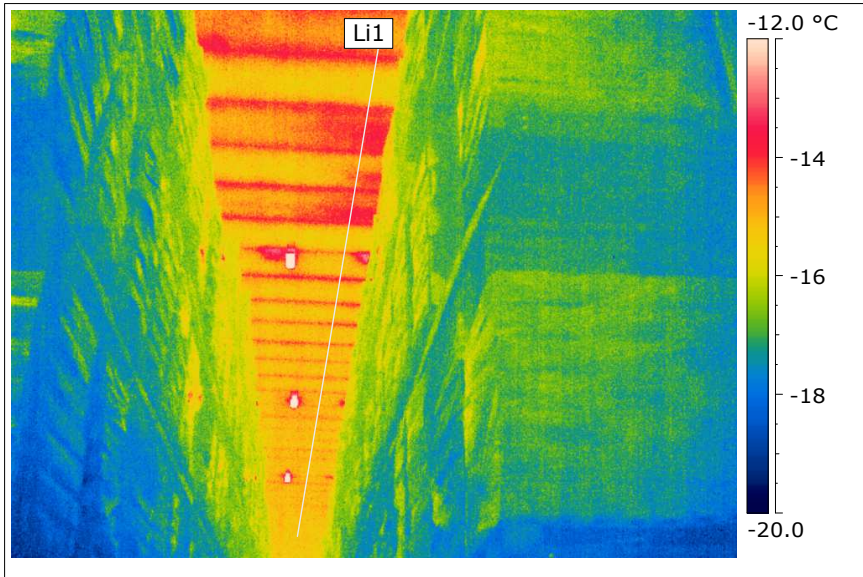
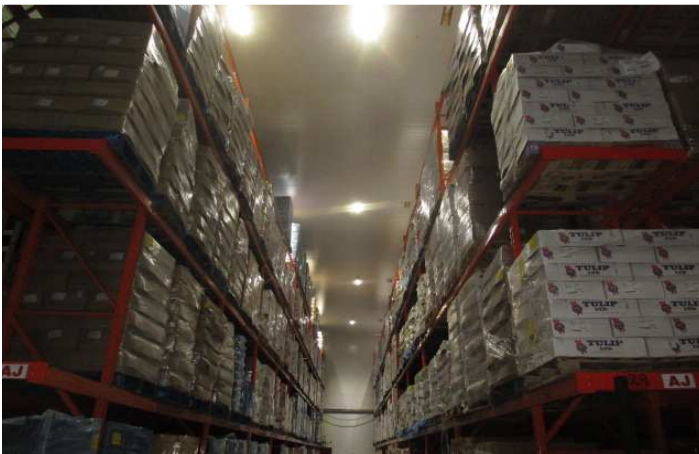
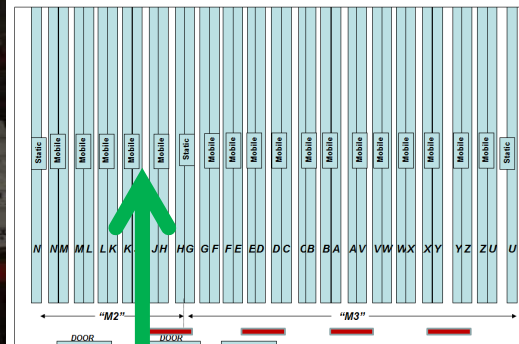
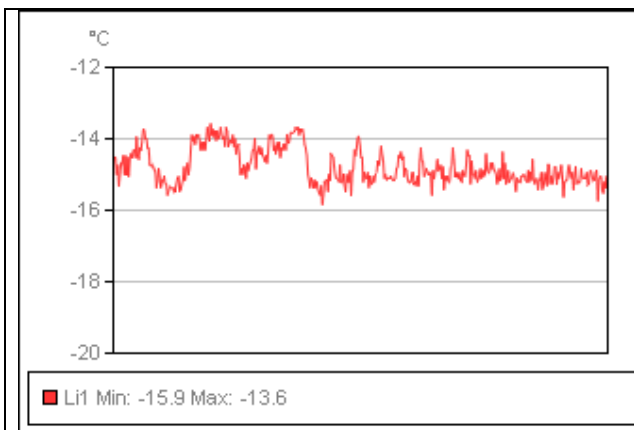
Area: A Store - Roof - Aisle J

It was noted that general surface temperatures in this area of the store appeared higher than other parts of the store.

It appears that the continual use of the entry doors in this area by trucks results in warm air ingress.

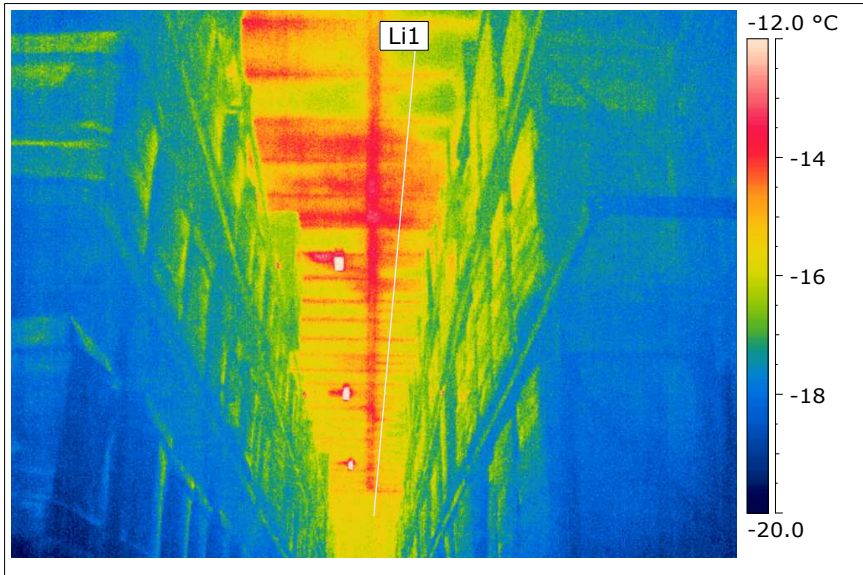
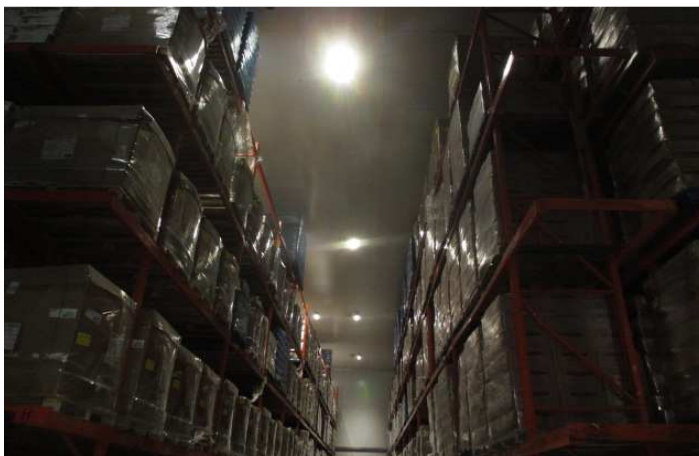
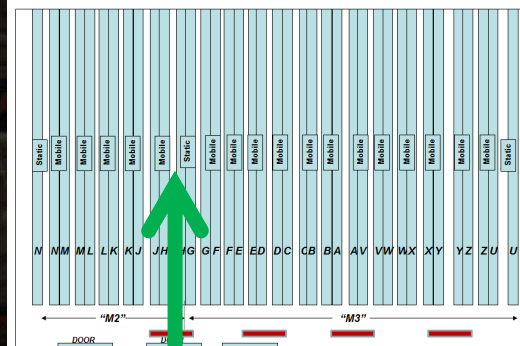
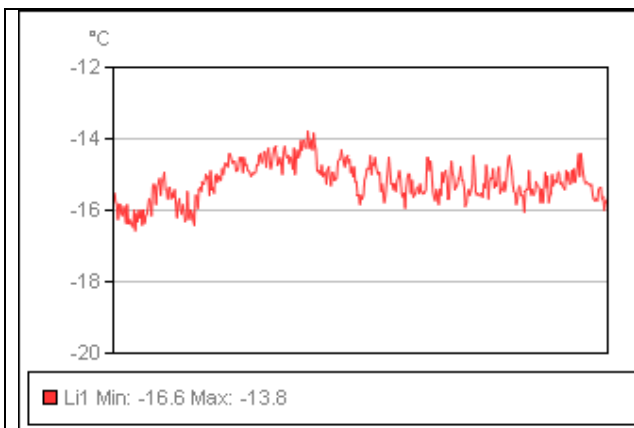
Area: A Store - Roof - Aisle H

It was noted that general surface temperatures in this area of the store appeared higher than other parts of the store.

It appears that the continual use of the entry doors in this area by trucks results in warm air ingress.
