Electronic Roof Leak Survey

SAMPLE REPORT

Pixel Thermographics Ltd

Electronic (Wet Test) Roof Leak Survey SAMPLE REPORT	Date:
---	---	--------------

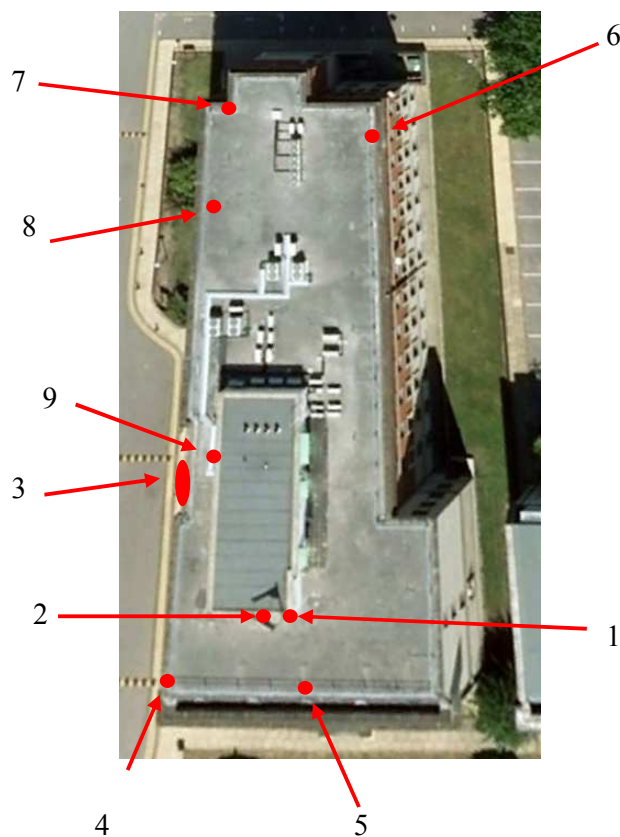
The survey revealed 9 areas where the integrity of the roof appears compromised.

The image below shows the locations of the ingress points:

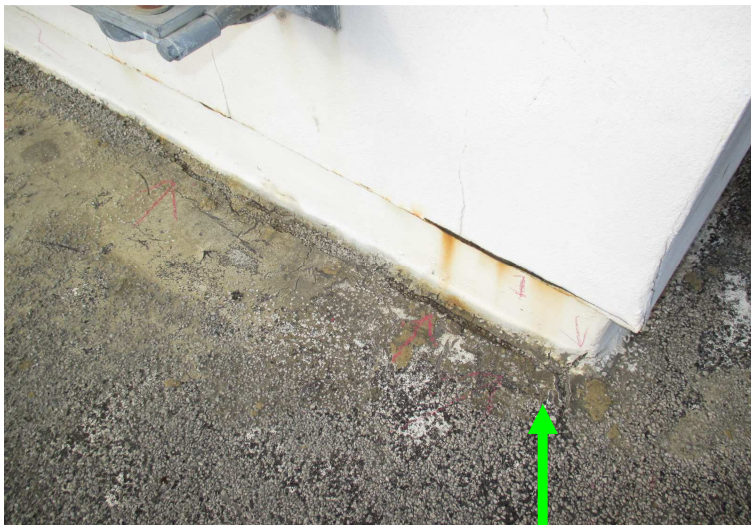
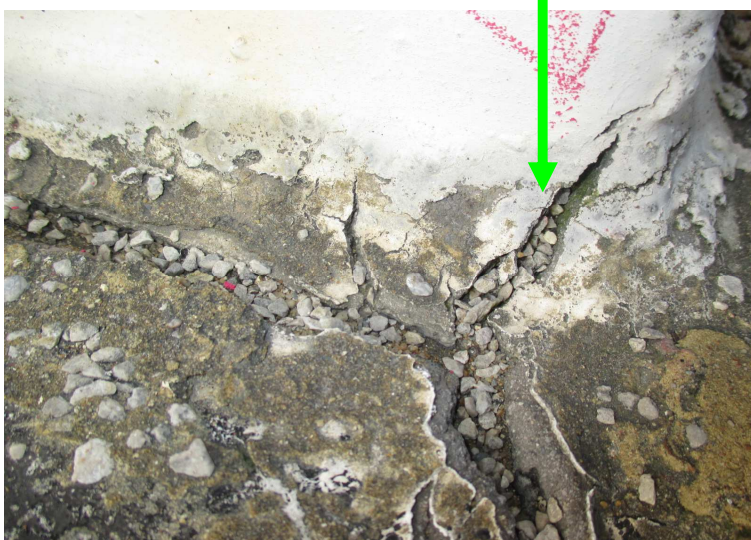
Leak Site 1

Water ingress detected.

Visual inspection revealed cracking at the corner of the upstand.

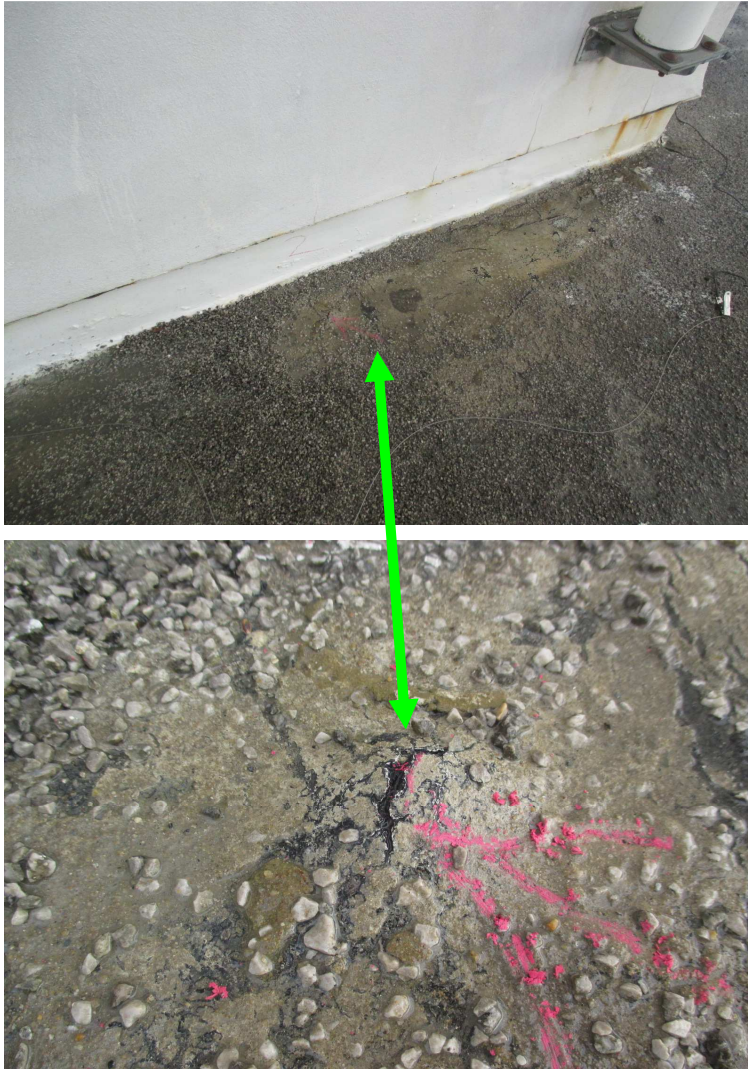
Leak Site 2

Water ingress detected.
Visual inspection revealed blistering of roof membrane.

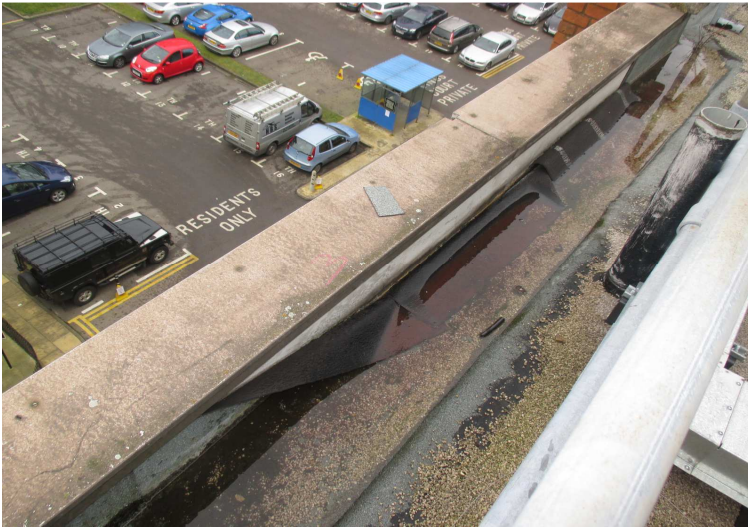
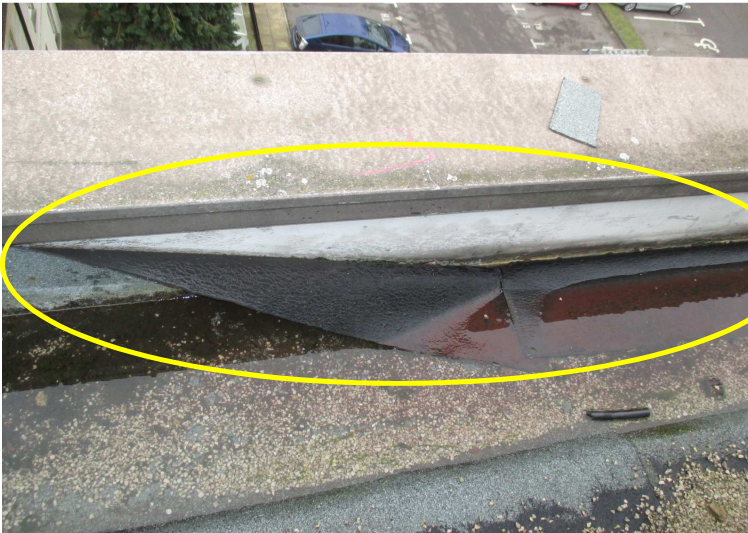
Leak Site 3

Visual inspection shows significant damage at upstand where felt waterproofing has completely failed.

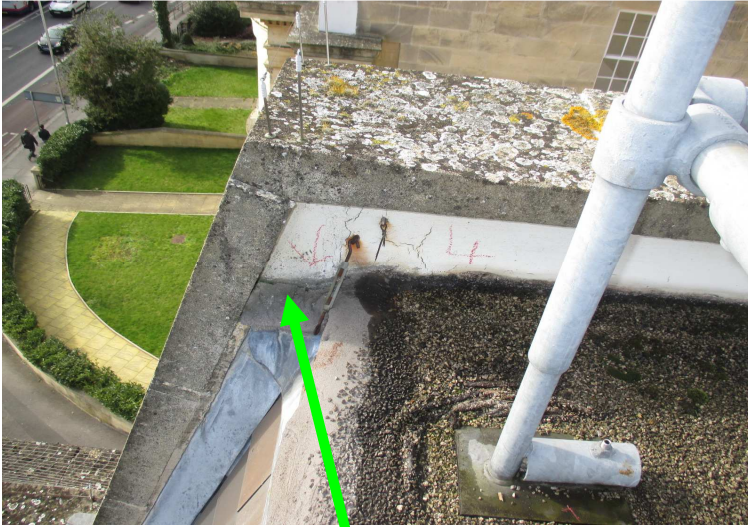
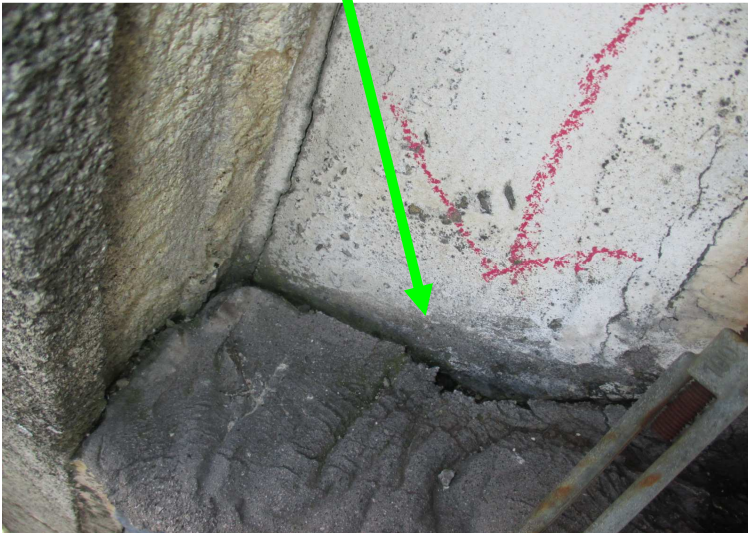
Leak Site 4

Water ingress detected.
Visual inspection revealed visible gap at corner detail.

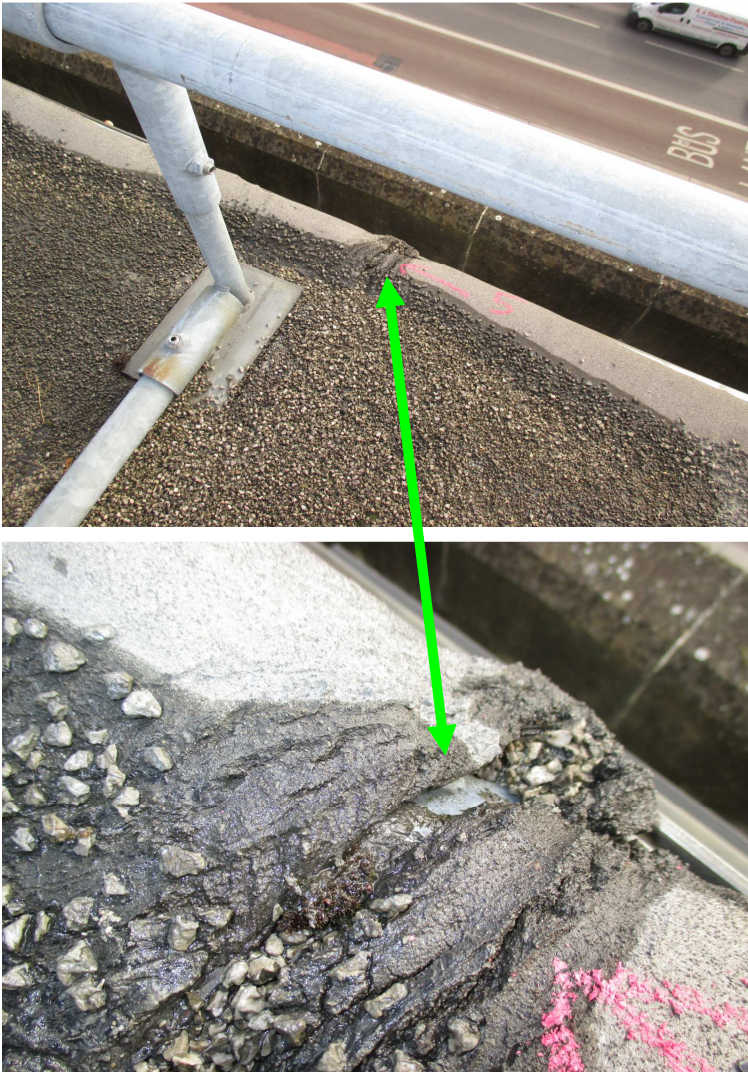
Leak Site 5

Water ingress detected.

Visual inspection revealed small opening in roof covering at edge detail.

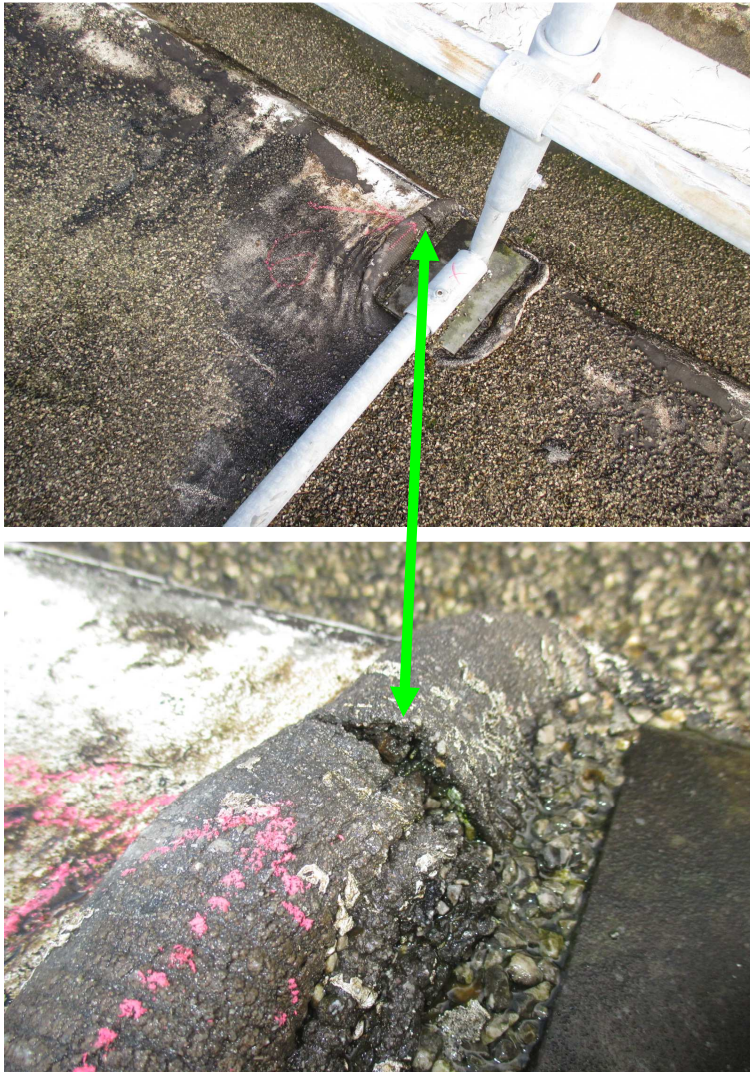
Leak Site 6

Water ingress detected.

Visual inspection revealed damage to roof covering at edge protection mounting.

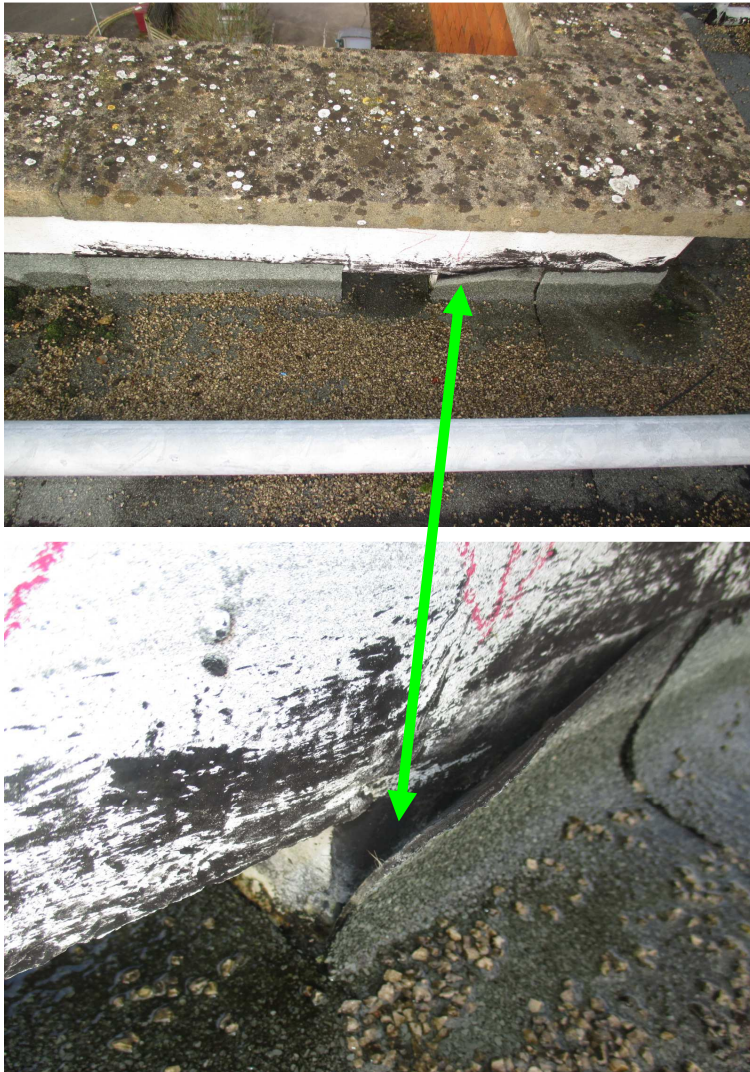
Leak Site 7

Visual inspection revealed felt starting to peel away from upstand close to drain outlet.

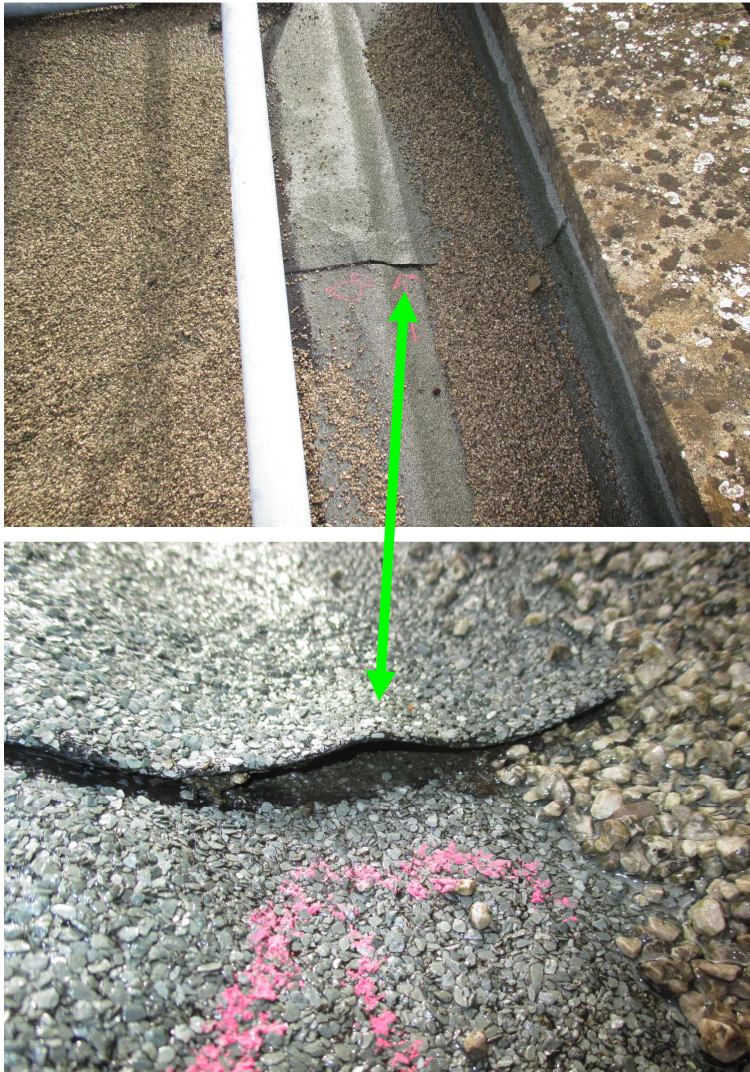
Leak Site 8

Water ingress detected.
Visual inspection revealed poor seal in felt in rain gully.

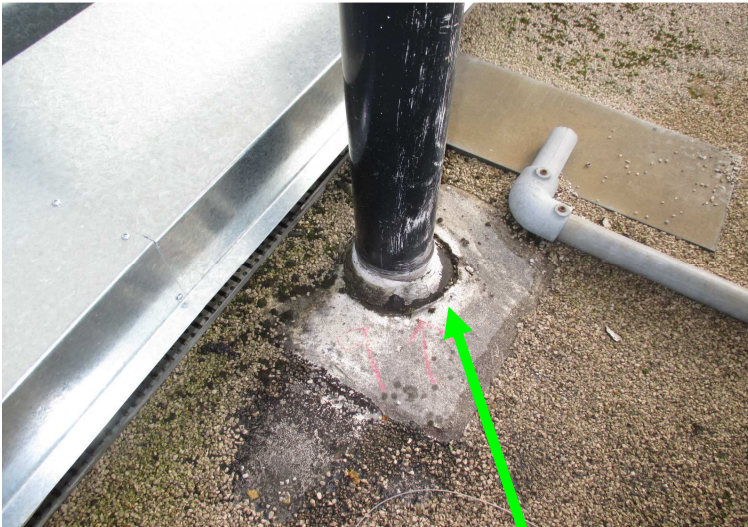
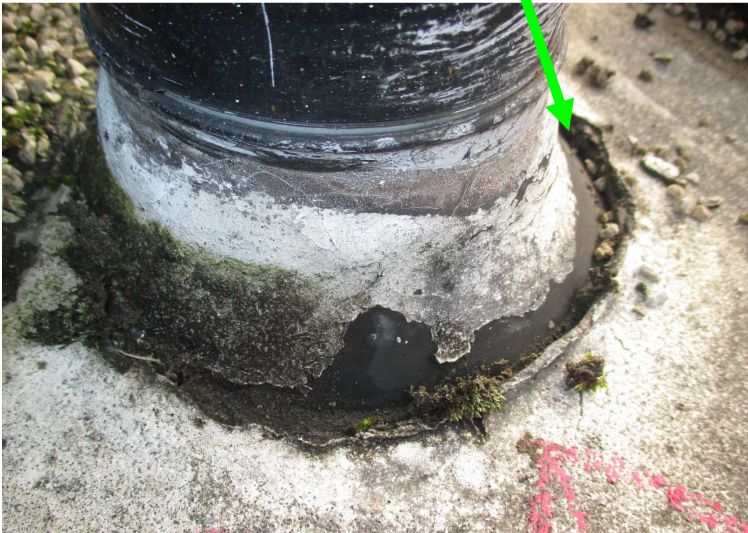
Leak Site 9

Water ingress detected.
Visual inspection revealed failed seal around vent pipe.
