Mechanical Thermographic Survey

SAMPLE REPORT

Pixel Thermographics Ltd

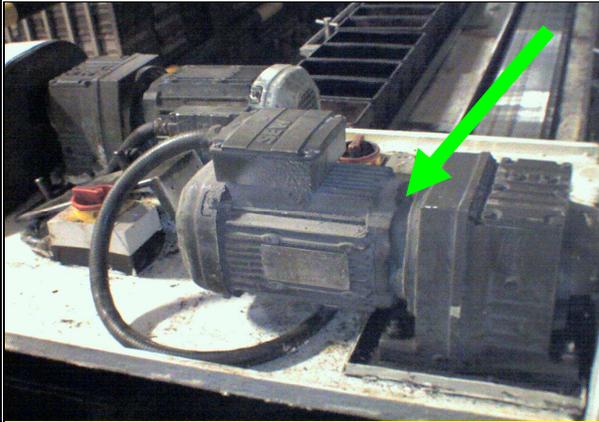
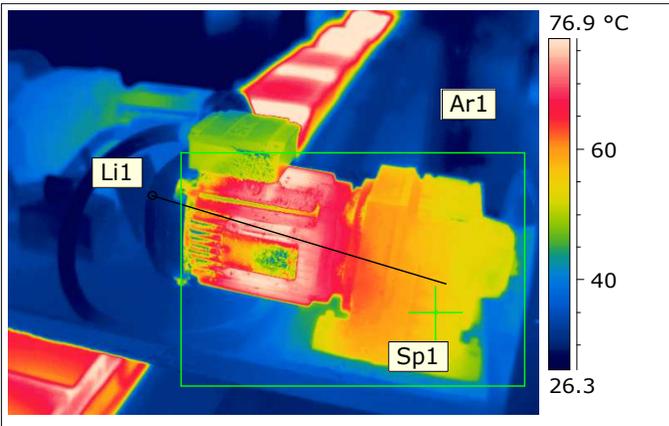
Location	A Plant Tin Return System (Oven Side)
Equipment	Prior to Moulder
Type	SEW Motor Gearbox

Difference Ar1 - Sp1	21.1 °C
Fault Rating	Priority 2

Elevated temperature noted on motor surfaces.

It was noted that this lane at the time of the survey was permanently loaded with trays which were not being loaded into the prover.

Check current loading on this drive.

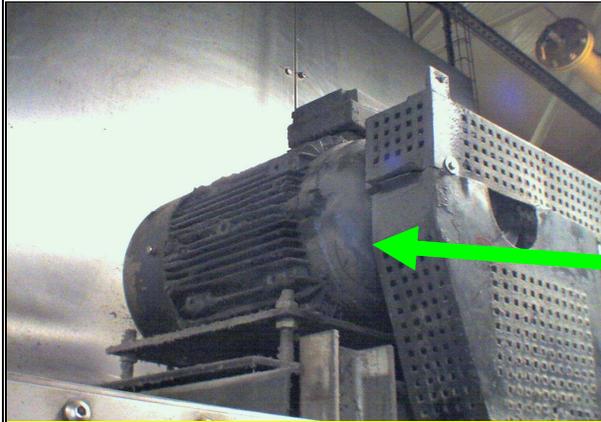
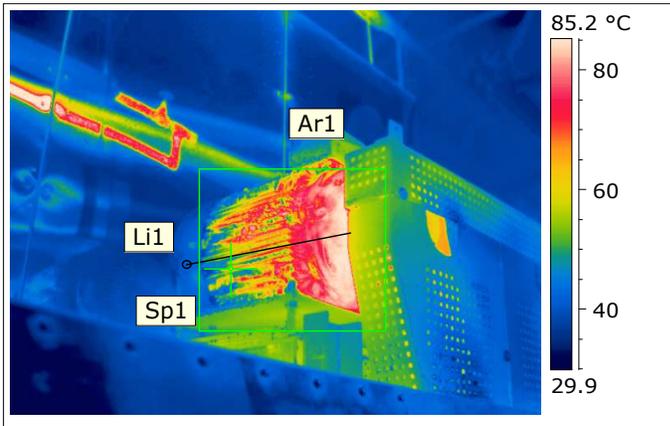
Location	A Plant Oven
Equipment	Main Circulation Fan (Inlet End)
Type	Fan Motor

Difference Ar1 - Sp1	28.2 °C
Fault Rating	Priority 2

Elevated temperature noted on NDE bearing housing on this drive.

Recommendation is to check bearing performance on this motor – utilise vibration analysis.

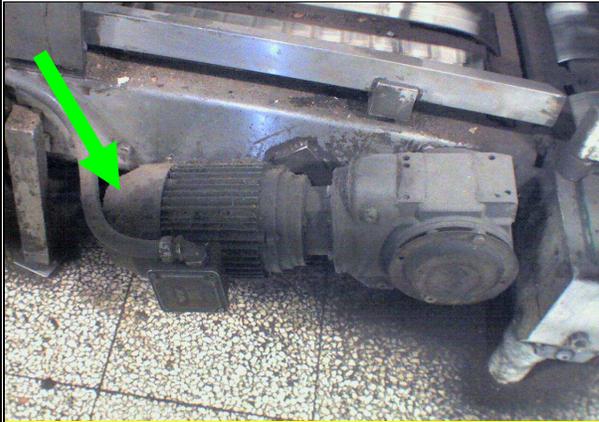
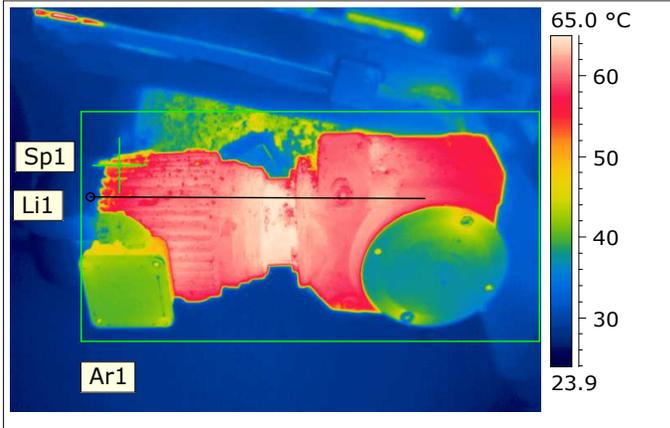
Location	A Plant Tin Return System
Equipment	Tin Cleaner
Type	SEW Motor Gearbox

Difference Ar1 - Sp1	13.3 °C
Fault Rating	Priority 2

Elevated temperatures noted on motor gearbox surfaces.

Likely cause of heat rise is poor air movement / cooling across the unit.

Check / clean the fan cowling to ensure maximum air movement & cooling.

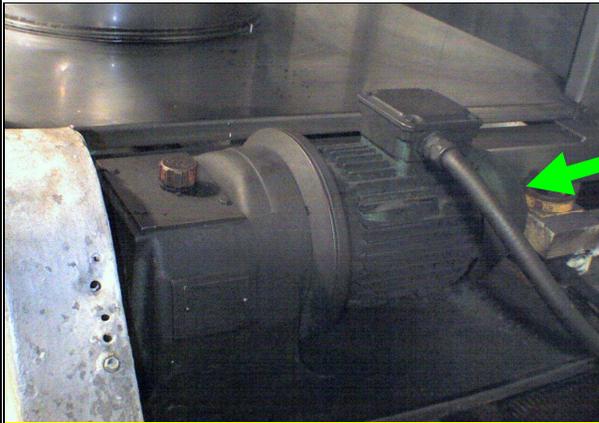
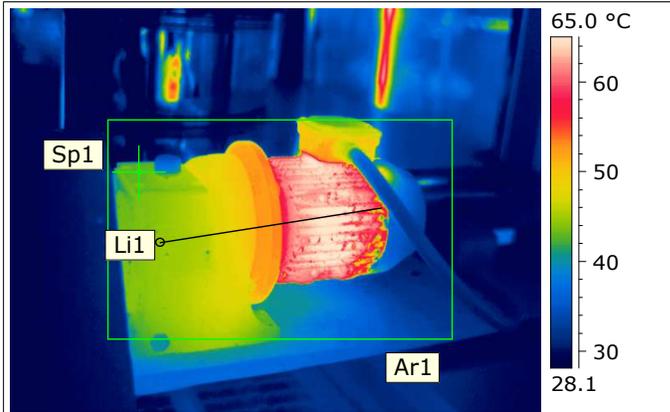
Location	A Plant Tin Return System
Equipment	Conveyor Under LEV Extract
Type	SEW Motor Gearbox

Difference Ar1 - Sp1	23.9 °C
Fault Rating	Priority 2

Elevated temperatures noted on motor gearbox surfaces.

Likely cause of heat rise is poor air movement / cooling across the unit.

Check / clean the fan cowling to ensure maximum air movement & cooling.

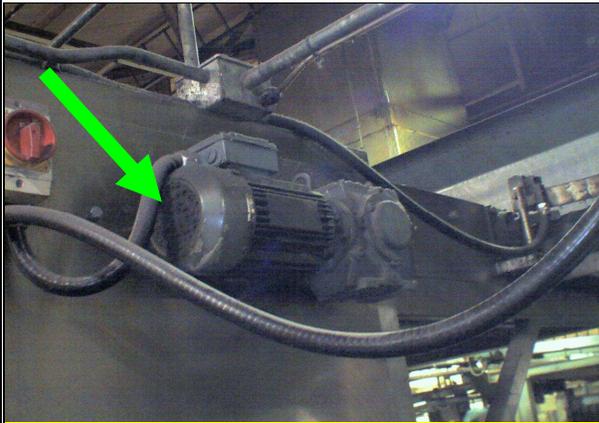
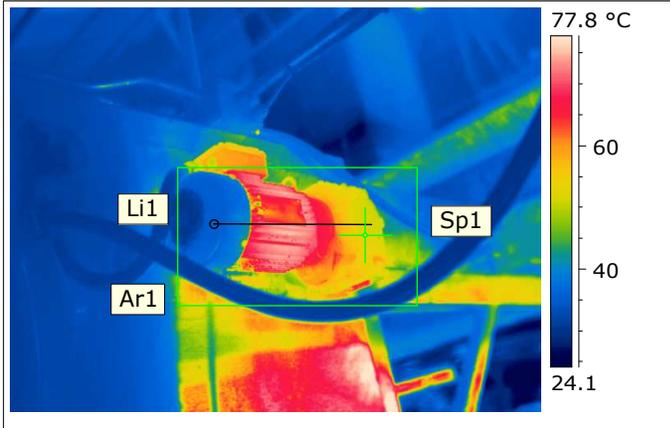
Location	A Plant Lid Return System
Equipment	Lid Take Off Drive
Type	SEW Motor Gearbox

Object Parameters	Value
Atmospheric Temperature	21.0 °C
Sp1 Temperature	52.2 °C
Ar1 Max. Temperature	75.3 °C
Emissivity	0.95
Object Distance	1.2 m
Reflected Apparent Temperature	21.0 °C
Image File name	IR_14704.jpg
Difference Ar1 - Sp1	23.1 °C
Fault Rating	Priority 2

Elevated temperatures noted on motor gearbox surfaces.

Likely cause of heat rise is poor air movement / cooling across the unit.

Check / clean the fan cowling to ensure maximum air movement & cooling.

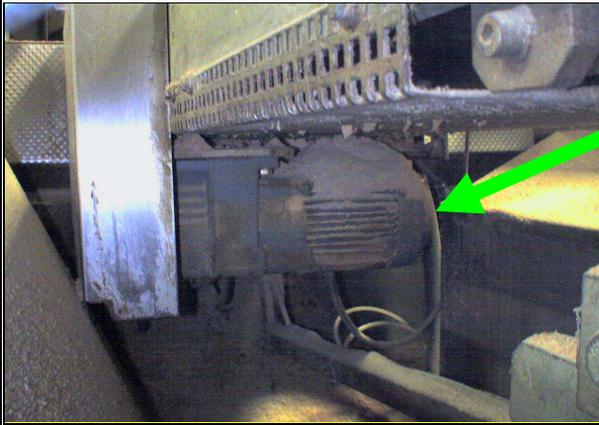
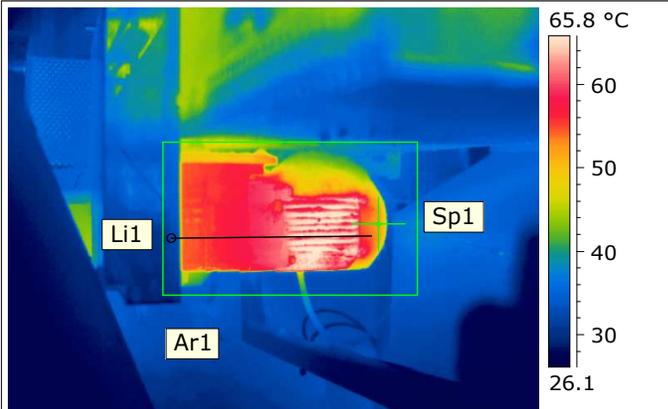
Location	A Plant Crustless Slicer
Equipment	Infeed Conveyor
Type	SEW Motor Gearbox

Object Parameters	Value
Atmospheric Temperature	21.0 °C
Sp1 Temperature	52.0 °C
Ar1 Max. Temperature	67.8 °C
Emissivity	0.95
Object Distance	1.2 m
Reflected Apparent Temperature	21.0 °C
Image File name	IR_14706.jpg
Difference Ar1 - Sp1	15.8 °C
Fault Rating	Priority 2

Elevated temperatures noted on motor gearbox surfaces.

Likely cause of heat rise is poor air movement / cooling across the unit.

Check / clean the fan cowling to ensure maximum air movement & cooling.

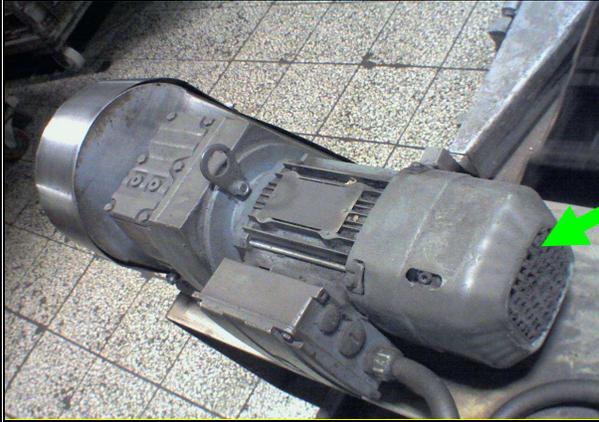
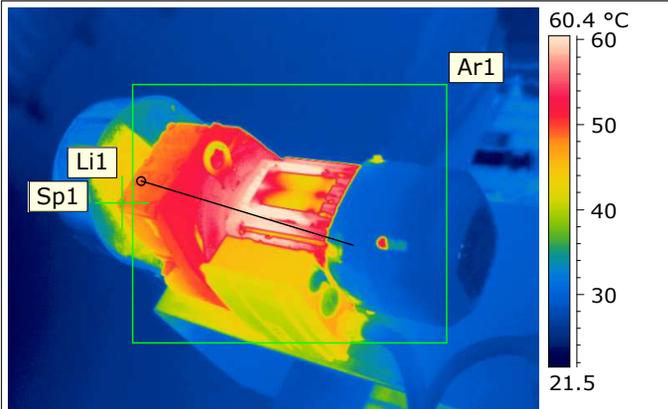
Location	B Plant Tin Return System
Equipment	Diverter Conveyor
Type	SEW Motor Gearbox

Object Parameters	Value
Atmospheric Temperature	21.0 °C
Sp1 Temperature	48.8 °C
Ar1 Max. Temperature	62.0 °C
Emissivity	0.95
Object Distance	1.2 m
Reflected Apparent Temperature	21.0 °C
Image File name	IR_14708.jpg
Difference Ar1 - Sp1	13.3 °C
Fault Rating	Priority 2

Elevated temperatures noted on motor gearbox surfaces.

Likely cause of heat rise is poor air movement / cooling across the unit.

Check / clean the fan cowling to ensure maximum air movement & cooling.

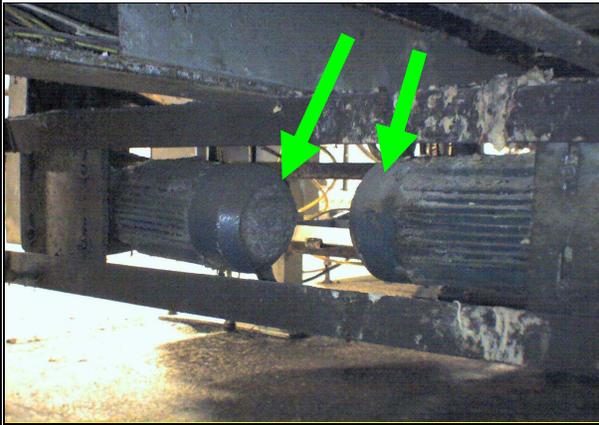
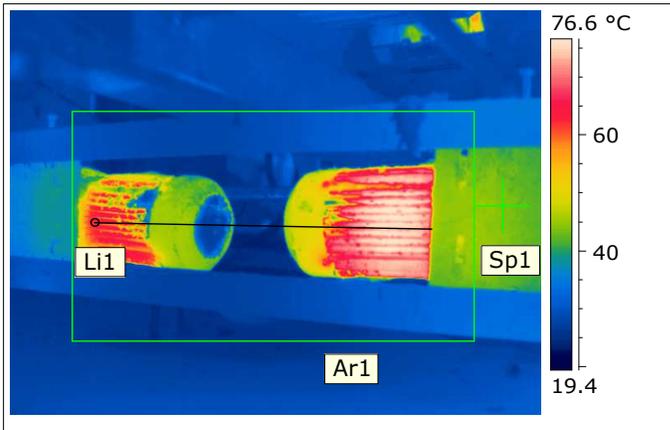
Location	B Plant Tin Return System
Equipment	Conveyor Under Moulder B257
Type	SEW Motor Gearbox

Difference Ar1 - Sp1	33.3 °C
Fault Rating	Priority 2

Elevated temperatures noted on both motor gearbox surfaces.

Likely cause of heat rise is poor air movement / cooling across the units.

Check / clean the fan cowlings to ensure maximum air movement & cooling.
