Thermographic BREEAM Compliance Survey

SAMPLE REPORT

Pixel Thermographics

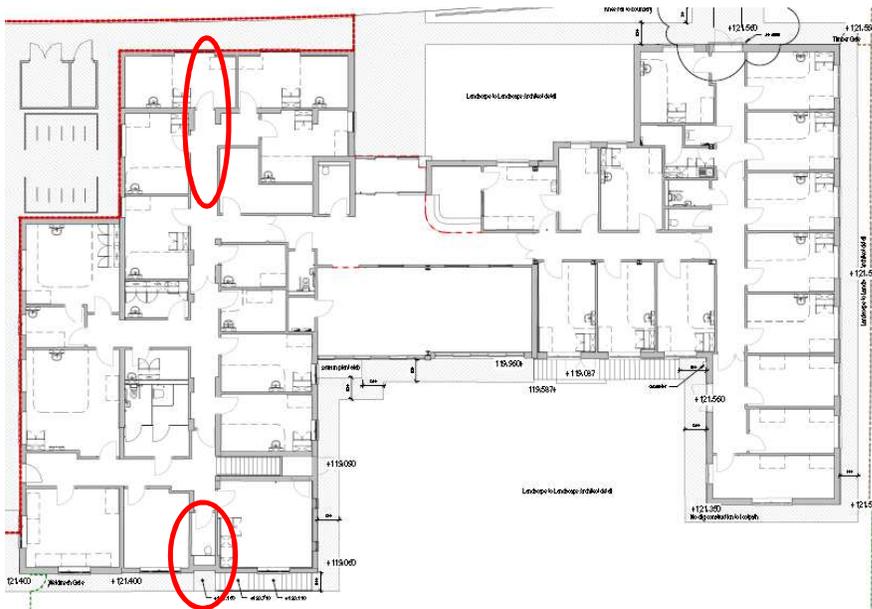
- Air Leakage / Heat Build Up within Void Above WC adjacent the staff room
- Air Leakage Due to heat Build Up in Roof Void

The areas circled above highlight the areas where air leakage was noted and which should be investigated and prevented.

Assuming that the remedial work is carried out to the areas of concern then this will assure conformation of compliance with the requirements for a thermographic survey in relation to BREEAM accreditation.

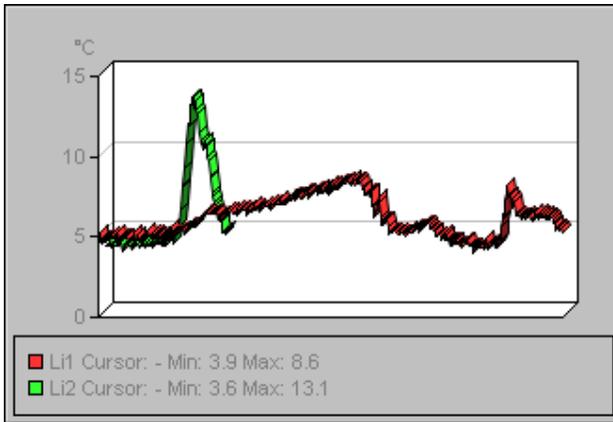
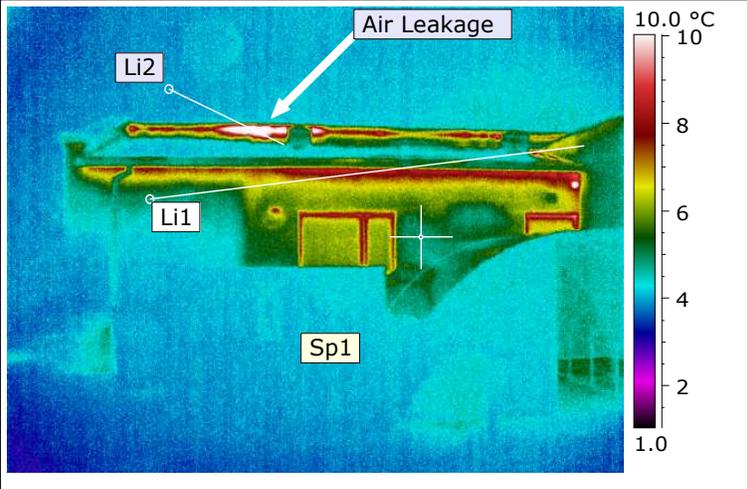
West Elevation

Suspected air leakage noted from upper ridge of roof which should be investigated to ascertain source of heat in this roof void. This should be prevented.

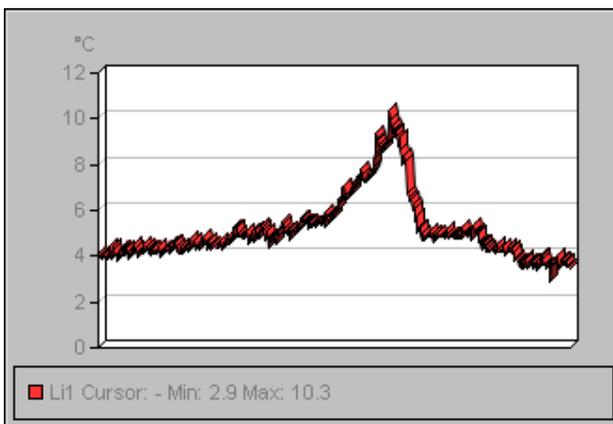
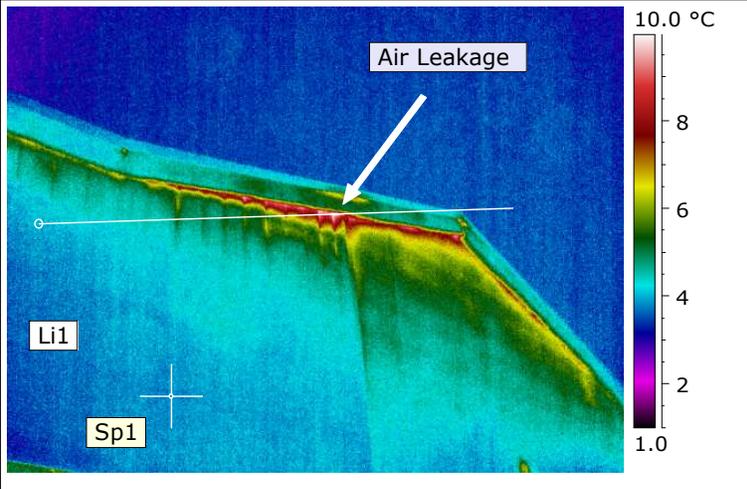
North Elevation

Suspected air leakage noted from upper ridge of roof which should be investigated to ascertain source of heat in this roof void. This should be prevented.

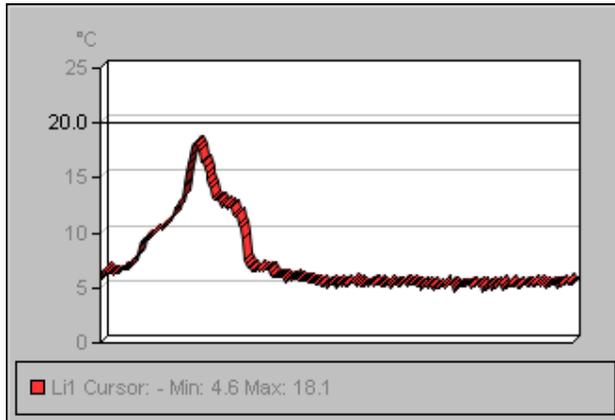
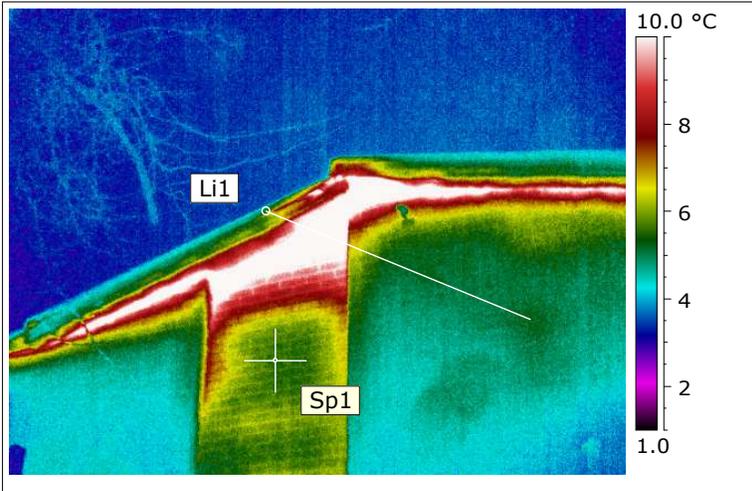
South Elevation

Thermal image highlights air leakage from soffit area. Heat build-up noted within the void behind this wall. Internal inspection (in WC) revealed radiant panel in ceiling with no insulation above resulting in heating of the void and heat escape from soffit as seen in thermal image.

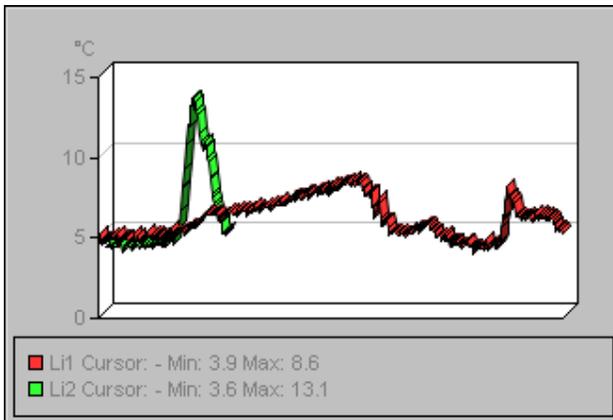
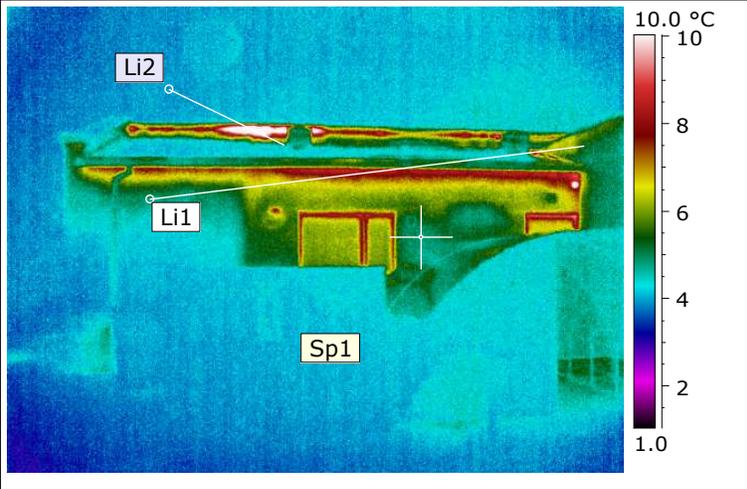
West Elevation

No insulated surfaces exceed the threshold temperature.
No evidence of thermal bridging.
Suspected air leakage noted from upper ridge of roof which should be investigated to ascertain source of heat in this roof void.

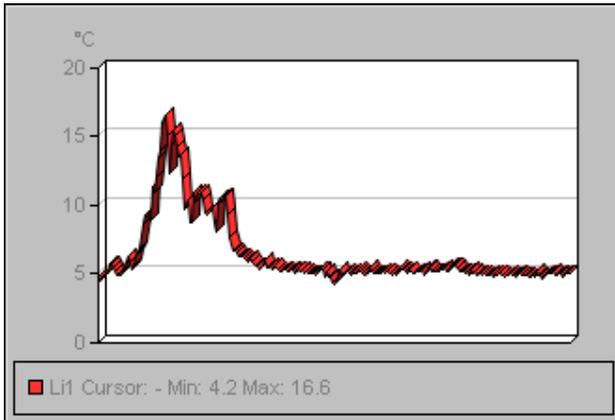
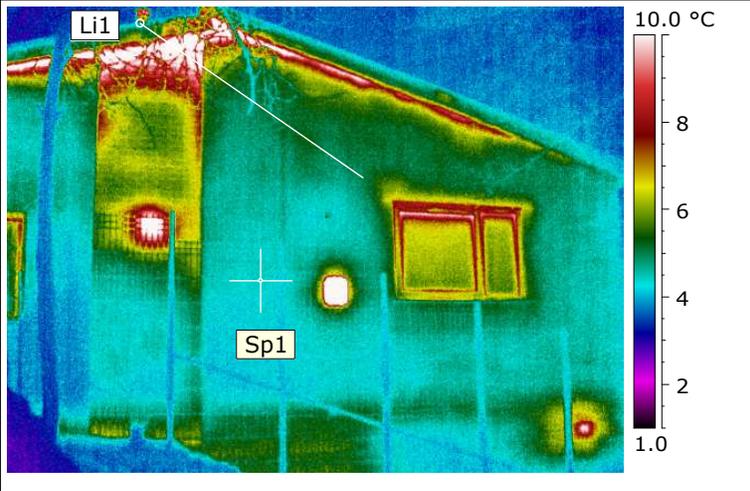
South Elevation

No insulated surfaces exceed the threshold temperature.
No evidence of thermal bridging.
Air leakage noted from area of wall where void is located.

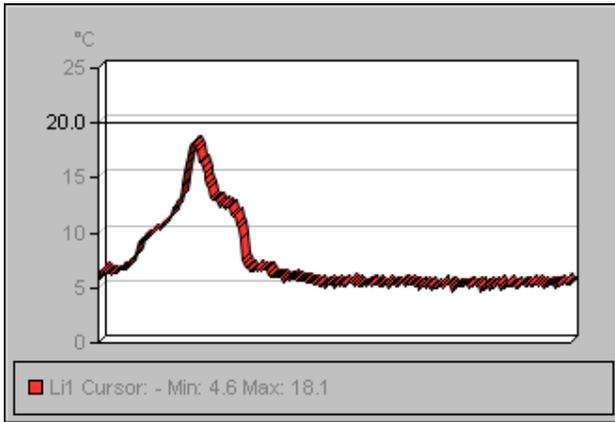
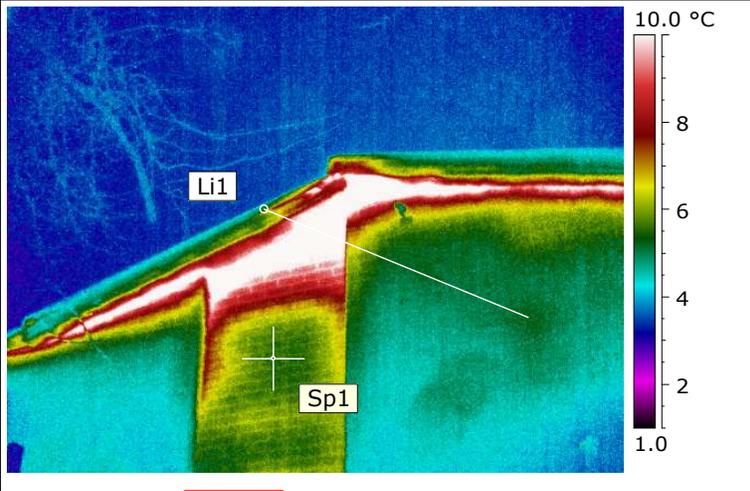
South Elevation

Thermal image highlights air leakage from soffit area. Heat build-up noted within the void behind this wall. Internal inspection (in WC) revealed radiant panel in ceiling with no insulation above resulting in heating of the void and heat escape from soffit as seen in thermal image.

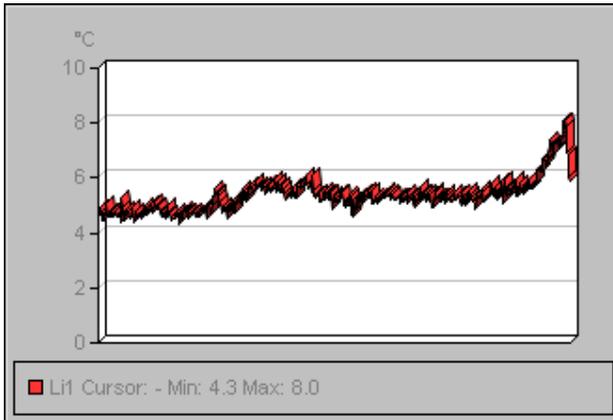
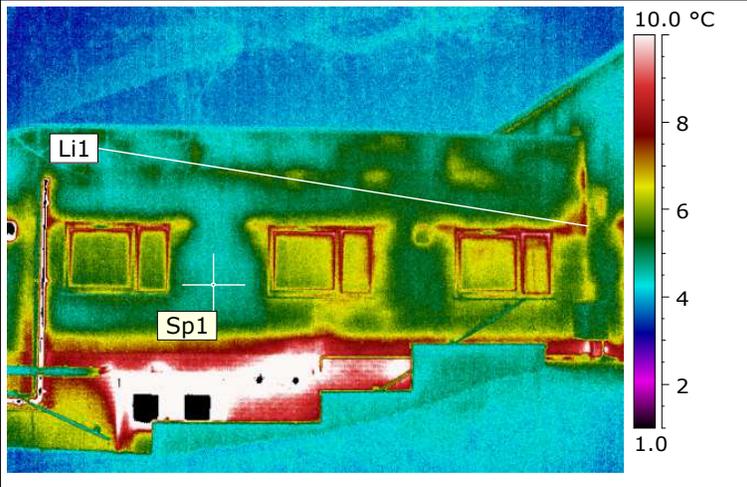
South Elevation

No insulated surfaces exceed the threshold temperature.
 No evidence of thermal bridging.
 No air leakage noted.
 Heat escape from boiler room noted which produces anomalies on this wall – this should be ignored.

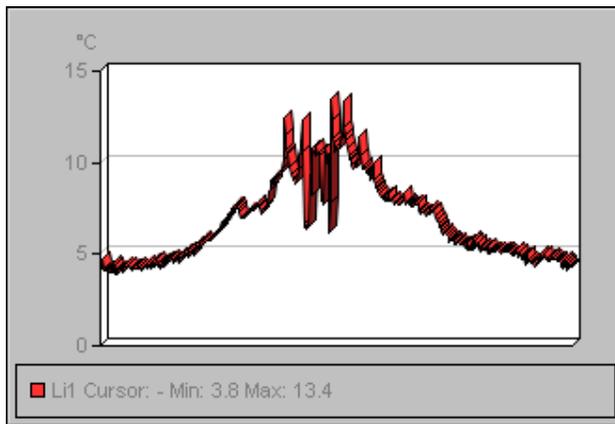
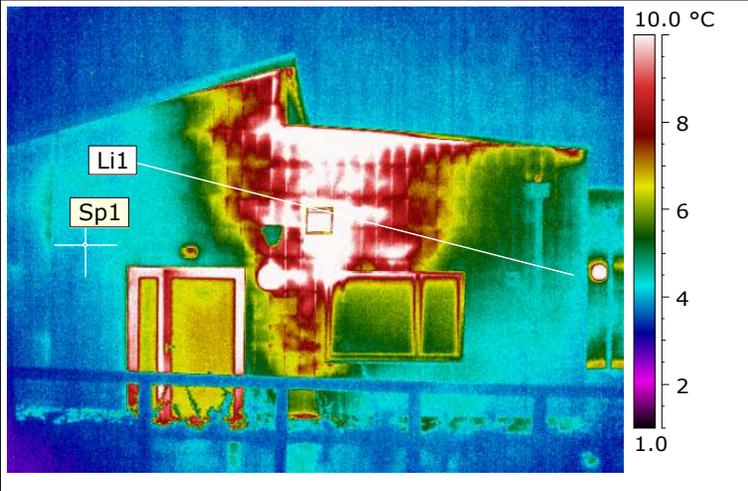
North Elevation

No insulated surfaces exceed the threshold temperature.
No evidence of thermal bridging.
No air leakage noted.
Effects of extract air from extract system on wall should be ignored.

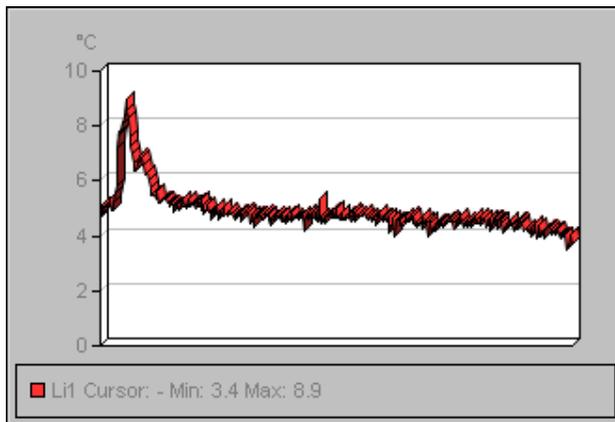
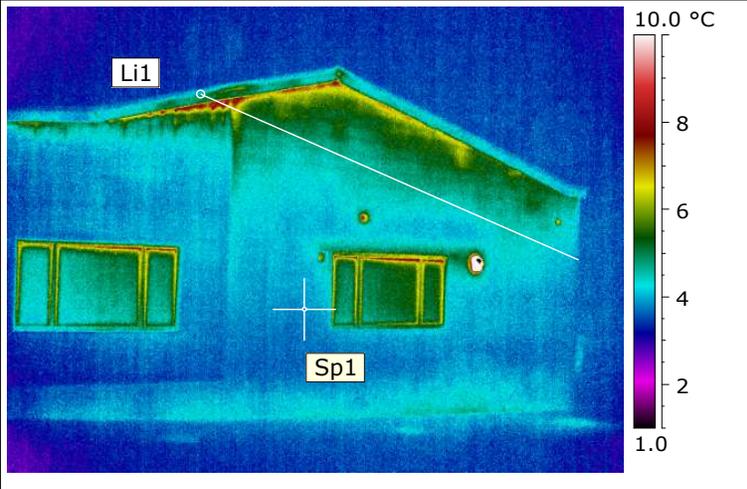
North Elevation

No insulated surfaces exceed the threshold temperature.
 No evidence of thermal bridging.
 Air leakage noted from soffit area.
 Investigation as to source of heat within the roof void required to prevent heat losses.

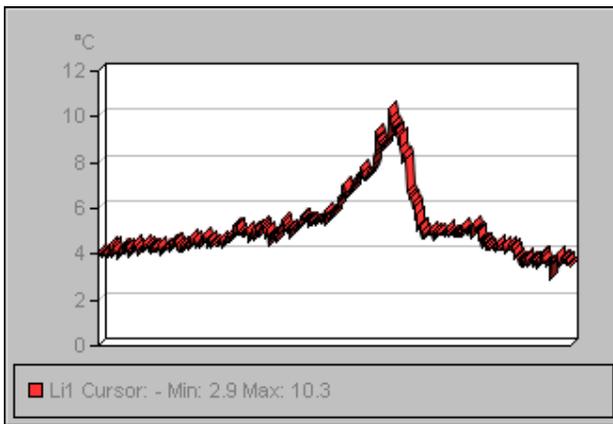
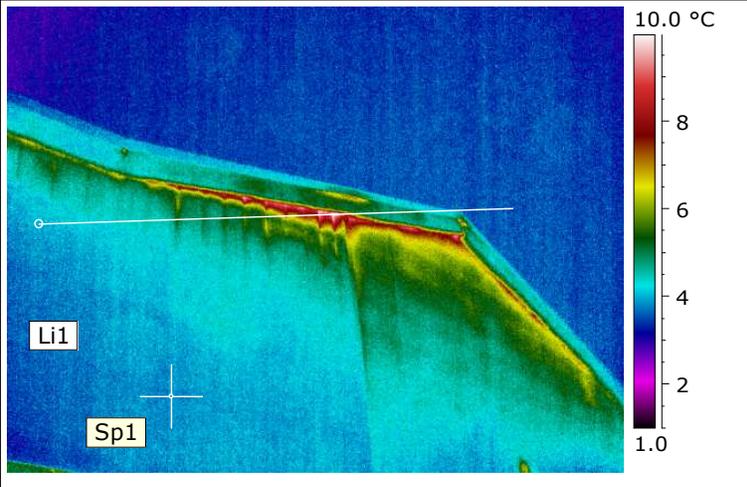
North Elevation

Thermal image highlights air leakage from soffit area of roof.
Investigation required to ascertain the source of heat within this roof void.
