**Residential Building Thermographic Survey**

**Sample Report**

**Pixel Thermographics Ltd**

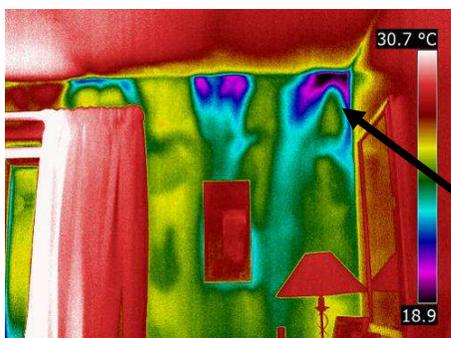
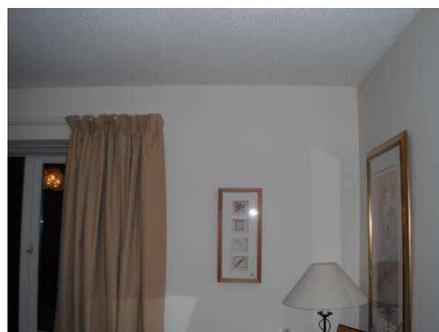
The survey highlighted significant cooling within the property due to cold air movement behind plasterboard walls. This air appears to enter behind the walls from within the loft where it is suspected that the tops of the plasterboard walls are not sealed.

*Cold air movement behind plasterboard walls*

This cold air movement will significantly cool the affected areas. The tops of the plasterboard walls should be sealed or blocked off within the attic area to prevent this cooling effect.

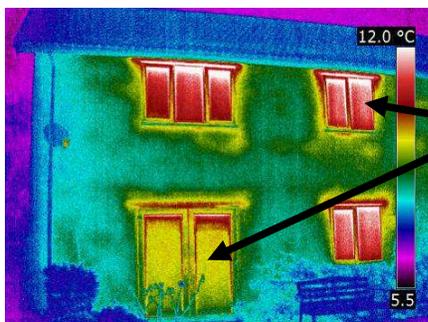
The double glazed units within the property appear to be less effective in terms of insulating performance than expected. The windows may have lost the gas or vacuum originally present and therefore result in higher heat losses.

*Higher heat loss from windows compared to patio door.*

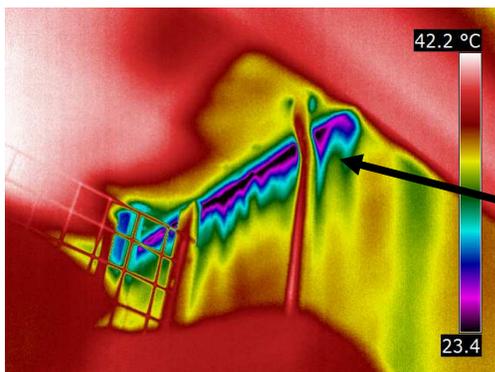
*Cold air ingress  
from visible gap  
at ceiling / wall  
detail*

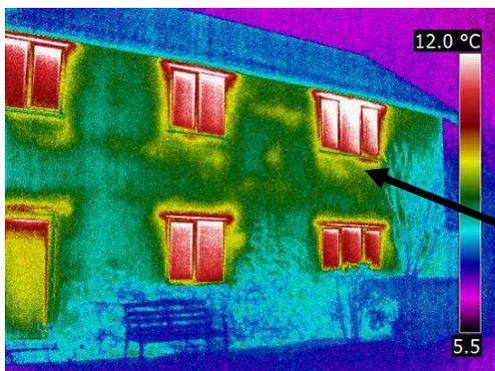
The external part of the survey has highlighted suspected gaps in the cavity wall insulation where the insulation may have sagged or settled over time.

*Possible gaps in cavity wall  
insulation are highlighted as  
warmer areas of wall.*

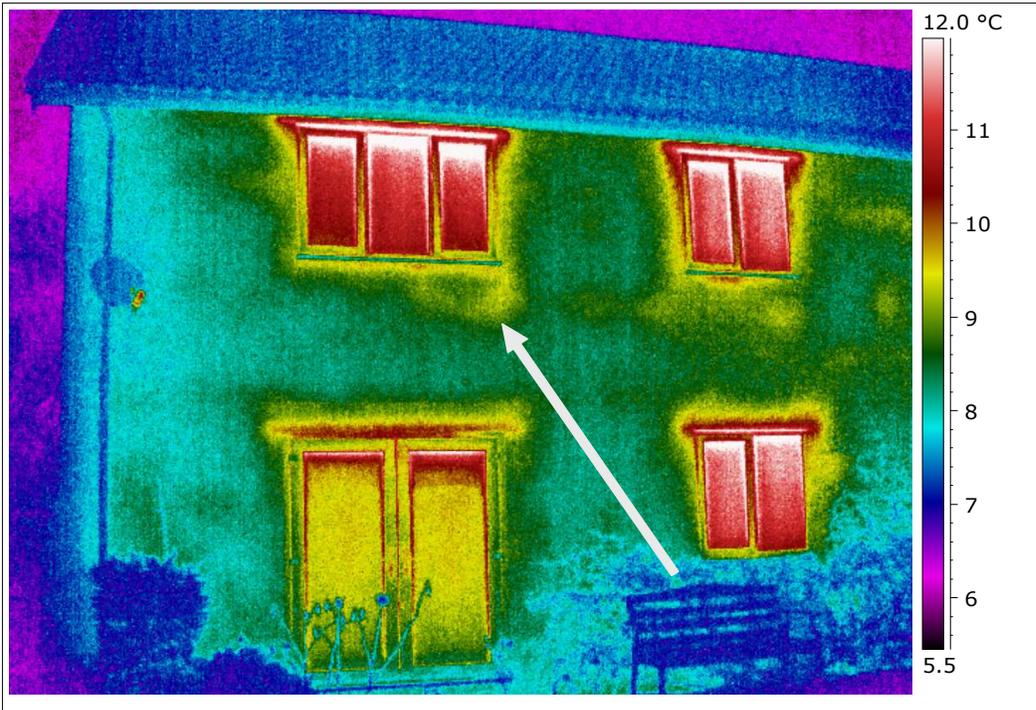
Area: External - South Elevation - Left

Thermal image highlights possible gaps in cavity wall insulation – particularly underneath and to the side of the windows where insulation may have settled over time.

The windows exhibit conductive heat losses which are higher than expected for double glazed units. These windows may have reduced insulating performance due to possible loss of gas or vacuum.

Thermal bridging noted above windows & patio door where support beams have not been insulated effectively and act as conductors for heat to be lost

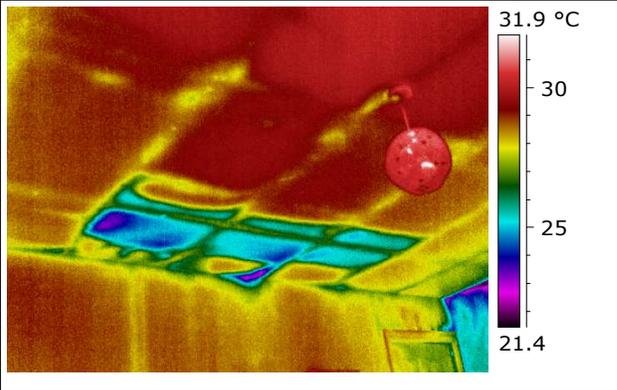
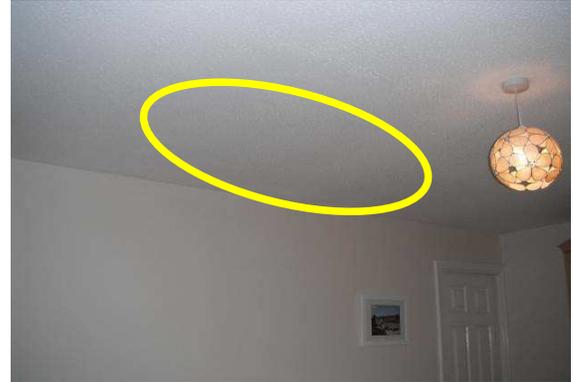
Area: 1st Floor - Master Bedroom - Ceiling

Loft insulation in this area appears consistent and effective except in the area directly below the water tank area.

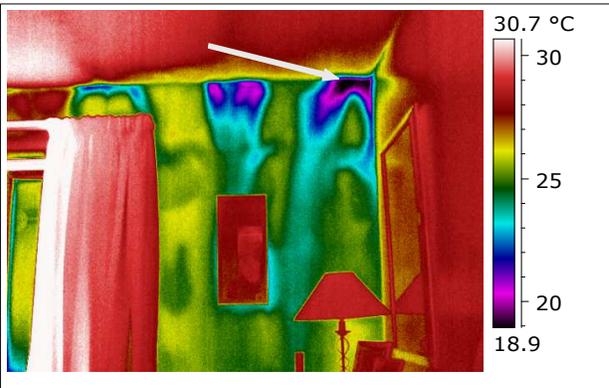
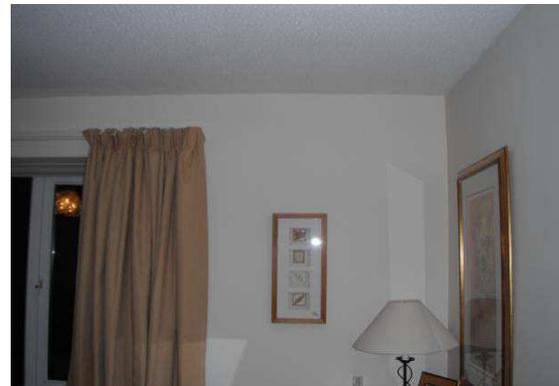
Area: 1st Floor - Master Bedroom - Wall

The cool (darker) areas on the walls indicate cold air movement behind the plasterboard walls. This cold air enters from within the loft area and results in significant cooling of the area. Any gaps at the top of the plasterboard walls should be suitably blocked to prevent this air movement.

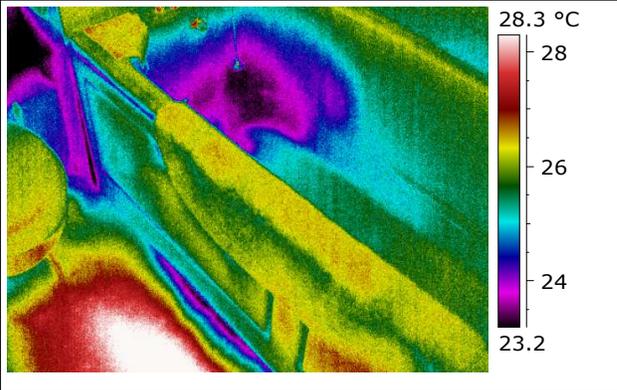
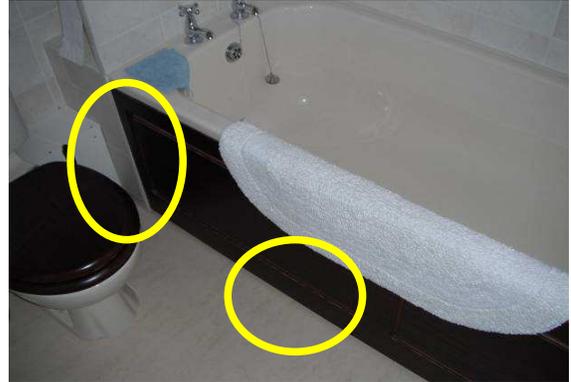
Area: 1st Floor - Master Bathroom - Bath Panels

Cool air appears to enter the room via the side and base of the bath panel. This air is likely to enter via the wall penetrations (concealed) where the pipework enters the room behind the bath. This should be sealed using suitable silicone sealant.

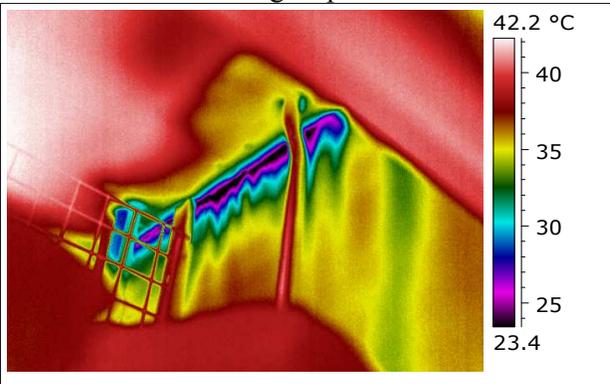
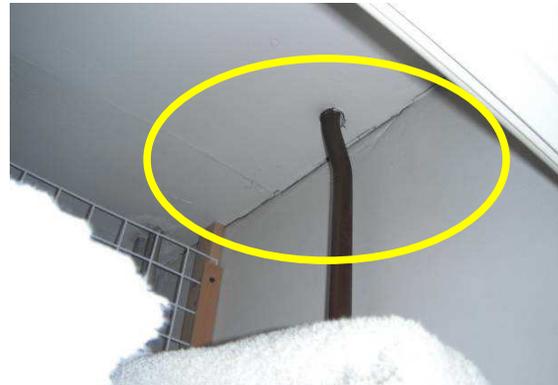
Area: 1st Floor - Airing Cupboard - Wall

Cool air enters the room via the gap between the wall and the ceiling. This gap should be suitably sealed.

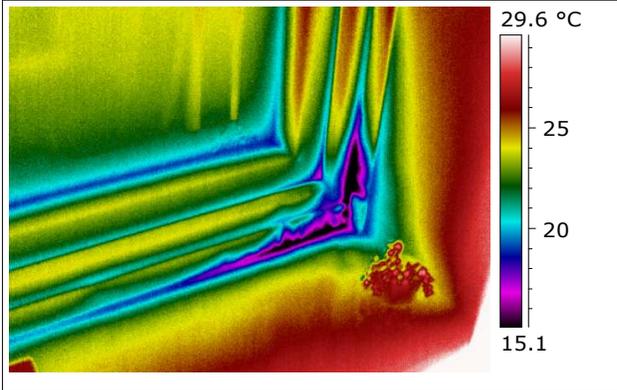
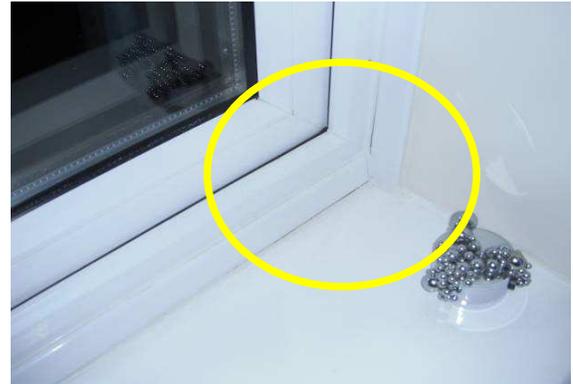
Area: 1st Floor - Bedroom 4 - Right Window

The cool (dark) areas indicate direct cold air entry into the room.  
This air appears to enter via the outside of the frame and via a visible gap in the silicone sealant. This sealant should be removed and resealed.

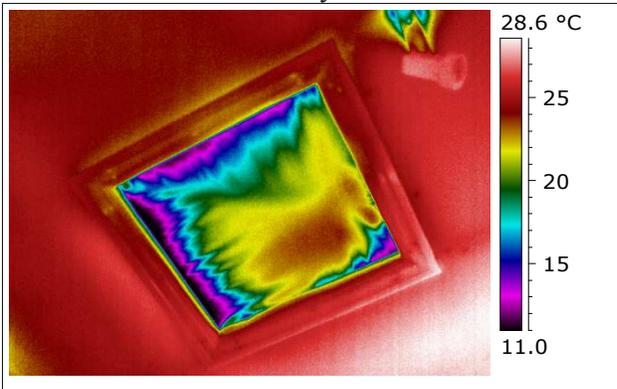
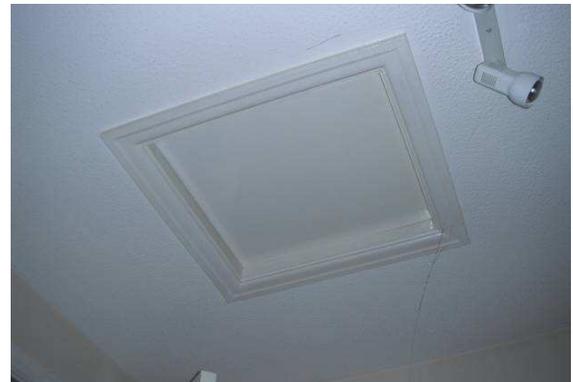
Area: Ground Floor - Study - Loft Access Hatch

Air entry into the room noted from the loft access hatch.  
A draught excluder could be fitted to prevent this cold air entry.

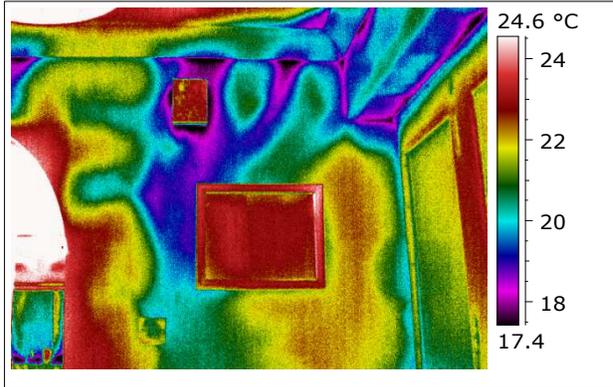
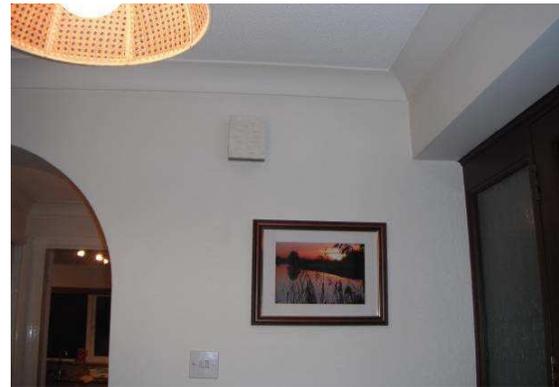
Area: Ground Floor - Entrance Hall - Wall

The cool (darker) areas indicate cold air movement behind the plasterboard walls. This cold air appears to originate from the porch area and preventing this cold air from entering the wall would help reduce heat losses in this area.

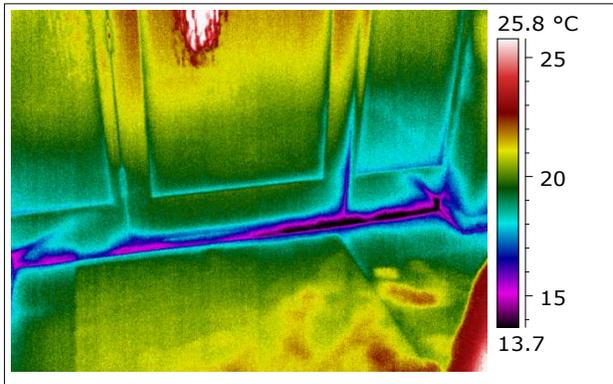
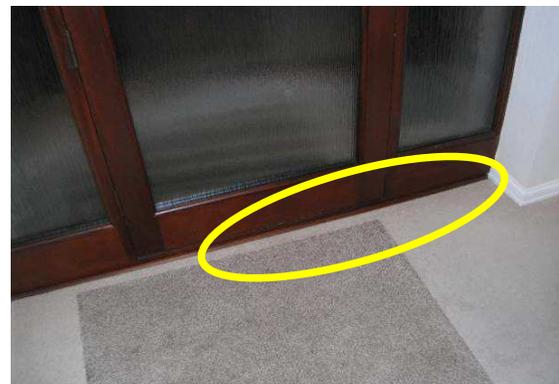
Area: Ground Floor - Entrance Hall - Front Door Frame

The cool (dark) areas indicate direct cold air entry into the room. This air appears to enter via the outside of the frame. The area directly behind the frame should be inspected and sealed appropriately.

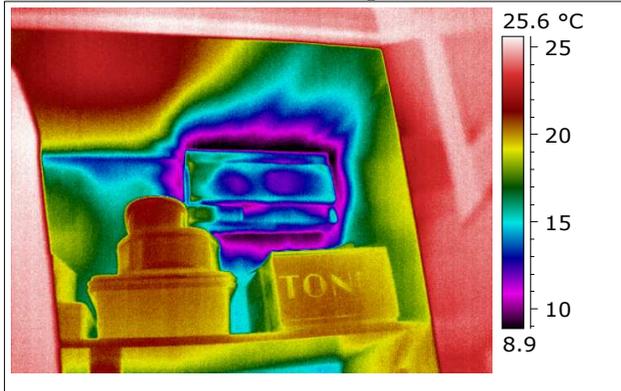
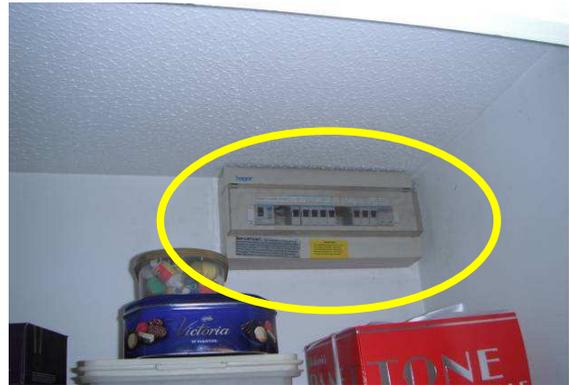
Area: Ground Floor - Boot Cupboard - Electrical Board

The cool (dark) areas indicate direct cold air entry into the room.  
This air appears to enter via the cable penetration in the wall behind which should be sealed where possible.

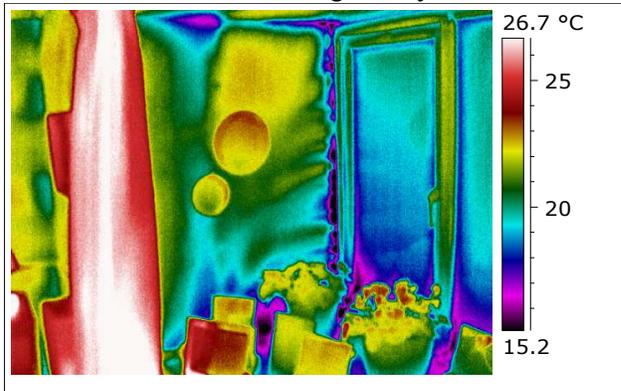
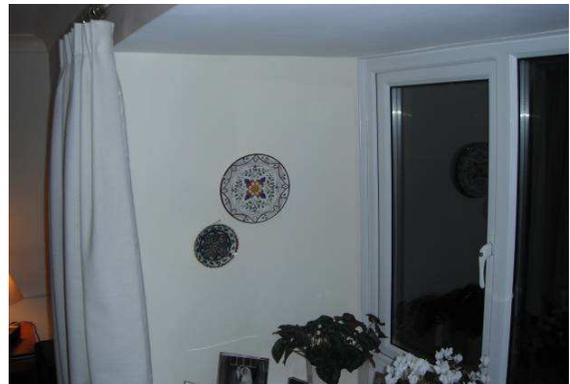
Area: Ground Floor - Lounge - Bay Window

The thermal image highlights several anomalies.  
Significant direct air ingress is noted via the sides of the window frame which appears to be poorly sealed.  
Additionally, air appears to move behind the sides of the dormer construction plasterboard walls. Air appears to enter from the top and bottom. These areas should be inspected externally to locate any gaps which should then be effectively sealed.

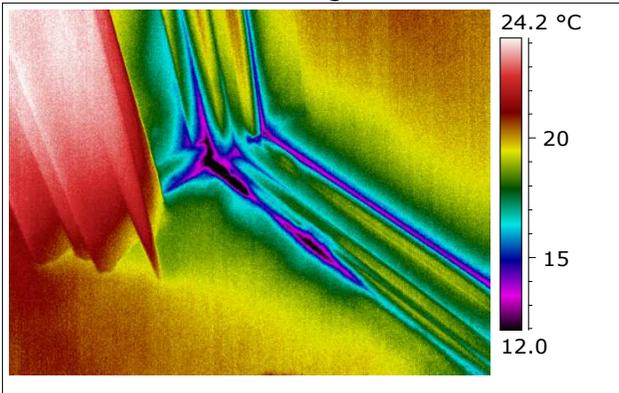
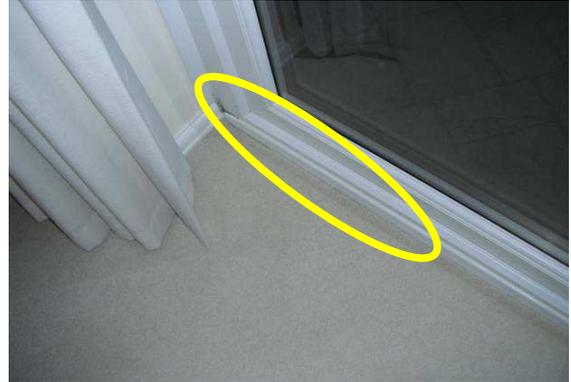
Area: Ground Floor - Lounge - Patio Door

Air ingress noted from the frame at the base of the door.  
The area directly outside this point should be inspected and sealed appropriately.

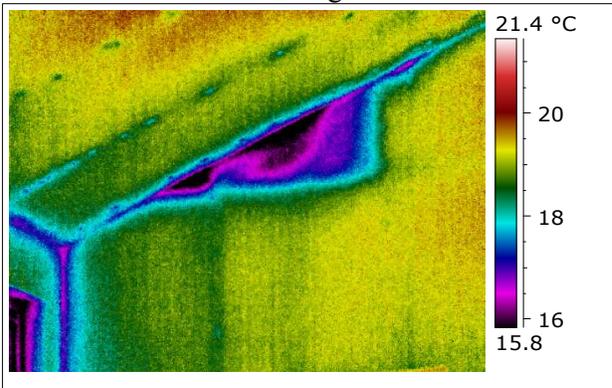
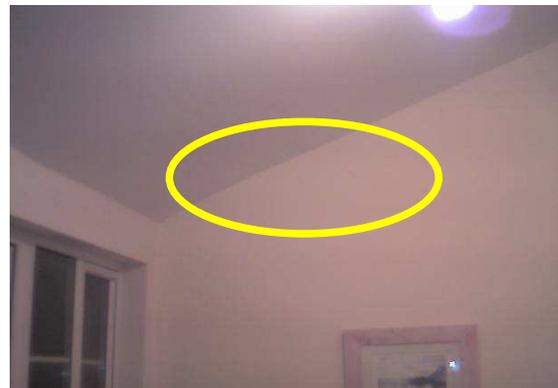
Area: Ground Floor - Lounge - Wall

The thermal image highlights a missing section of insulation at the top of the wall towards the patio door.
