Compressed Air Leak Survey

SAMPLE REPORT

Bury St Edmunds

Pixel Thermographics Ltd

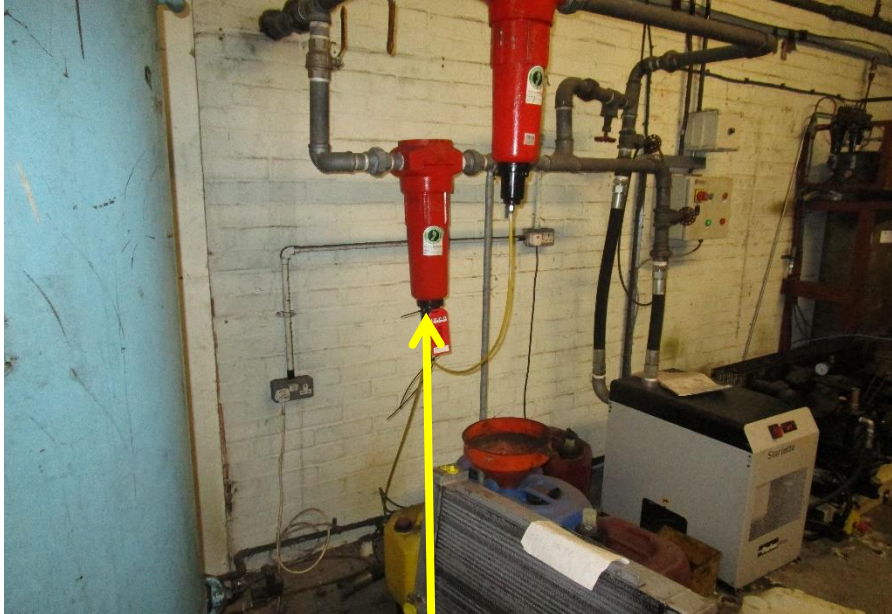
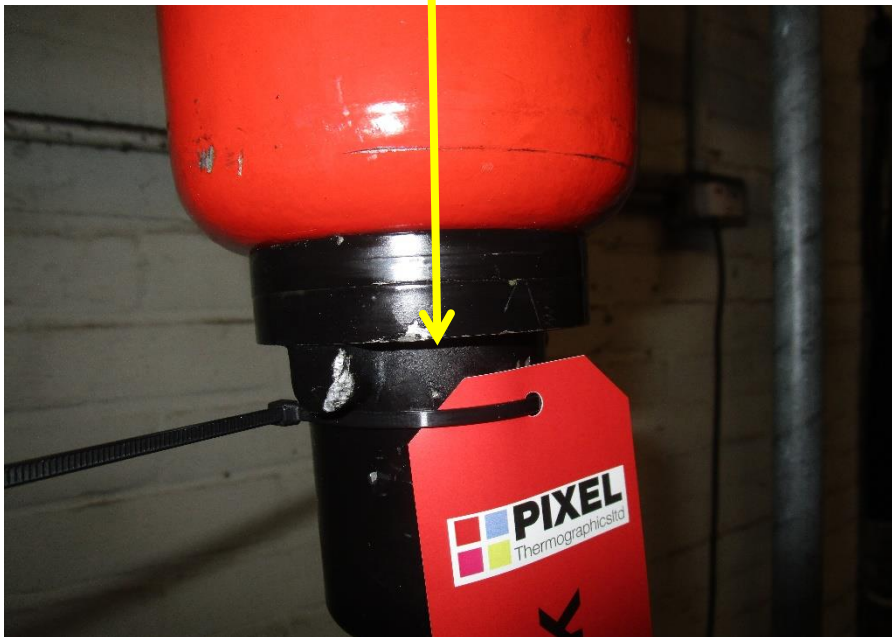
Leak No.	Location	Nature of Leak	Level
1	Compressor House	Leak From Filter Body	1

Annual Cost of Leak:	£86
-----------------------------	------------

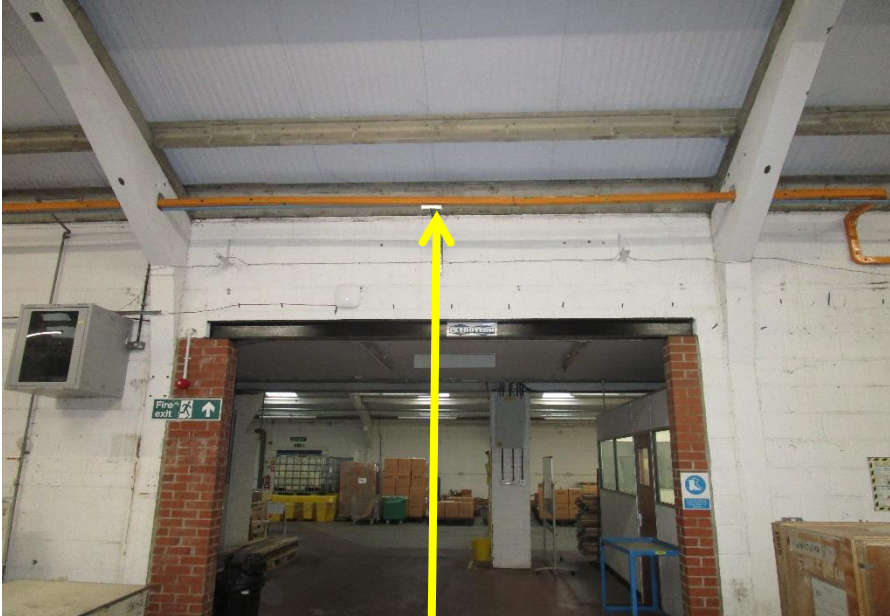
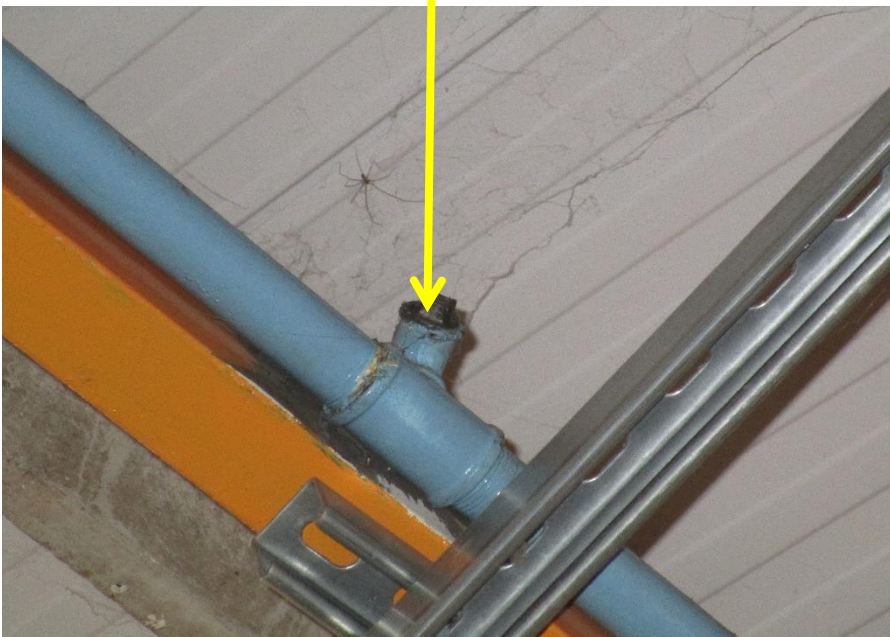
Leak No.	Location	Nature of Leak	Level
2	Stores	Leak From Threaded Pipe Blank Connection High Level (No Label Attached)	1

Annual Cost of Leak:	£86
-----------------------------	------------

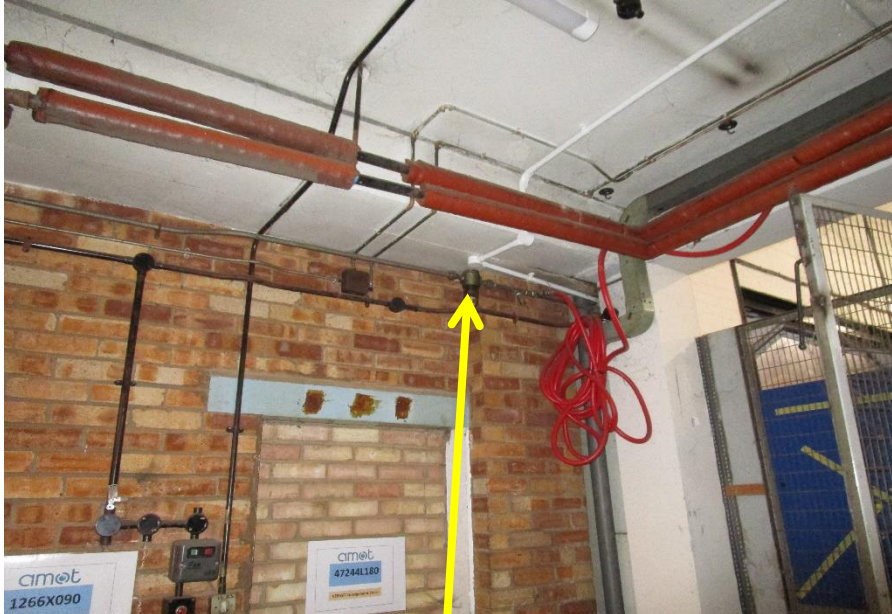
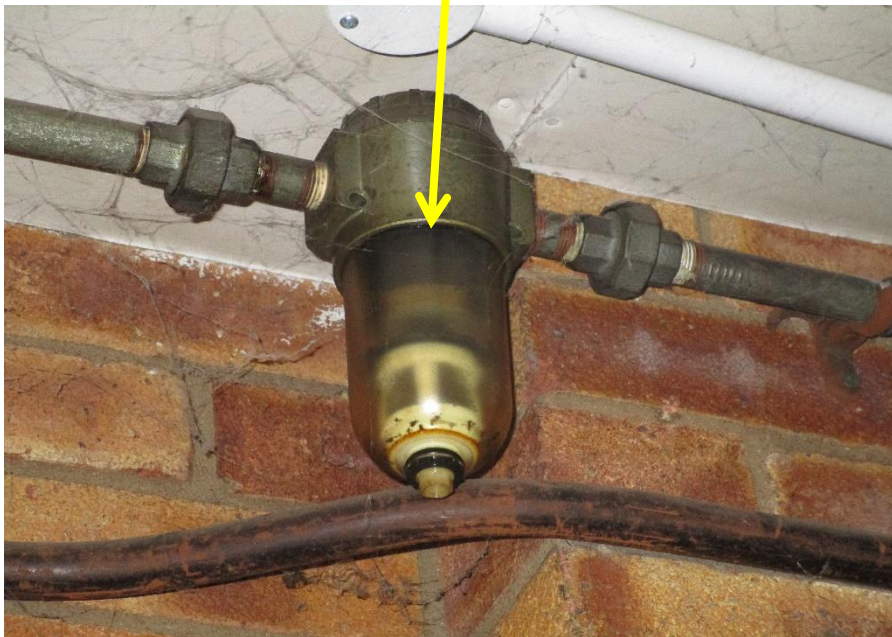
Leak No.	Location	Nature of Leak	Level
3	Stock Room	Leak From Filter Body	3

Annual Cost of Leak:	£672
-----------------------------	-------------

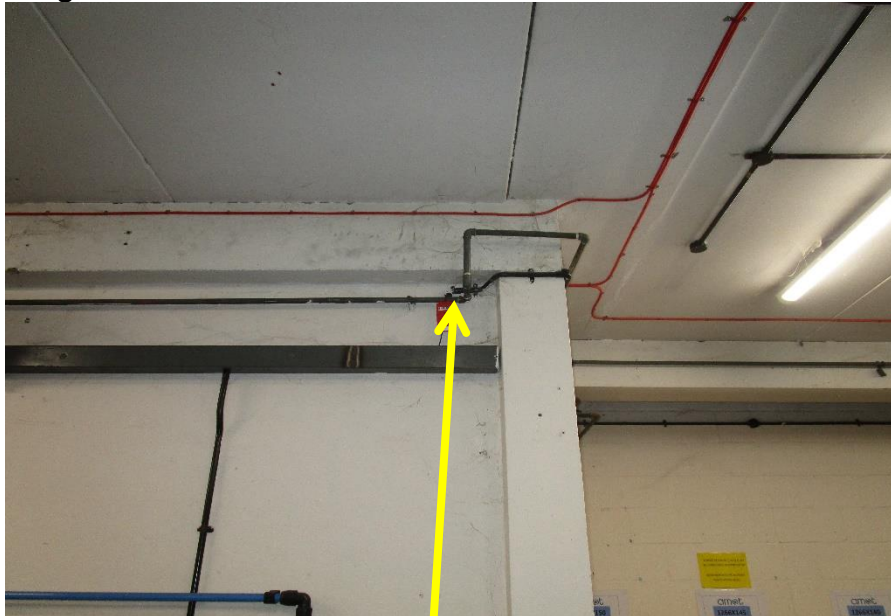
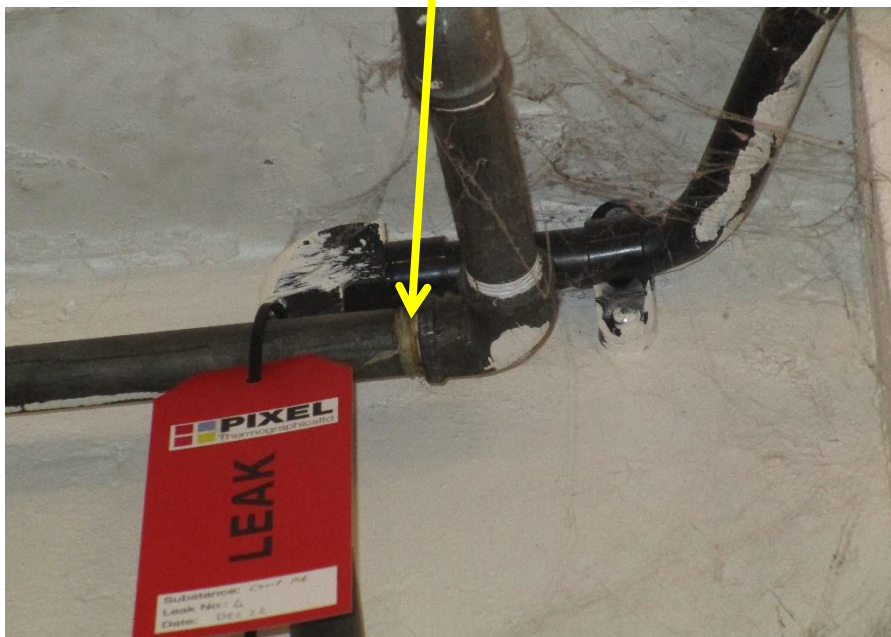
Leak No.	Location	Nature of Leak	Level
4	Stock Room	Leak From Threaded 90 Degree Bend	1

Annual Cost of Leak:	£86
-----------------------------	------------

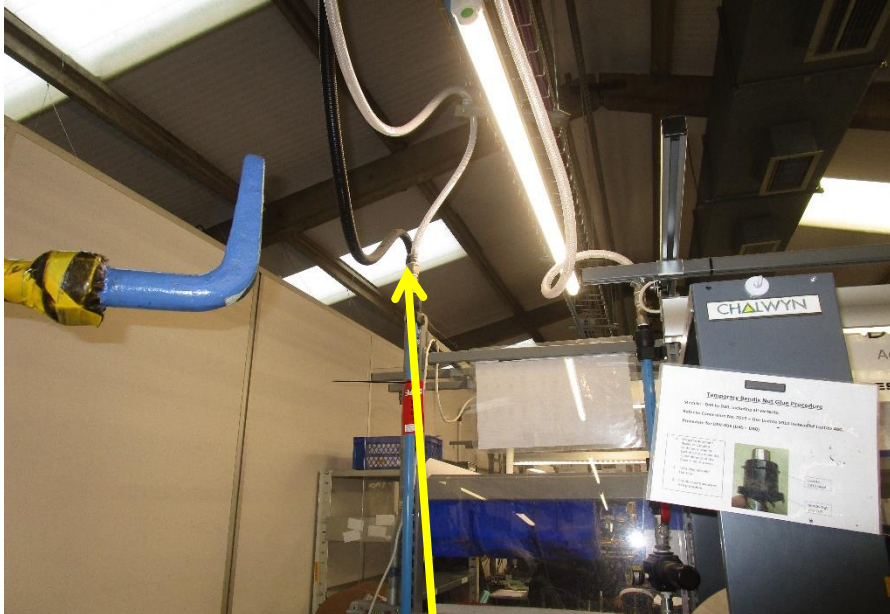
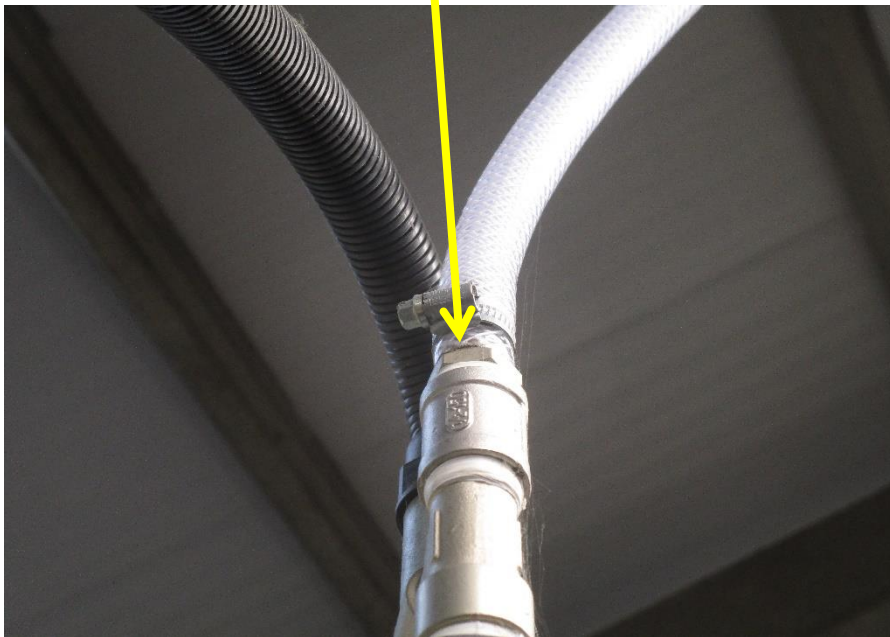
Leak No.	Location	Nature of Leak	Level
5	Dess Chalwyn Dess 9	Leak From Jubilee Hose Connection	2

Annual Cost of Leak:	£336
-----------------------------	-------------

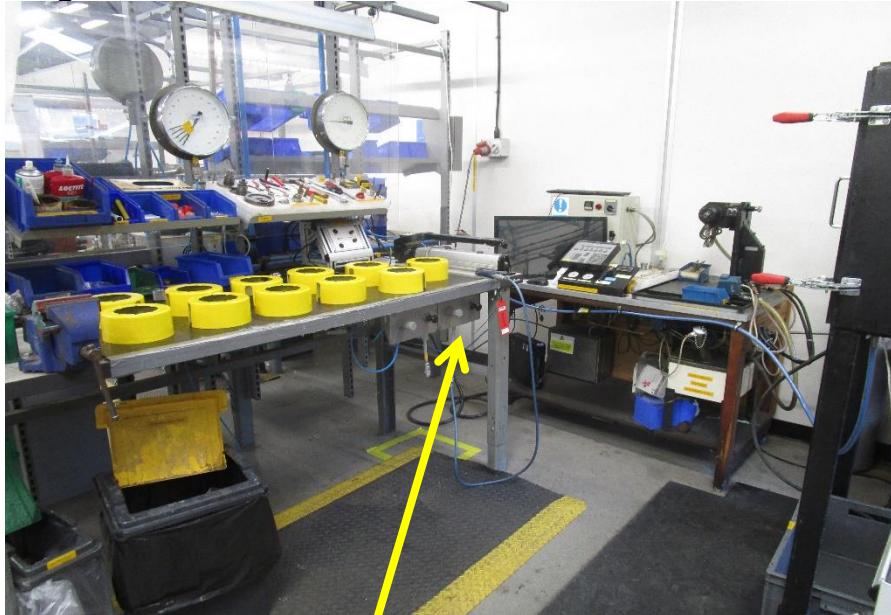
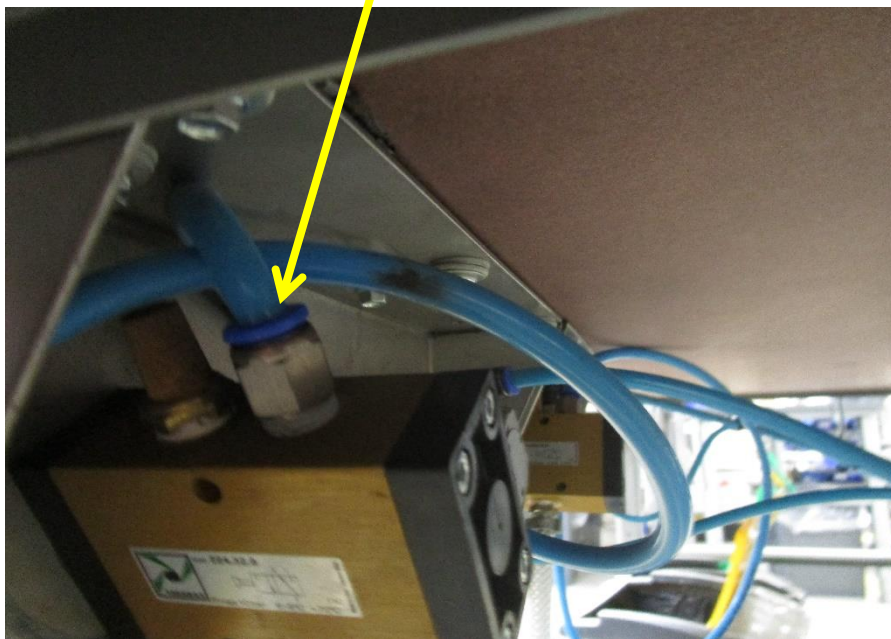
Leak No.	Location	Nature of Leak	Level
6	Dess Chalwyn Dess 0	Leak From Push Fit Hose Connection Under Work Station	2

Annual Cost of Leak:	£336
-----------------------------	-------------

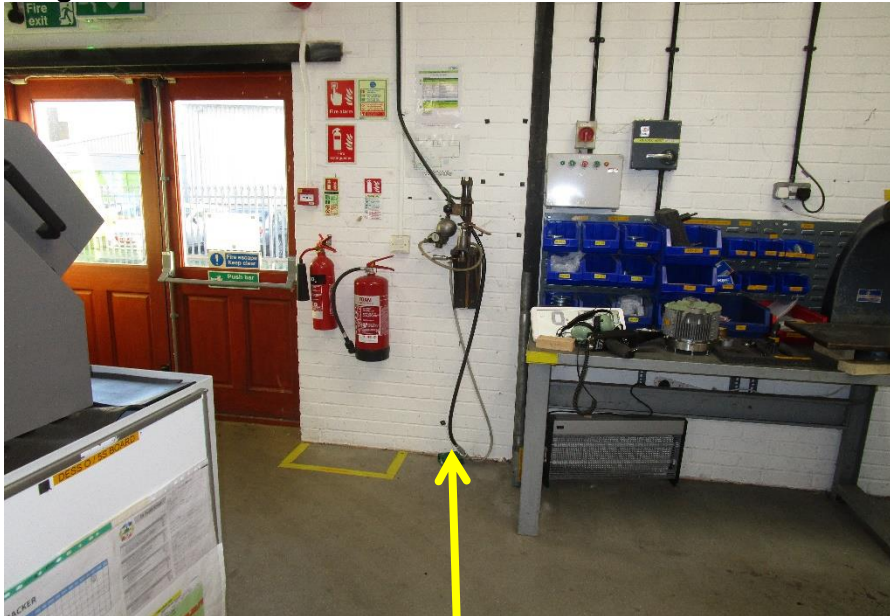
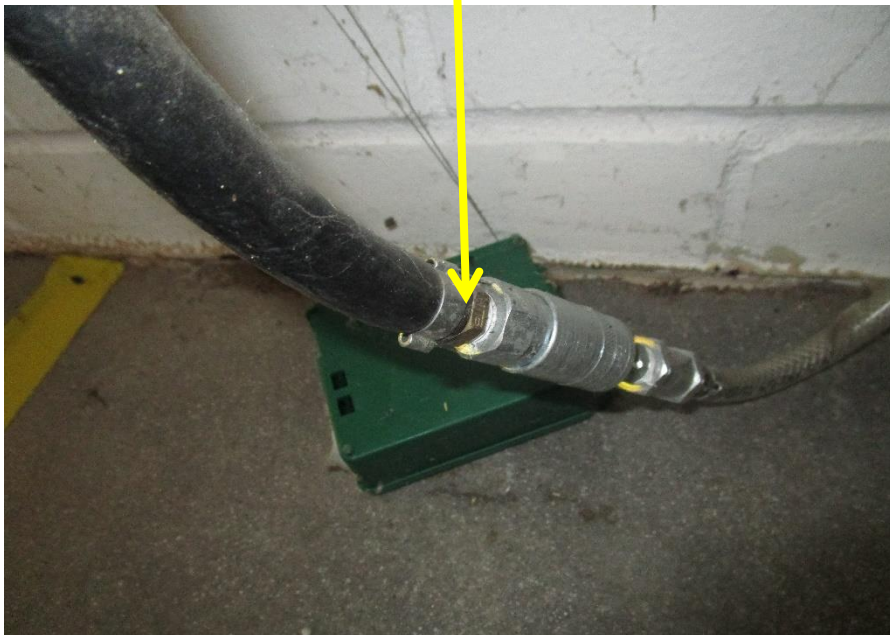
Leak No.	Location	Nature of Leak	Level
7	Dess Chalwyn	Leak From Crimped Hose Connection	1

Annual Cost of Leak:	£86
-----------------------------	------------

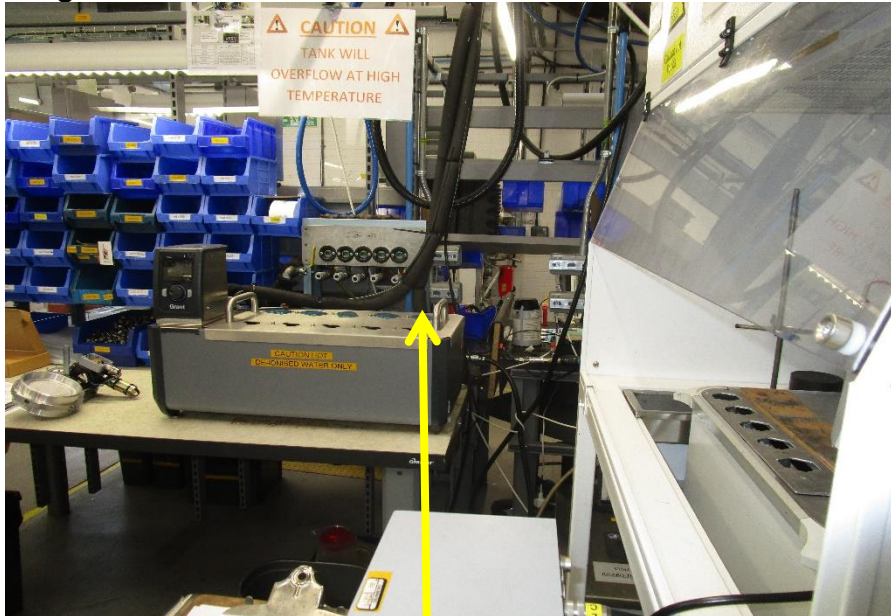
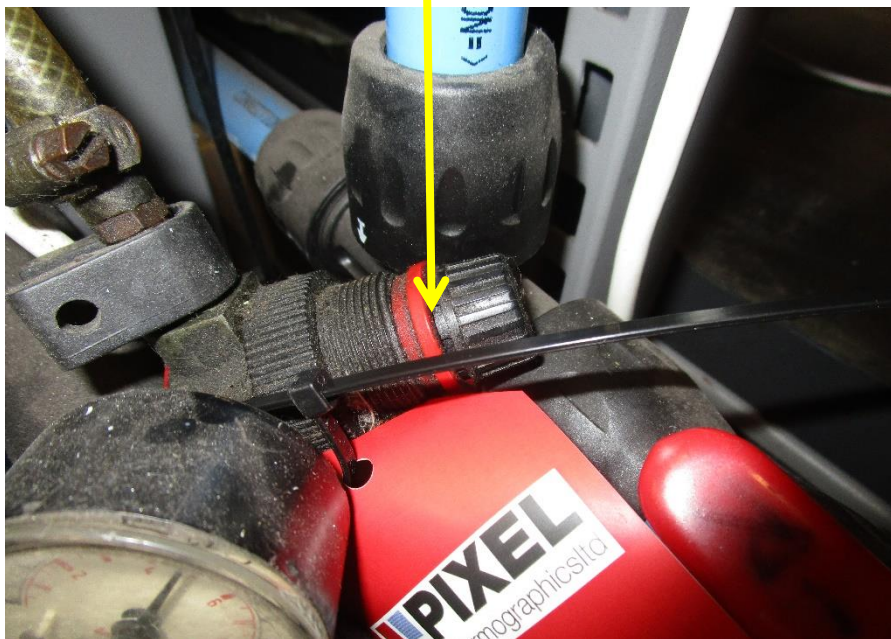
Leak No.	Location	Nature of Leak	Level
8	Dess Chalwyn Scon 2	Leak From Regulator Body	3

Annual Cost of Leak:	£672
-----------------------------	-------------

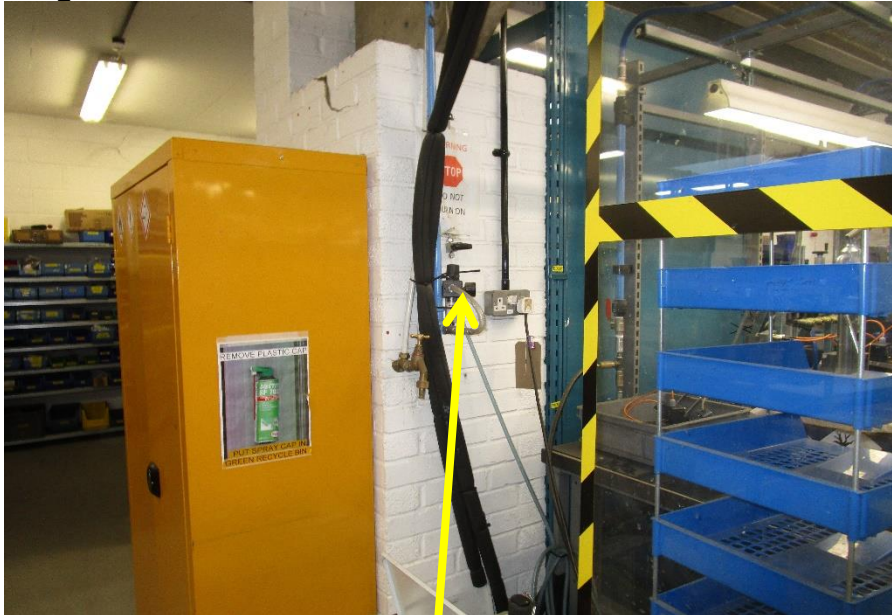
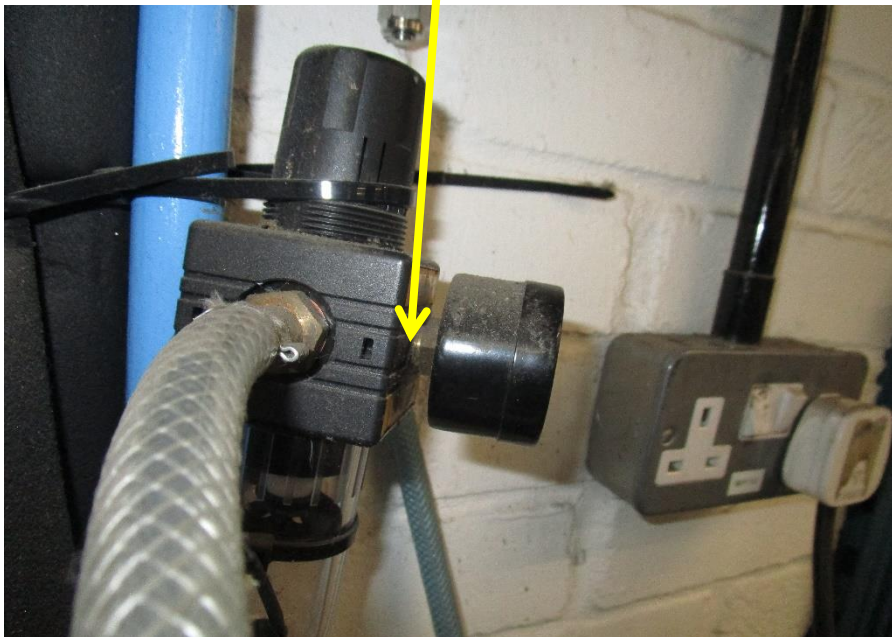
Leak No.	Location	Nature of Leak	Level
9	Dess Chalwyn Scon 1	Leak From Threaded Filter Connection to Gauge	1

Annual Cost of Leak:	£86
-----------------------------	------------

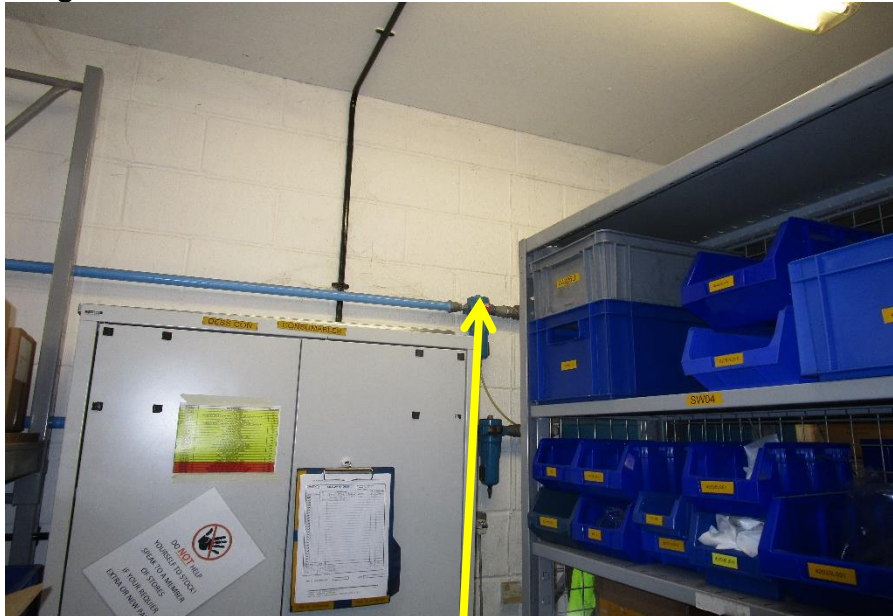
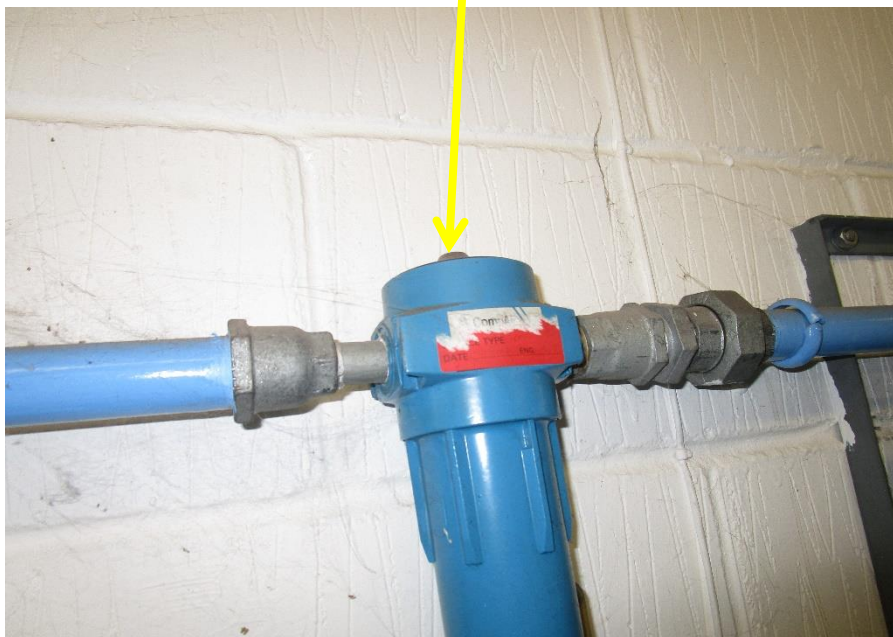
Leak No.	Location	Nature of Leak	Level
10	Dess Chalwyn	Leak From Top of Filter Body	3

Annual Cost of Leak:	£672
-----------------------------	-------------

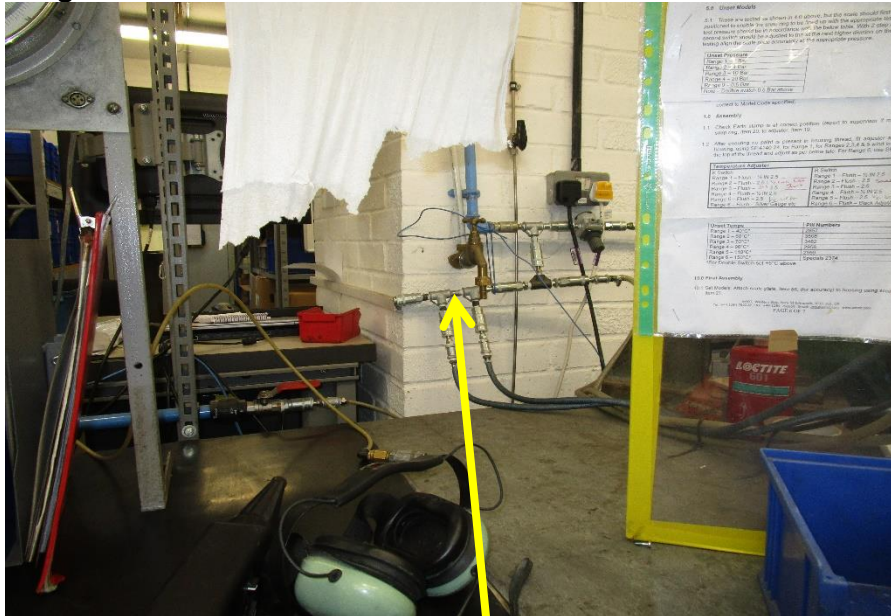
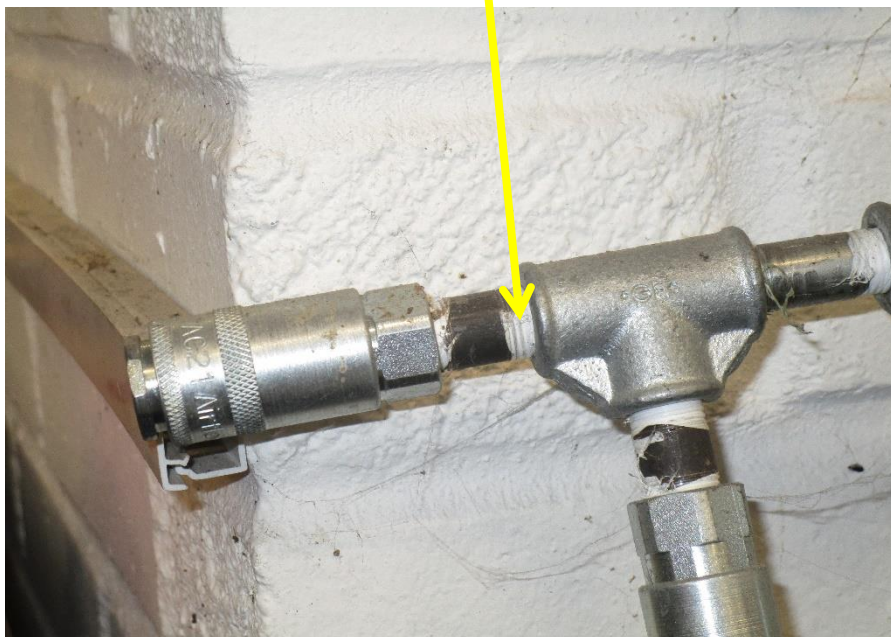
Leak No.	Location	Nature of Leak	Level
11	Dess Chalwyn Sccon 1	Leak From Threaded Connection to Tee	2

Annual Cost of Leak:	£336
-----------------------------	-------------

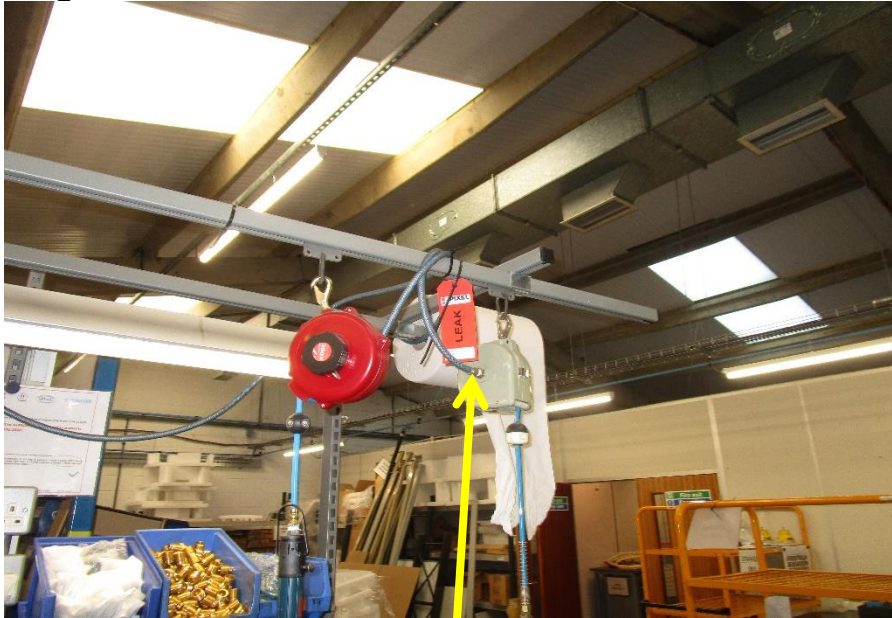
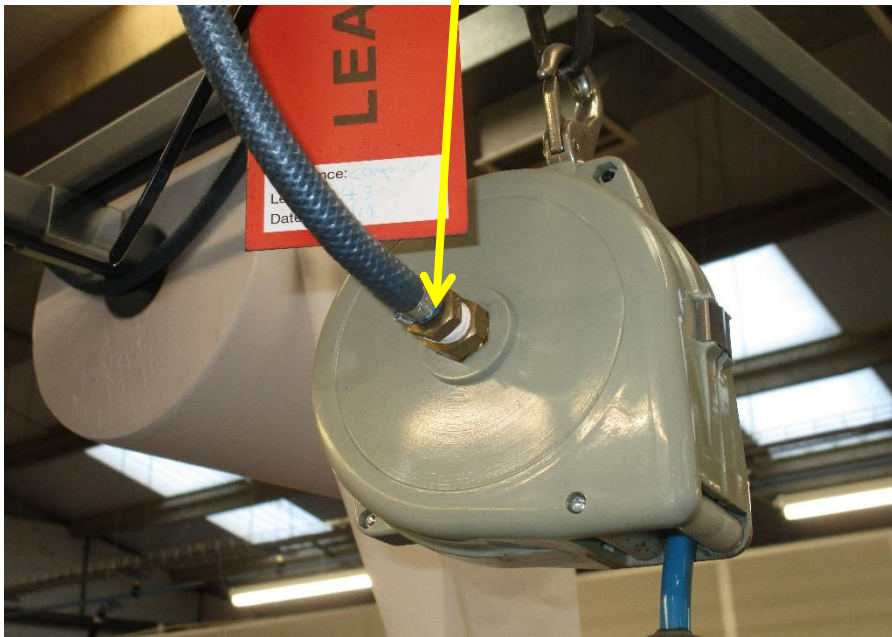
Leak No.	Location	Nature of Leak	Level
12	Dess Chalwyn Scon 1	Leak From Jubilee Hose Connection to Reel	1

Annual Cost of Leak:	£86
-----------------------------	------------

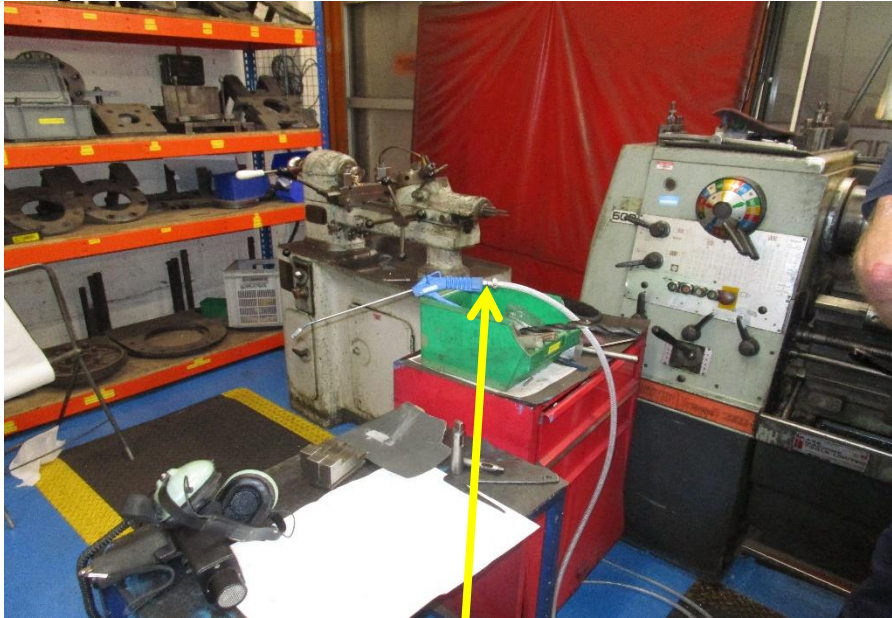
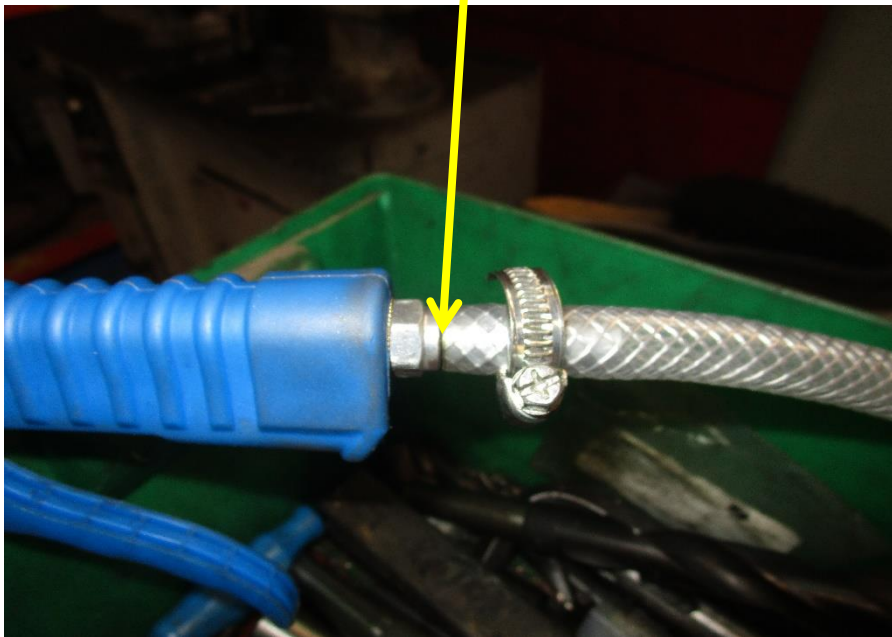
Leak No.	Location	Nature of Leak	Level
13	Lathe Area	Leak From Jubilee Hose Connection to Air Gun	2

Annual Cost of Leak:	£336
-----------------------------	-------------

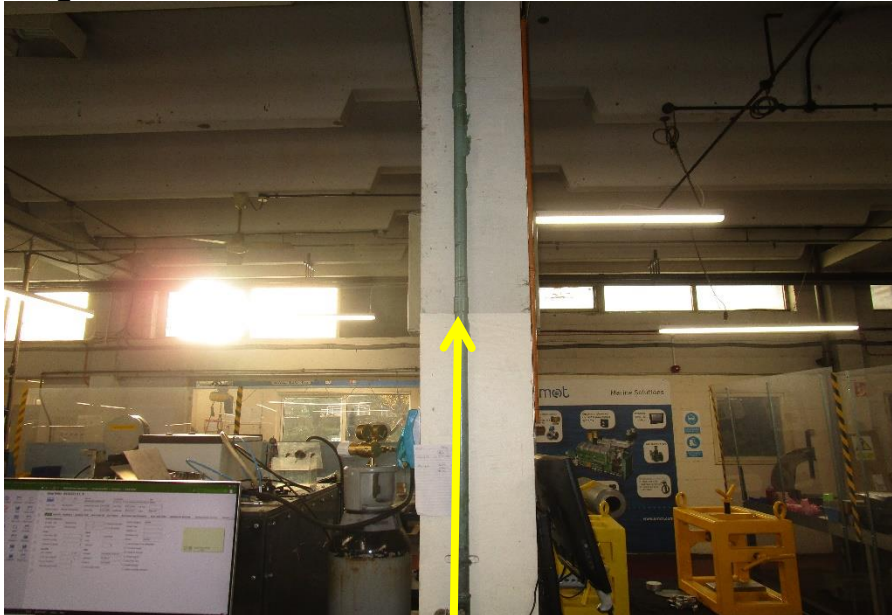
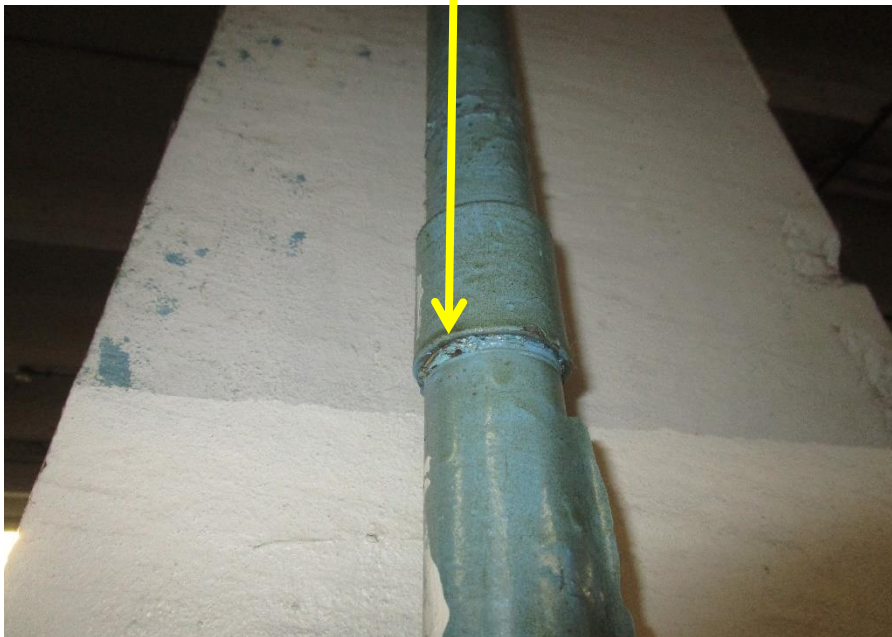
Leak No.	Location	Nature of Leak	Level
14	Air Start Area	Leak From Threaded Pipe Joint Connection	1

Annual Cost of Leak:	£86
-----------------------------	------------

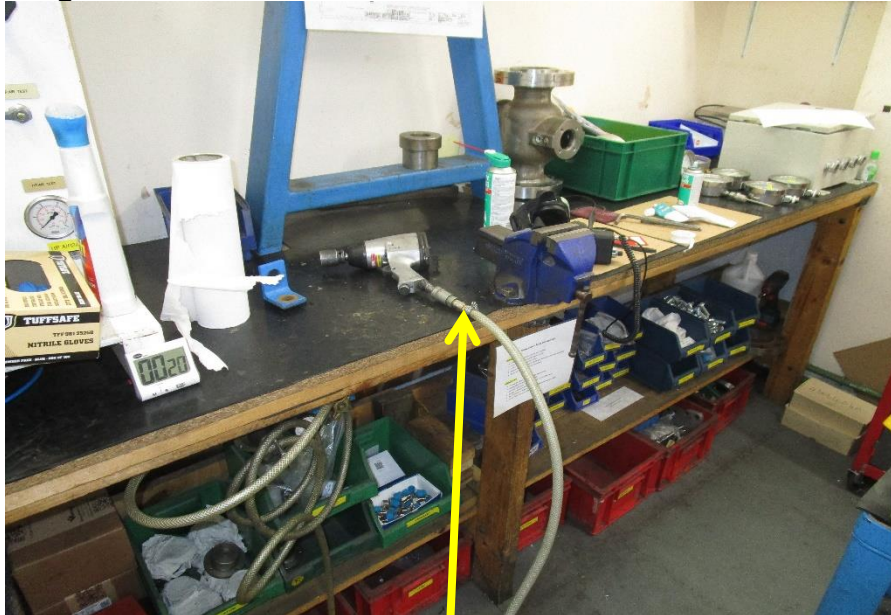
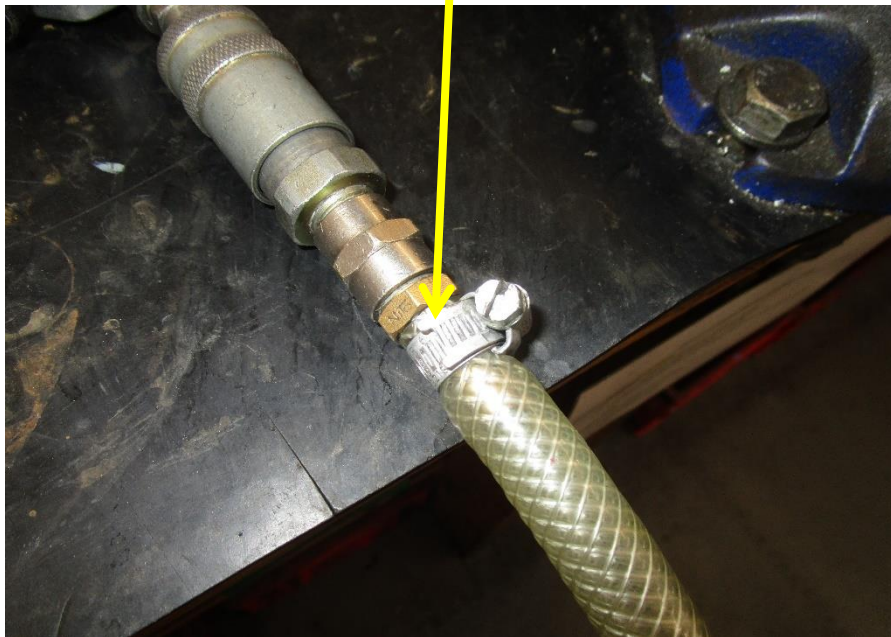
Leak No.	Location	Nature of Leak	Level
15	Centrax Room	Leak From Jubilee Hose Connection to Air Drill	2

Annual Cost of Leak:	£336
-----------------------------	-------------

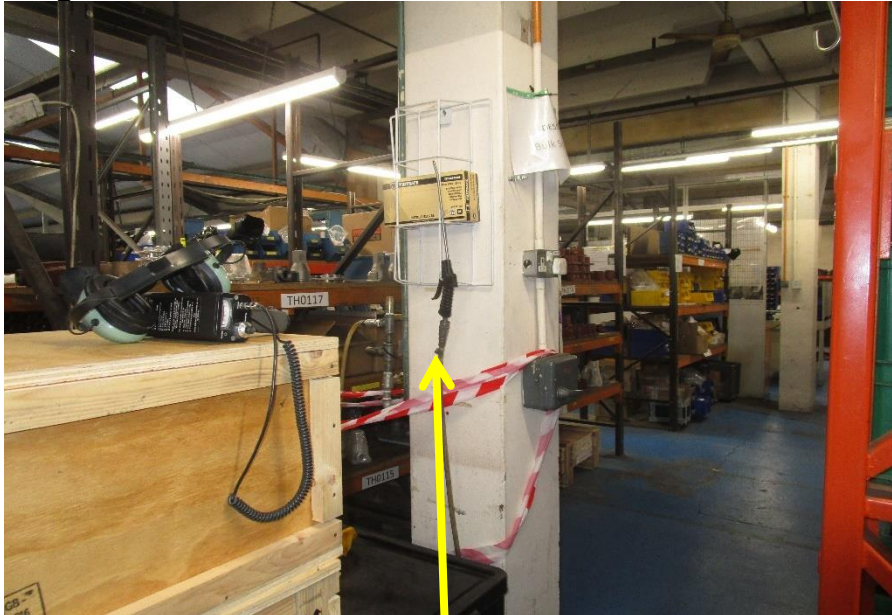
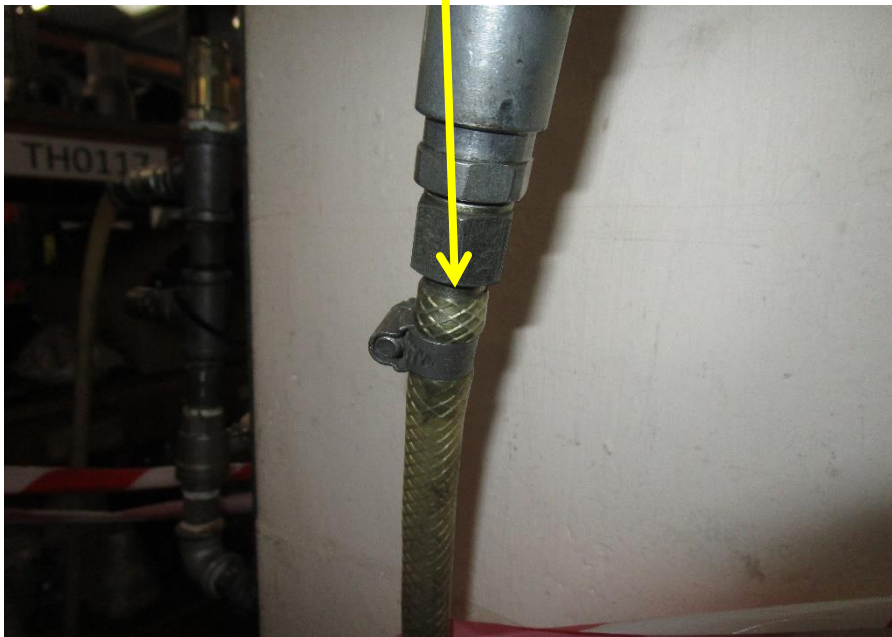
Leak No.	Location	Nature of Leak	Level
16	Bulk Storage Area	Leak From Quick Release Connection to Air Gun	1

Annual Cost of Leak:	£86
-----------------------------	------------

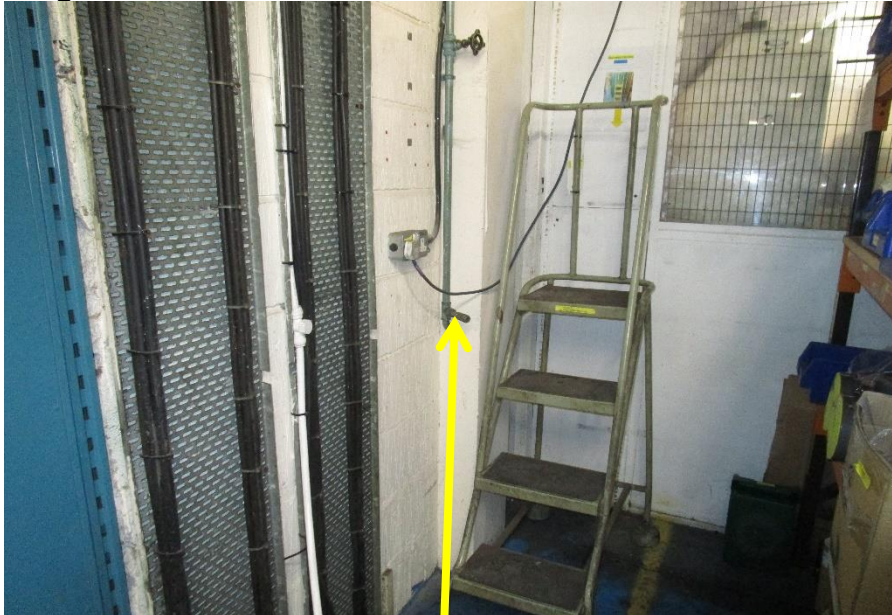
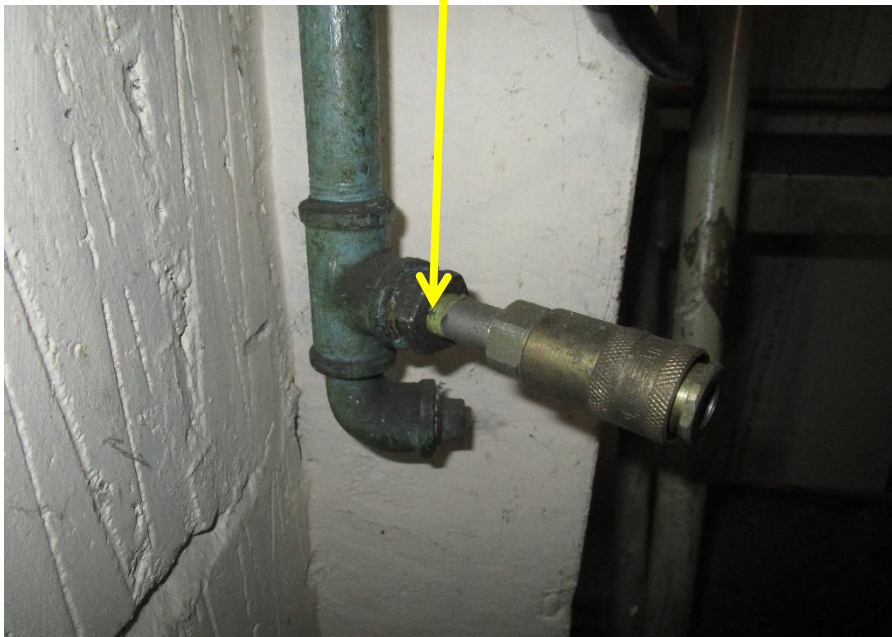
Leak No.	Location	Nature of Leak	Level
17	Bulk Storage Area	Leak From Threaded Quick Release Connection to Tee	1

Annual Cost of Leak:	£86
-----------------------------	------------

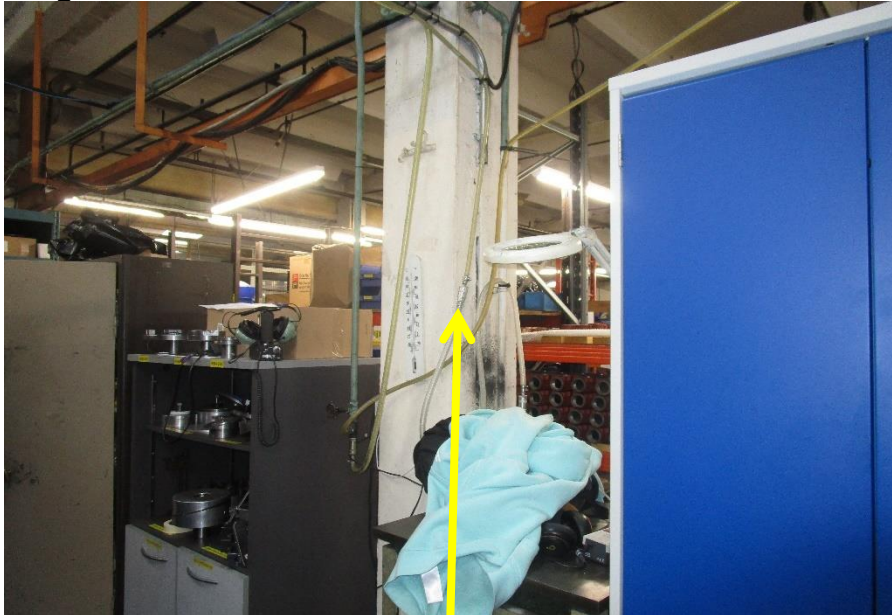
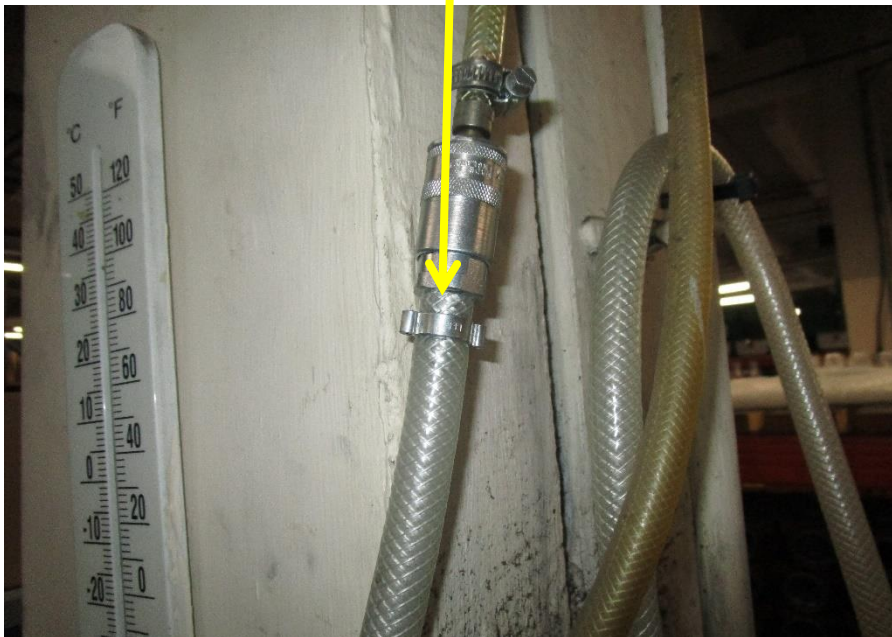
Leak No.	Location	Nature of Leak	Level
18	Shop Floor	Leak From Crimped Hose Connection to Quick Release	1

Annual Cost of Leak:	£86
-----------------------------	------------

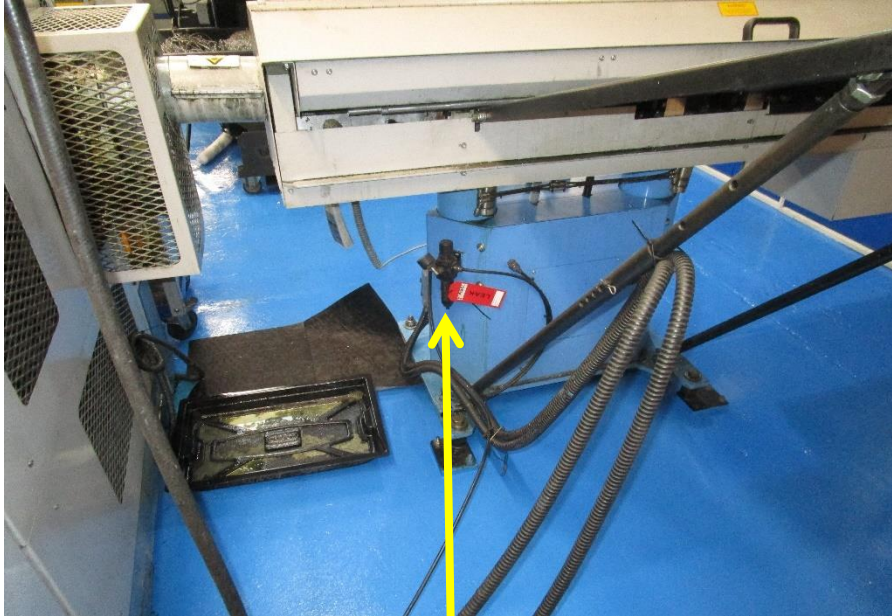
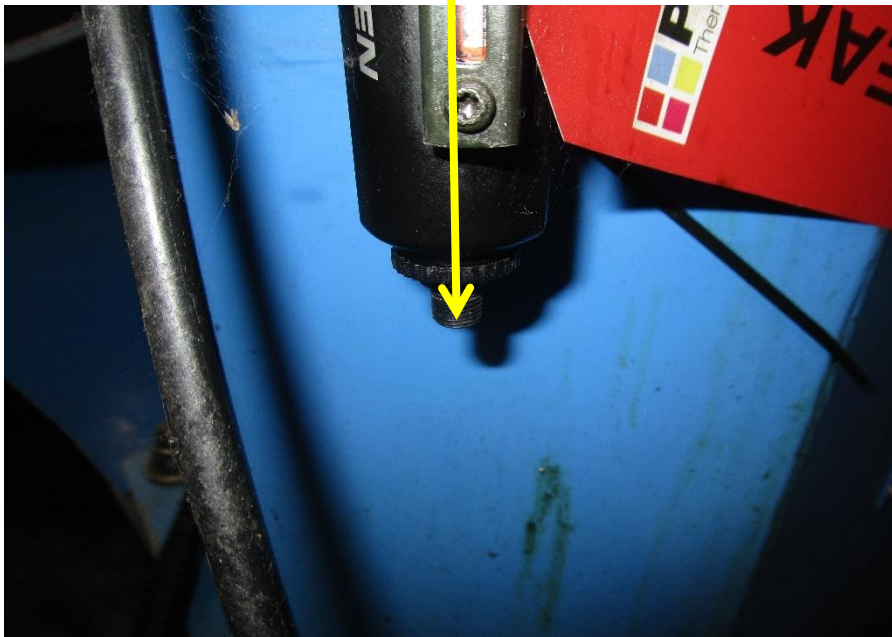
Leak No.	Location	Nature of Leak	Level
19	Shop Floor	Leak From Regulator Filter Drain	2

Annual Cost of Leak:	£336
-----------------------------	-------------

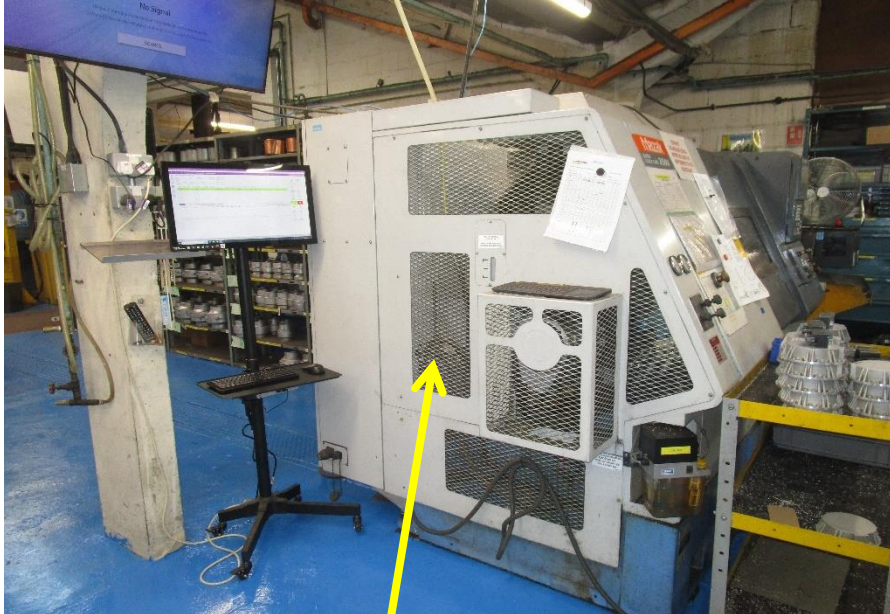
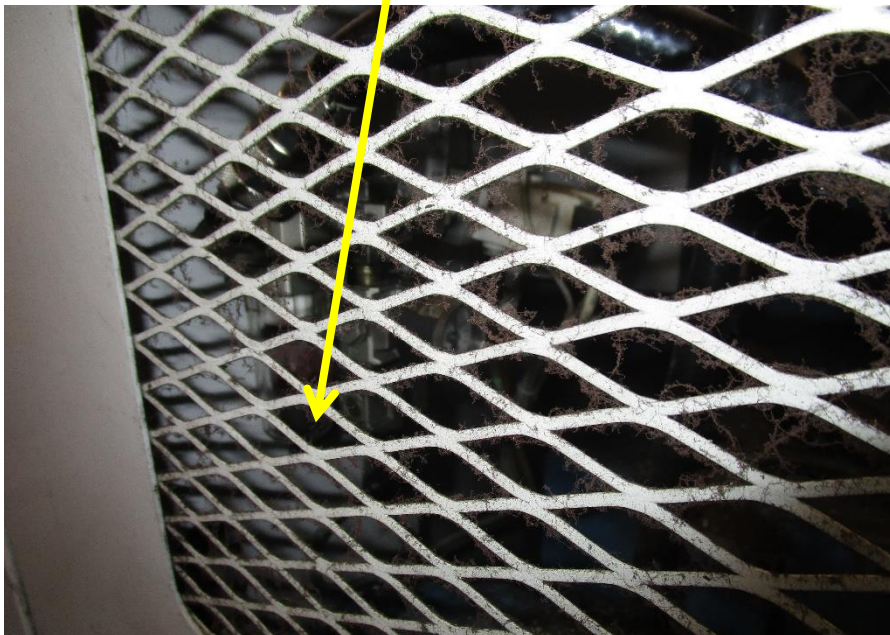
Leak No.	Location	Nature of Leak	Level
20	Shop Floor	Leak From Within Mazak 2	2

Annual Cost of Leak:	£336
-----------------------------	-------------
