Compressed Air Leak Survey

SAMPLE REPORT

Bury St Edmunds

Pixel Thermographics Ltd

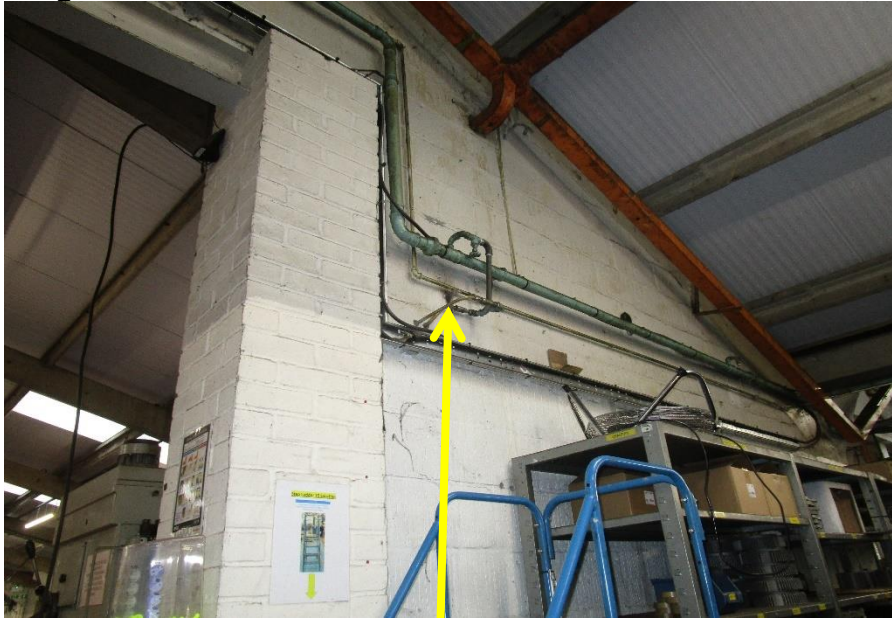
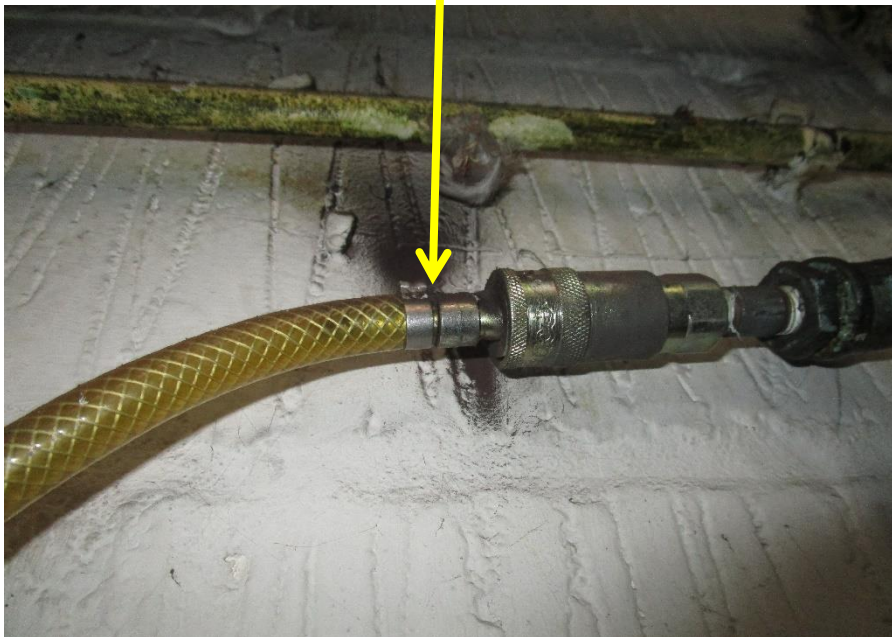
Leak No.	Location	Nature of Leak	Level
21	Shop Floor	Leak From Crimped Hose Connection to Quick Release	3

Annual Cost of Leak:	£672
-----------------------------	-------------

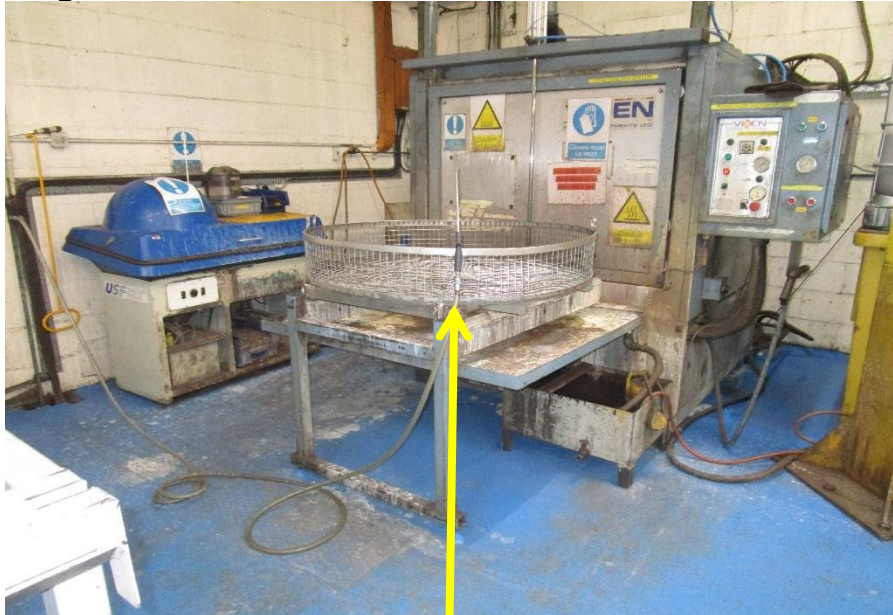
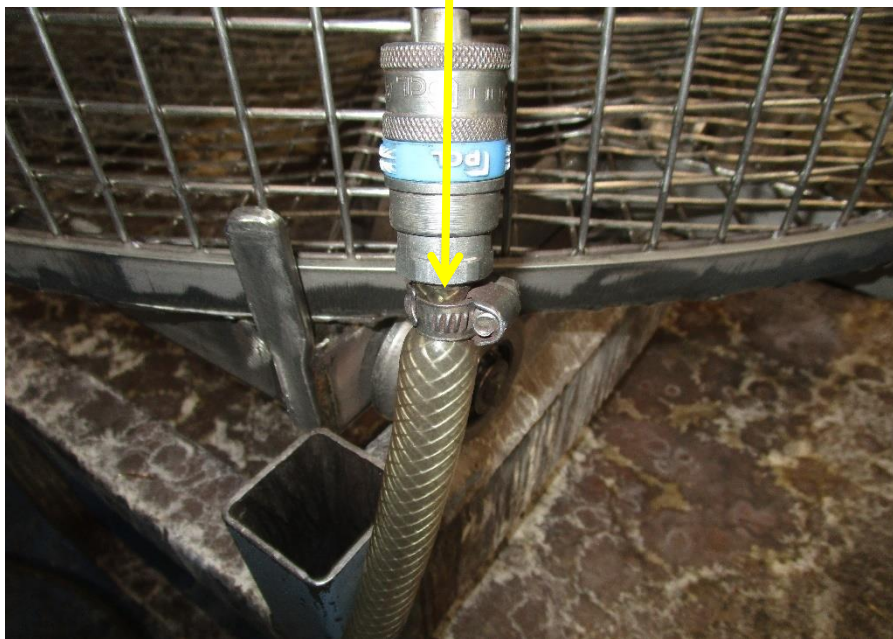
Leak No.	Location	Nature of Leak	Level
22	Shop Floor	Leak From Jubilee Hose Connection to Air Gun	2

Annual Cost of Leak:	£336
-----------------------------	-------------

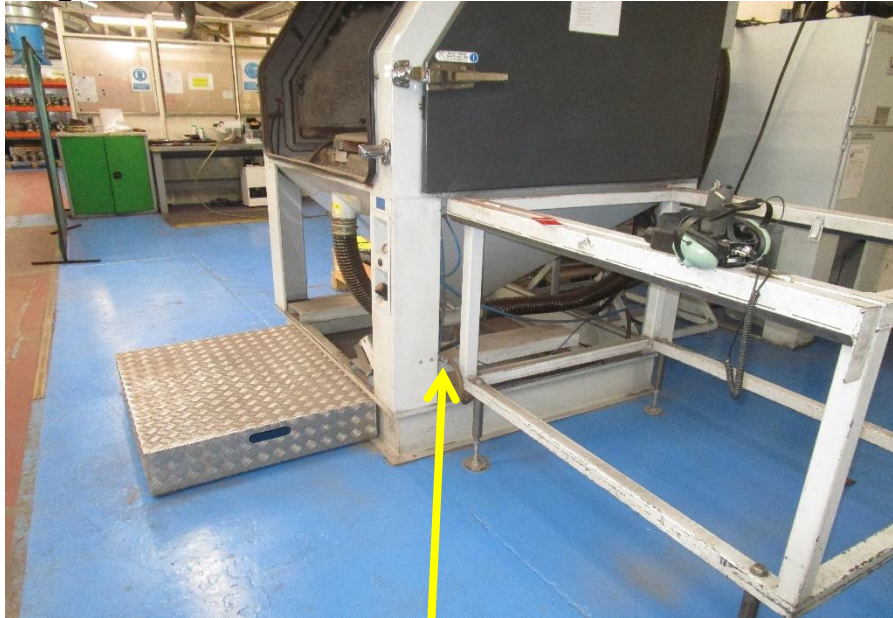
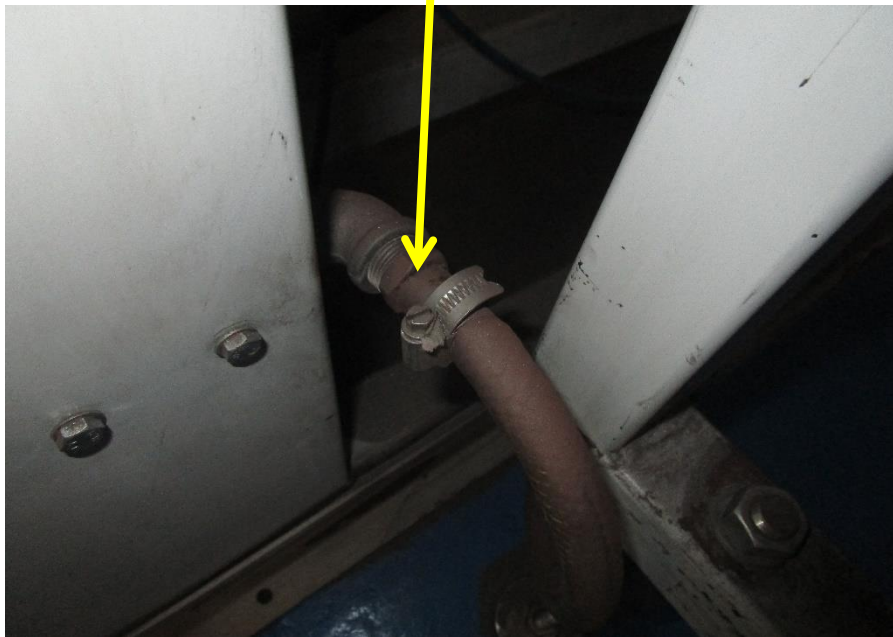
Leak No.	Location	Nature of Leak	Level
23	Shop Floor	Leak From Jubilee Hose Connection to 90 Degree Angle	3

Annual Cost of Leak:	£672
-----------------------------	-------------

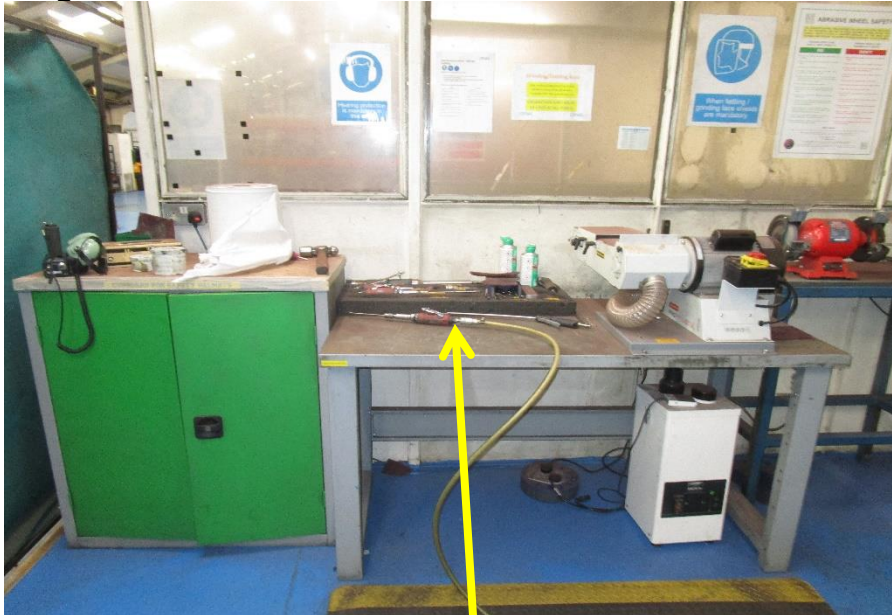
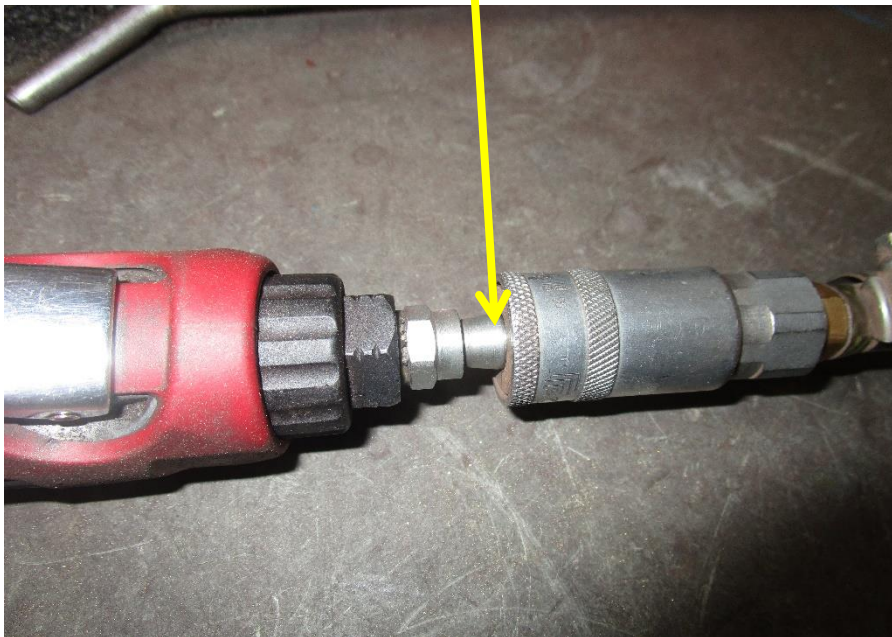
Leak No.	Location	Nature of Leak	Level
24	Shop Floor	Leak From Quick Release Connection to Air Grinder	3

Annual Cost of Leak:	£672
-----------------------------	-------------

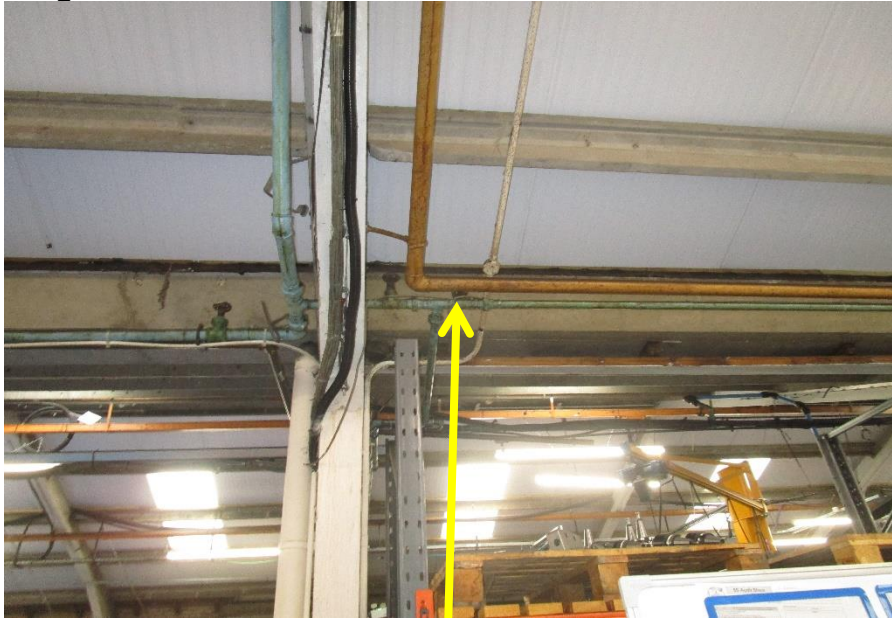
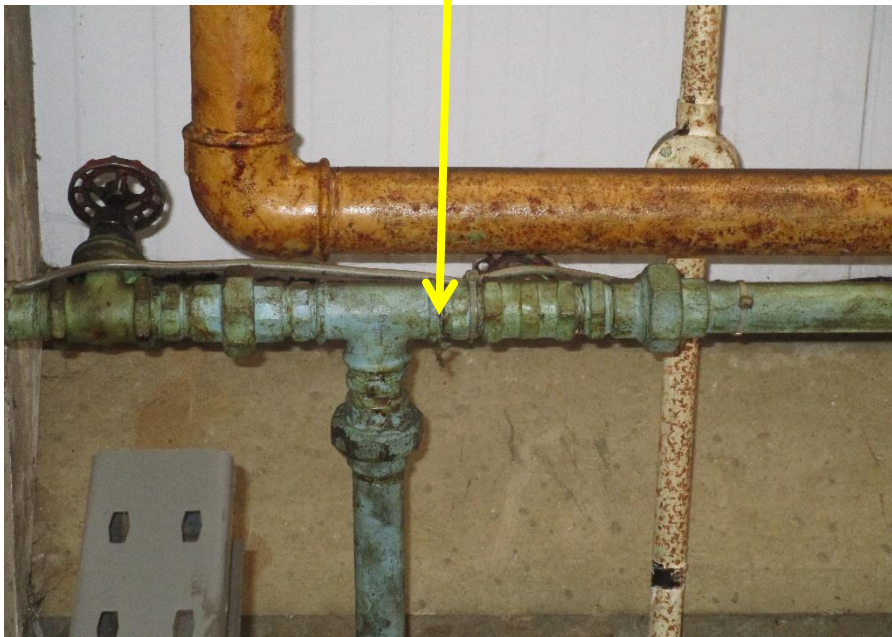
Leak No.	Location	Nature of Leak	Level
25	Shop Floor	Leak From Pipe Work High Level By Machine 2 (No Label Attached)	2

Annual Cost of Leak:	£336
-----------------------------	-------------

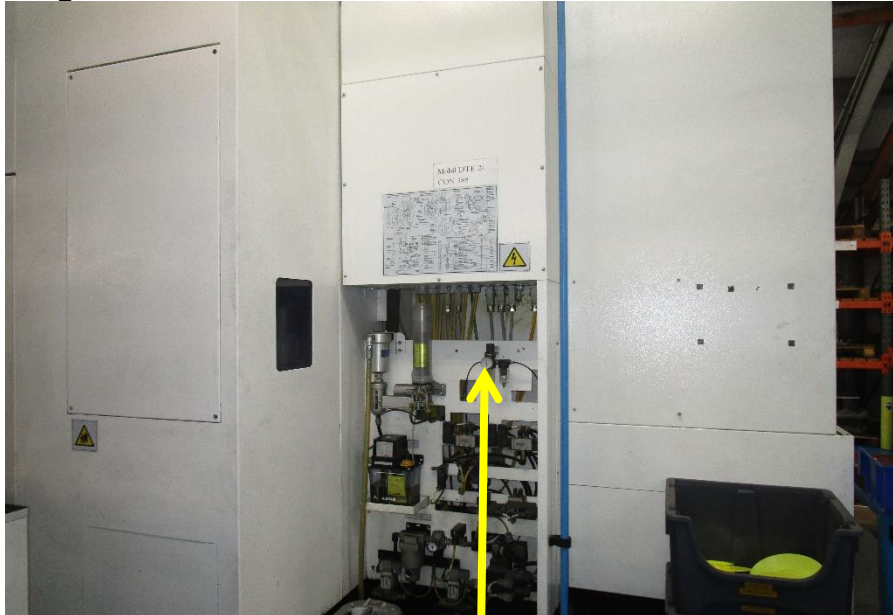
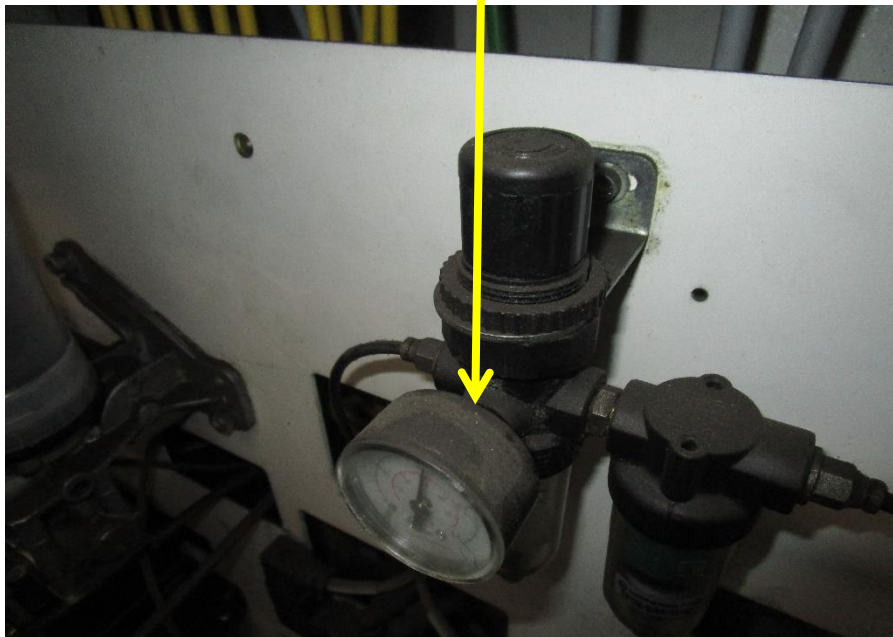
Leak No.	Location	Nature of Leak	Level
26	Shop Floor	Leak From Threaded Filter Connection to Gauge	1

Annual Cost of Leak:	£86
-----------------------------	------------

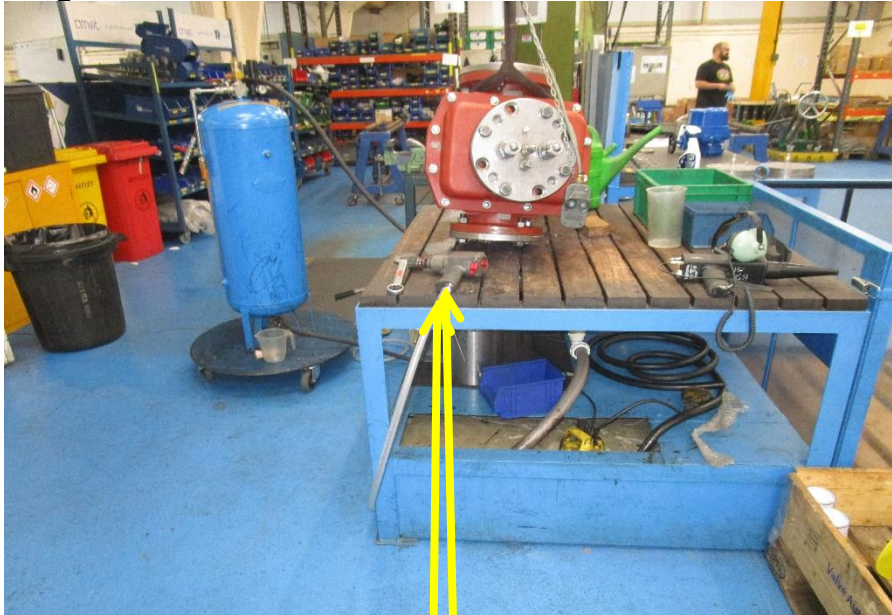
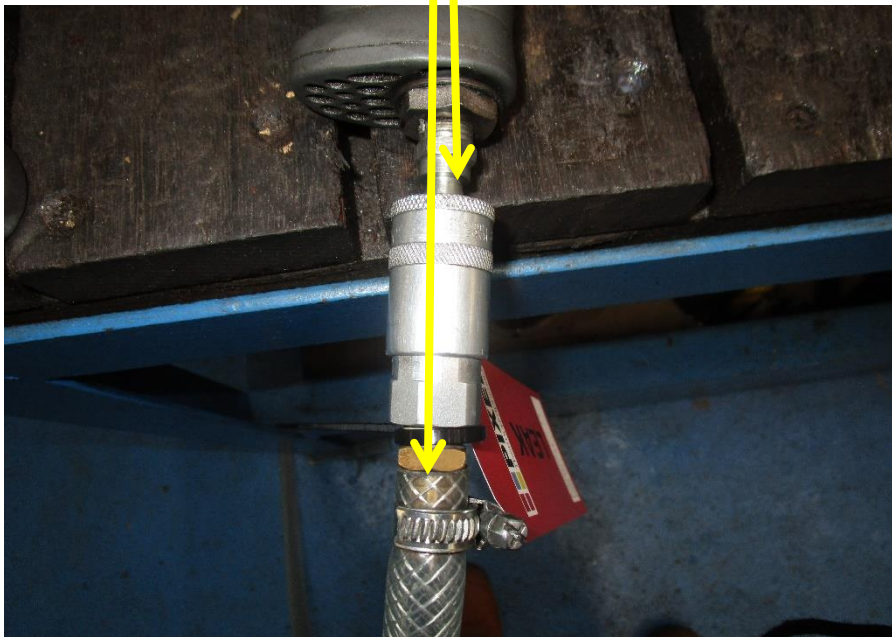
Leak No.	Location	Nature of Leak	Level
27	Shop Floor	Leak From Jubilee Hose Connection & Quick Release Connection to Air Gun	2

Annual Cost of Leak:	£336
-----------------------------	-------------

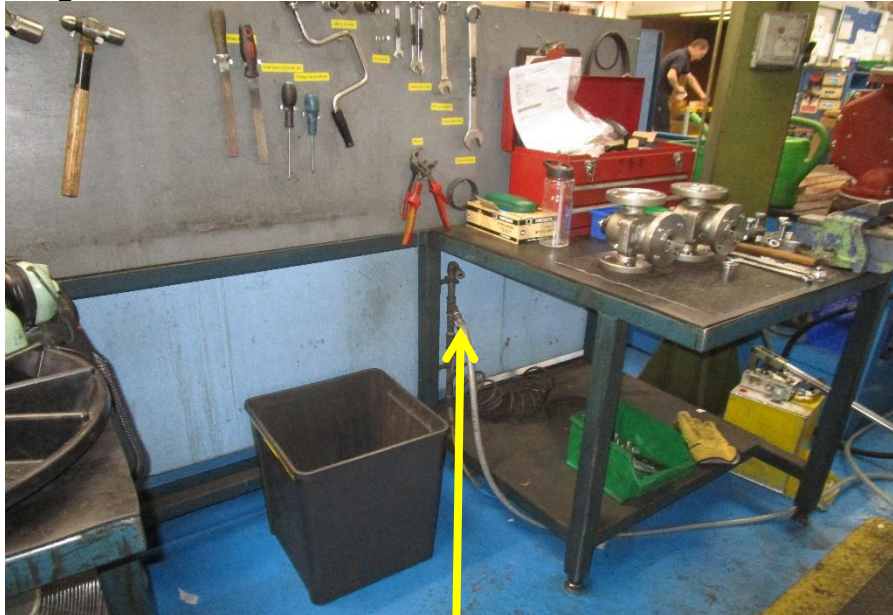
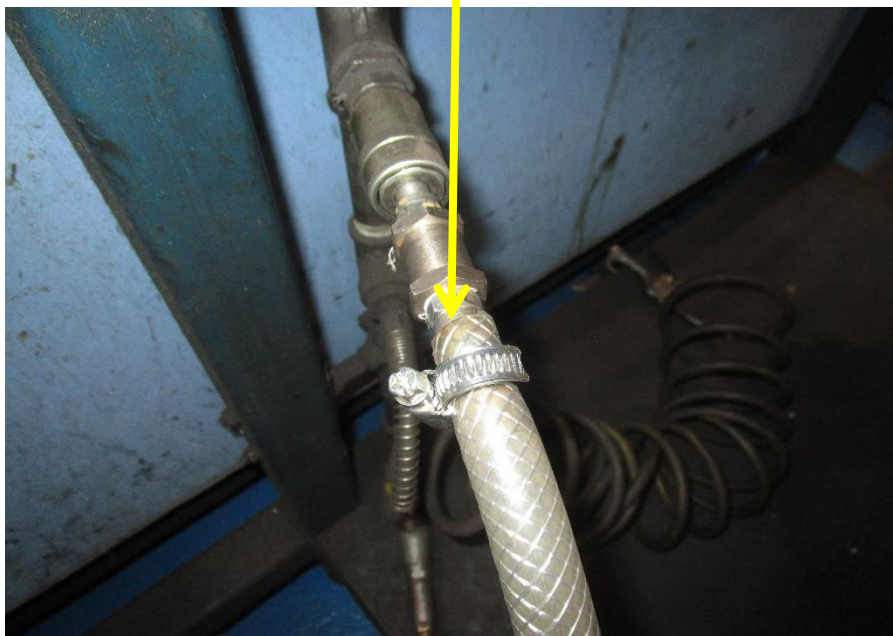
Leak No.	Location	Nature of Leak	Level
28	Shop Floor	Leak From Jubilee Hose Connection to Quick Release	2

Annual Cost of Leak:	£336
-----------------------------	-------------

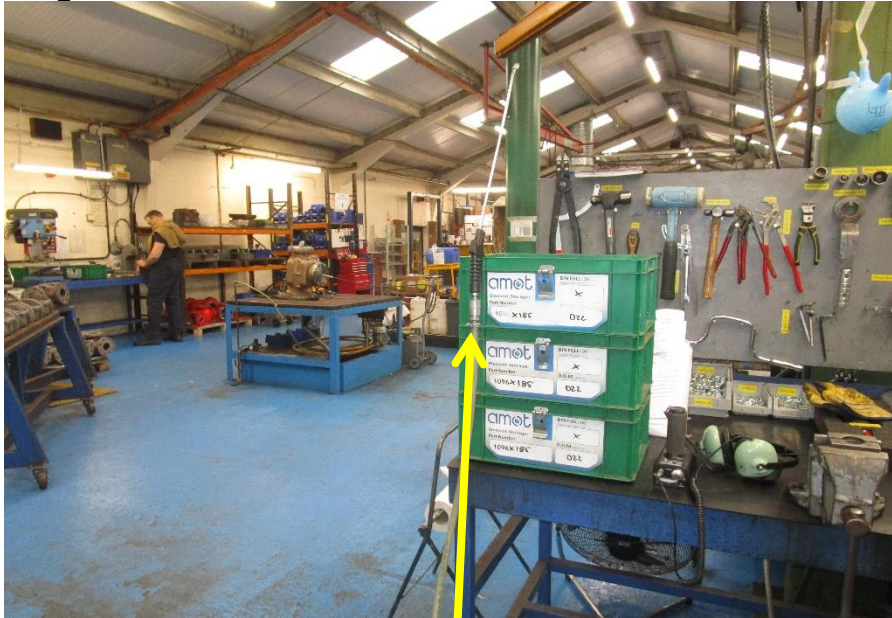
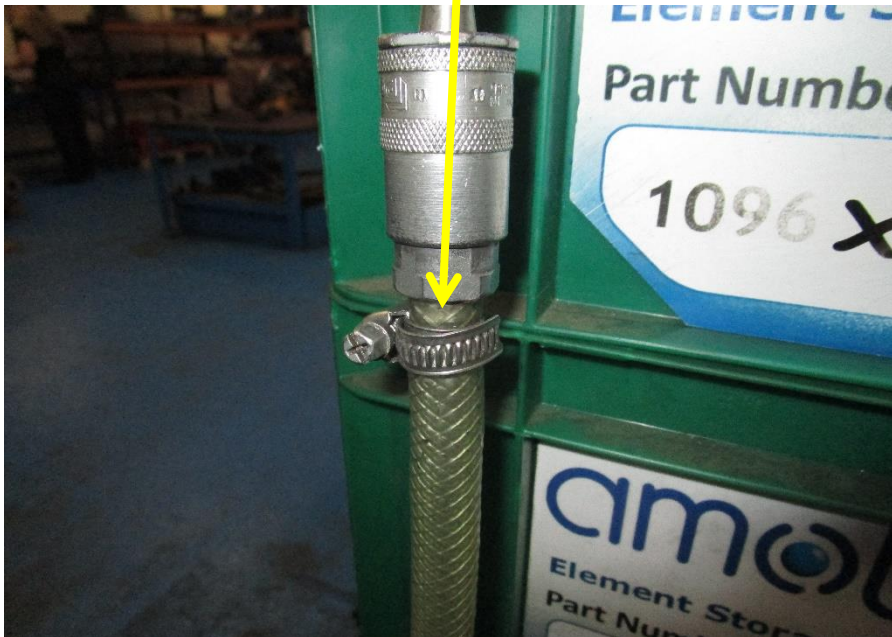
Leak No.	Location	Nature of Leak	Level
29	Shop Floor	Leak From Jubilee Hose Connection to Air Gun	2

Annual Cost of Leak:	£336
-----------------------------	-------------

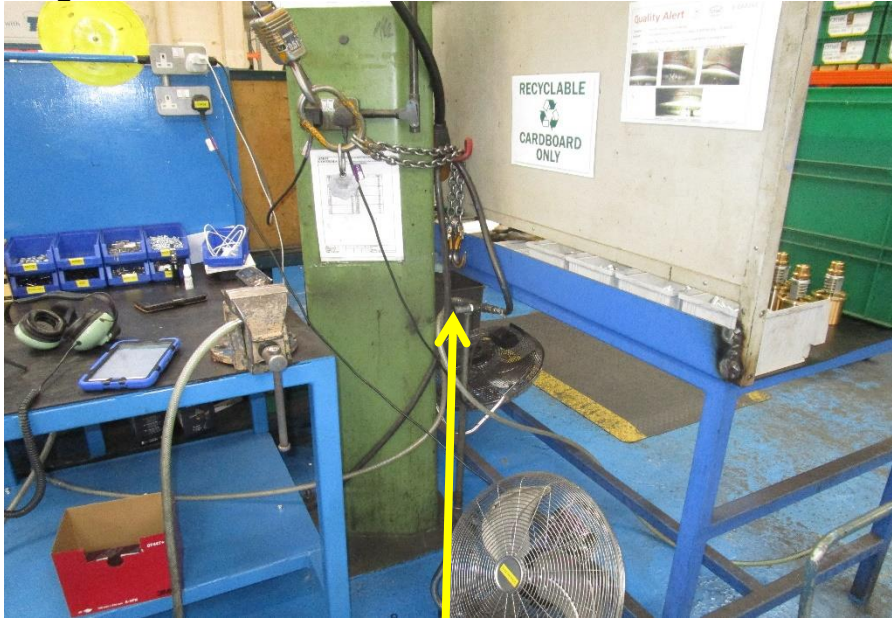
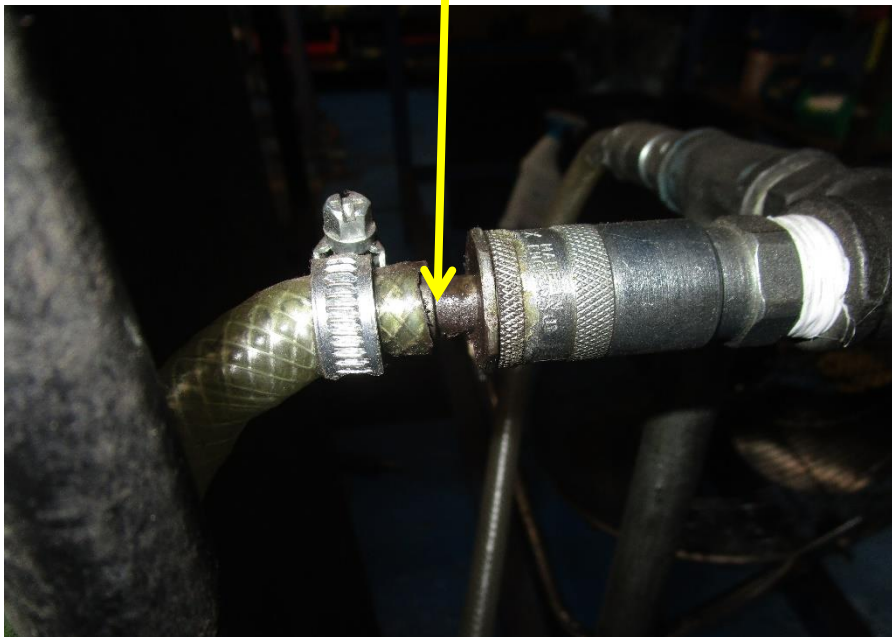
Leak No.	Location	Nature of Leak	Level
30	Shop Floor	Leak From Jubilee Hose Connection to Quick Release	3

Annual Cost of Leak:	£672
-----------------------------	-------------

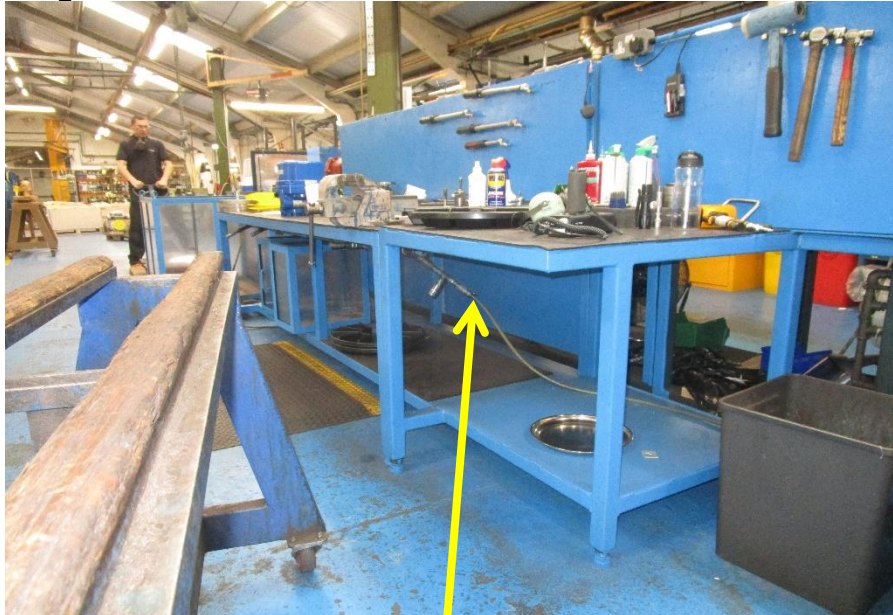
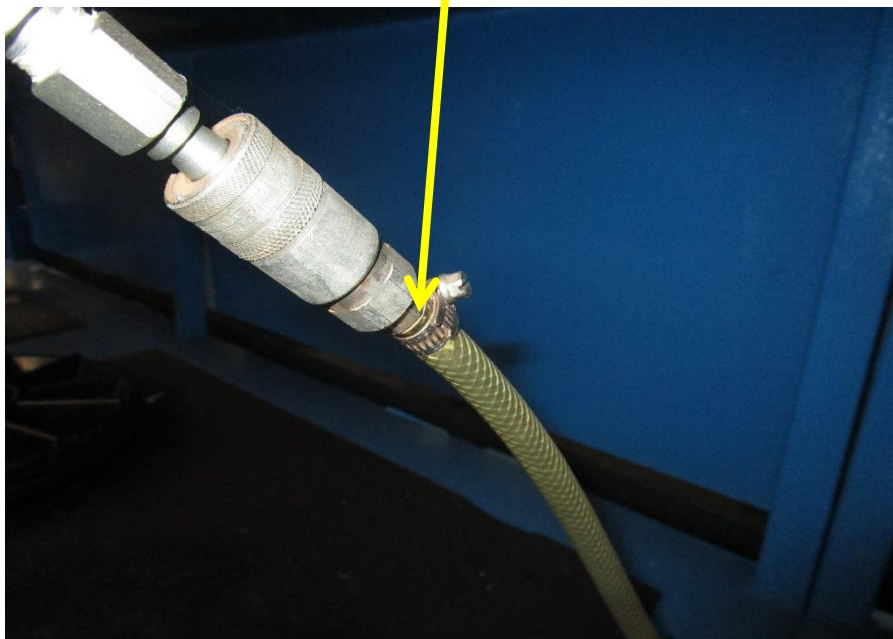
Leak No.	Location	Nature of Leak	Level
31	Shop Floor	Leak From Jubilee Hose Connection to Quick Release	2

Annual Cost of Leak:	£336
-----------------------------	-------------

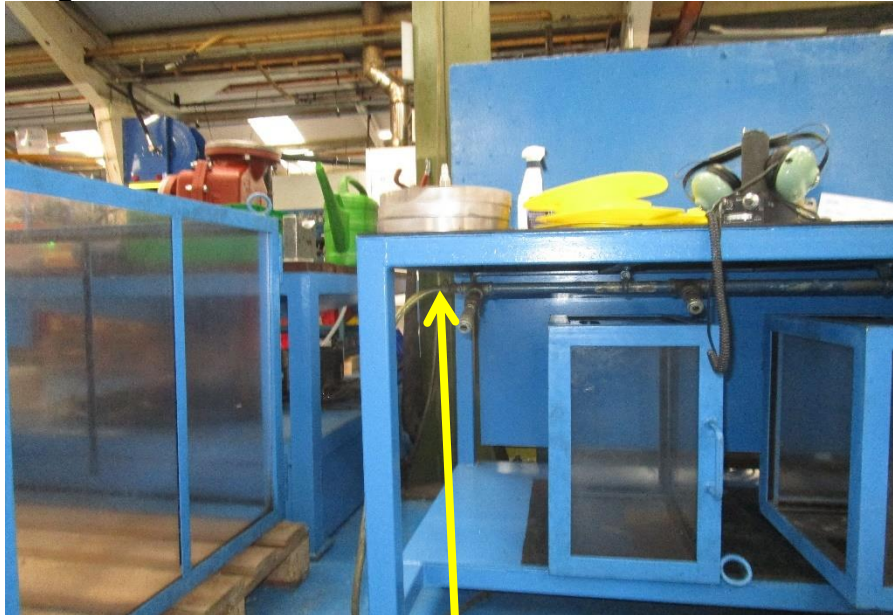
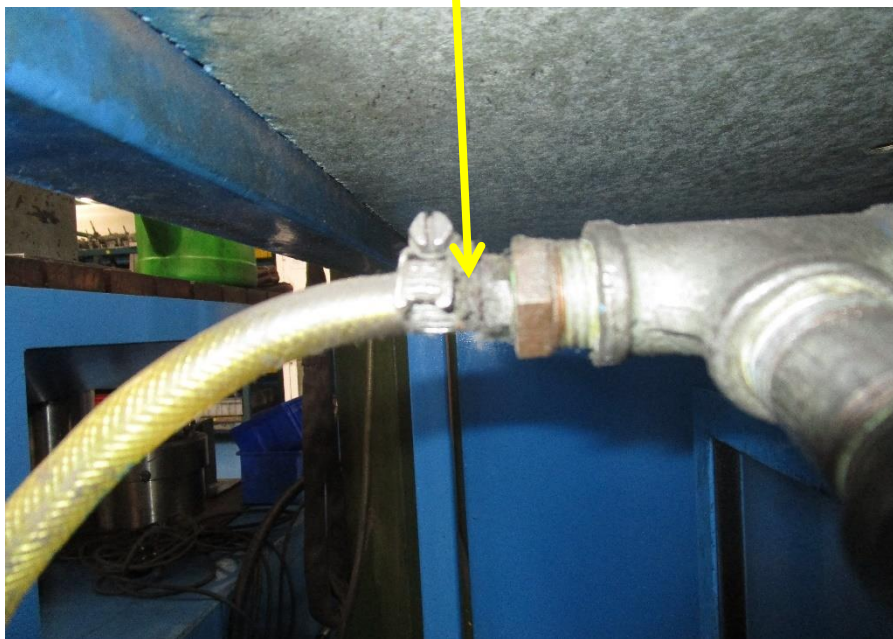
Leak No.	Location	Nature of Leak	Level
32	Shop Floor	Leak From Jubilee Hose Connection to Tee	2

Annual Cost of Leak:	£336
-----------------------------	-------------
