Electrical Thermographic Survey

Sample Report

Pixel Thermographics Ltd

Thermographic Electrical Inspection Sample Report	Inspection Date:
---	--	-------------------------

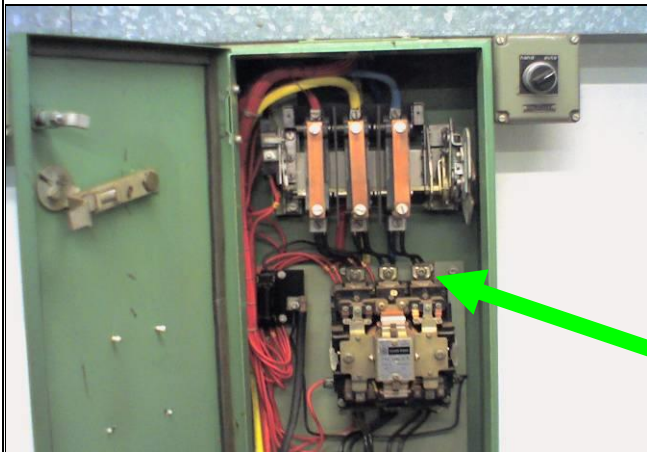
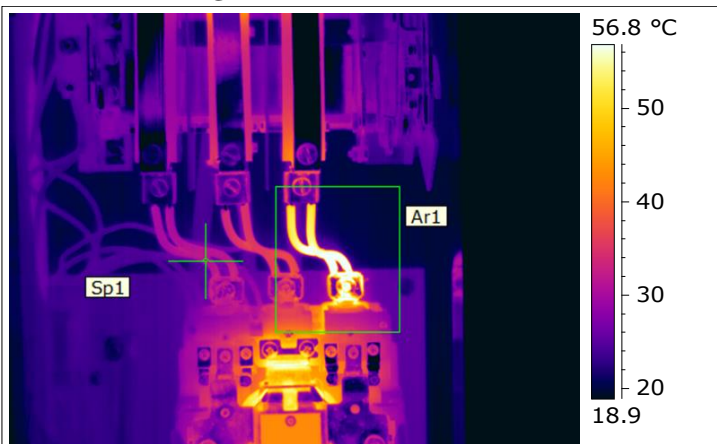
Location	Block 157 Pump House
Equipment	157 Pump Set 3
Type	Contactors

Difference Ar1 - Sp1	36.0 °C
Fault Rating	Priority 1

Elevated temperature noted on incoming feed to contactor from isolator.

Current measurements were taken and 43 Amps was measured across each phase indicating that load is not the cause of the temperature rise.

Likely cause of the rise is a poor or high resistance connection.

Recommendation is to inspect, clean and remake off this connection

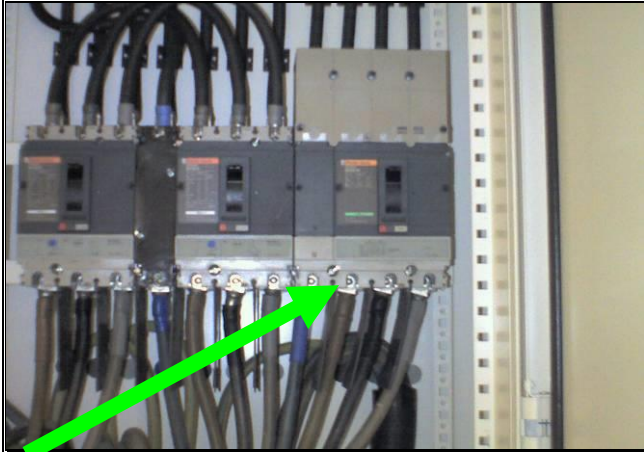
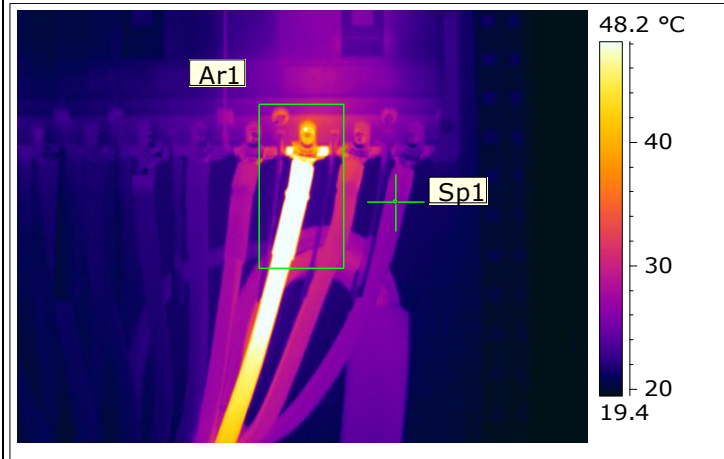
Location	Old Wing - Main UPS Room
Equipment	UPS Input / Output Panel
Type	Connection From Breaker

Difference Ar1 - Sp1	32.6 °C
Fault Rating	Priority 2

Elevated temperature noted on phase 1 (brown) outgoing connection from the breaker.

The temperature varied considerably during the course of the survey and the Thermographer witnessed temperatures up to 70°C shortly before this image was recorded.

The likely cause of this rise in temperature is a poor or loose connection to the breaker.

Recommendation is to isolate, disconnect, clean and remake off this connection.

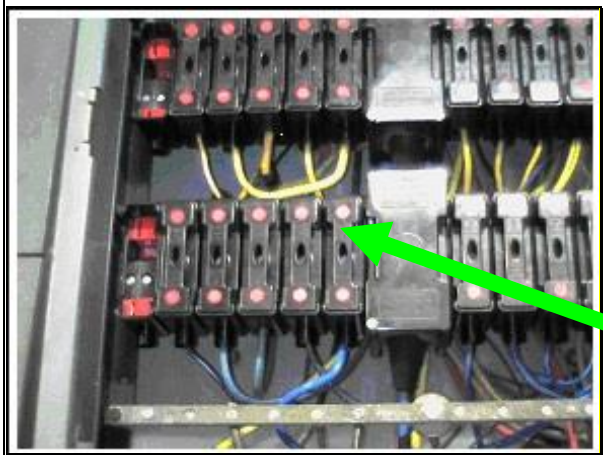
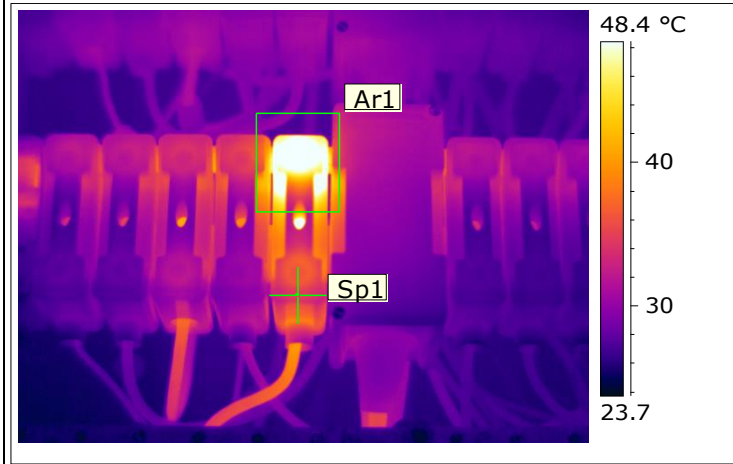
Location	Main Switchroom 2
Equipment	Fuseboard A-1-4-6
Type	Fuse Blue 6

Difference Ar1 - Sp1	22.0 °C
Fault Rating	Priority 2

Raised temperature noted on in-feed side of fuse carrier.

Temperature imbalance such as this would not be expected across a fuse and indicates an internal problem.

Possible source of temperature rise includes poor connection, loose fuse fixing, or high resistance blade connections.

Recommendation is to inspect, check fuse carrier blades for signs of pitting or heat damage, replace the fuse, re-tighten the fuse fixings and re-tighten all connections.

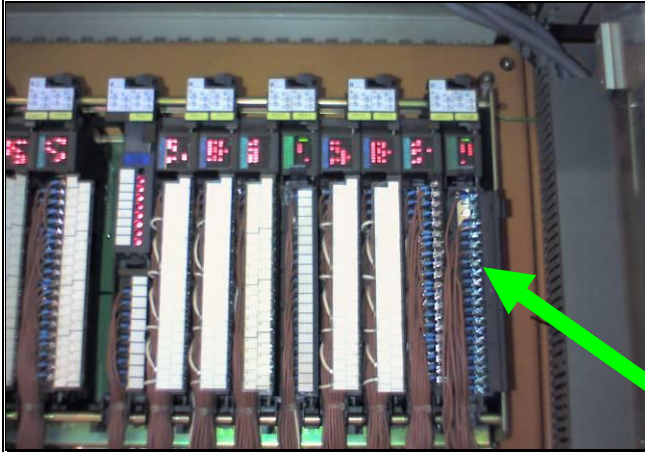
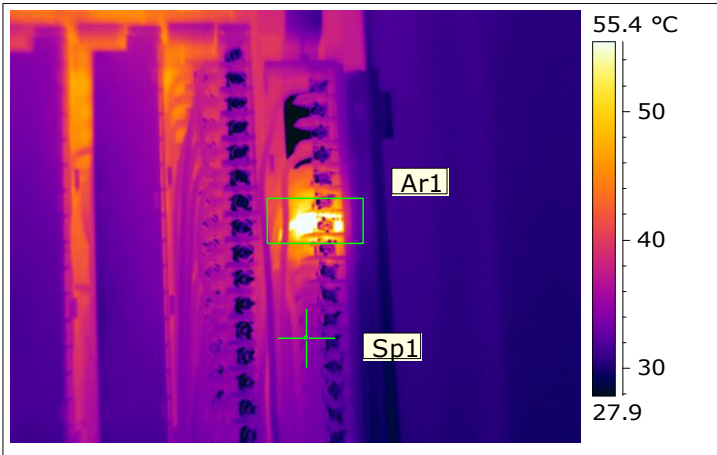
Location	Line 7 PLC Section
Equipment	AB PLC Digital Output Rack
Type	Terminal No. 7

Difference Ar1 - Sp1	37.5 °C
Fault Rating	Priority 1

Temperature increase on terminal No.7.

Likely cause of heat rise is a loose connection to the PLC module.

Recommendation is to tighten up the terminal screw on the device.

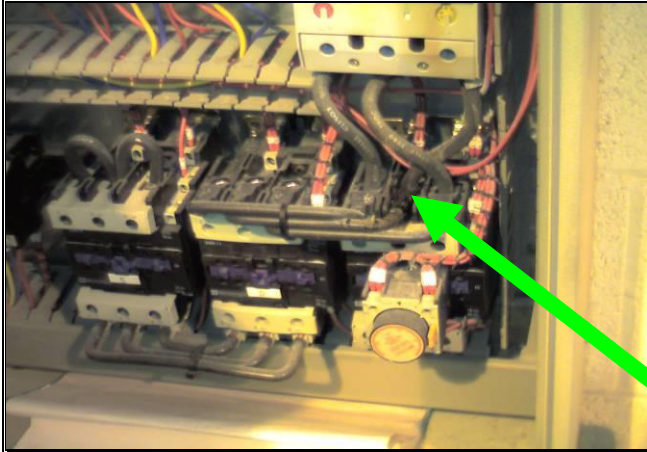
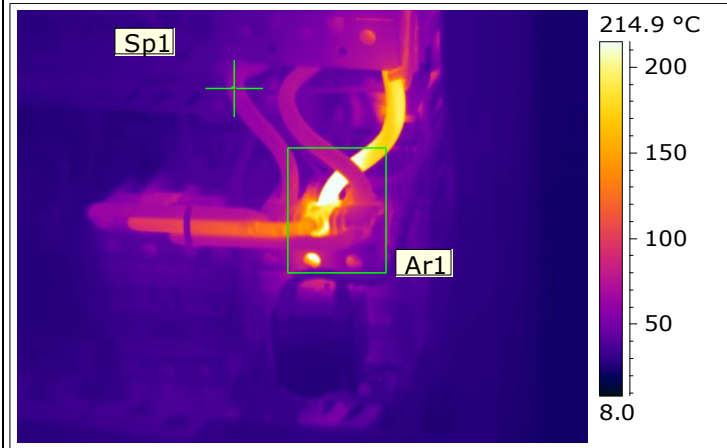
Location	Sanitex Roller Machine
Equipment	Main Control Panel
Type	Overload Incoming Phase 3

Difference Ar1 - Sp1	212.7 °C
Fault Rating	Priority 1

Dangerously high temperatures noted on incoming phase 2 connection to main overload unit.

Visible heat damage also noted at the time of the survey.

The unit manager and operator were both made aware of this fault immediately and the decision was made to isolate this equipment until a repair could be carried out.

Recommendation is to replace the overload, the contactor and the 3 feed cables which have all suffered heat damage as a result of this fault.

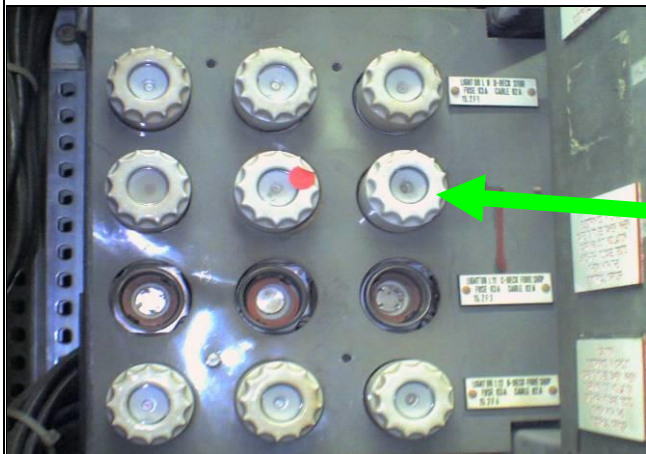
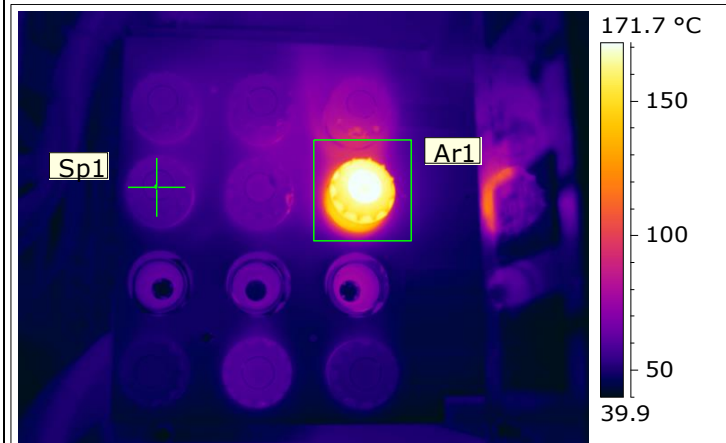
Location	Main Control Room
Equipment	Main Switchboard (Aft)
Type	Panel 15 - Bottle Fuse - Lighting Board L11 Phase 3

Difference Ar1 - Sp1	134.9 °C
Fault Rating	Priority 1

Significantly elevated surface temperatures noted on bottle fuse carrier.

Likely causes of heat rise include dirty or pitted conductive surface, loose or poorly fitted fuse carrier or poor outgoing connection at rear.

Recommendation is to remove the carrier, replace the fuse, check all surfaces are clean and re-install the carrier ensuring it is tight and secure.

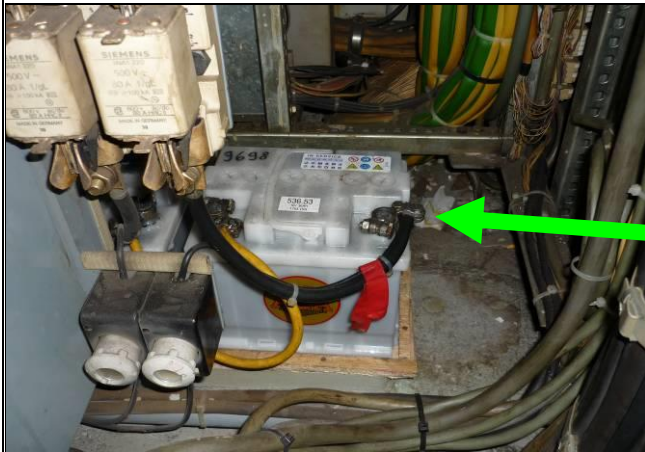
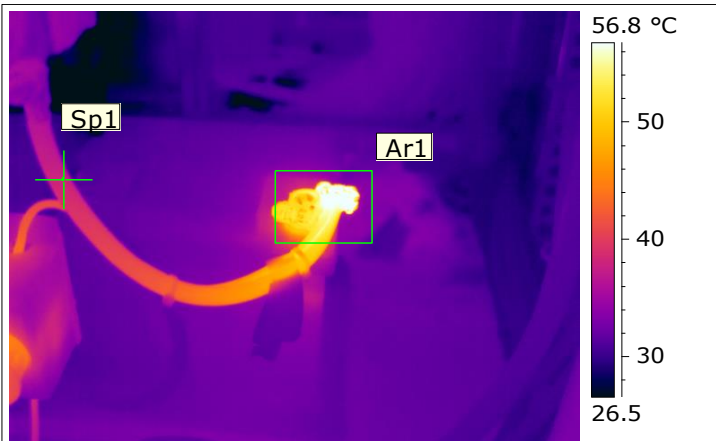
Location	Main Control Room
Equipment	Main Switchboard (Central)
Type	24V Simos Alarms Negative Battery Connection

Difference Ar1 - Sp1	23.5 °C
Fault Rating	Priority 2

Elevated temperature noted on battery negative connection.

Likely cause of heat rise is a poor or loose connection.

Recommendation is to inspect, clean and re-tighten this connection.

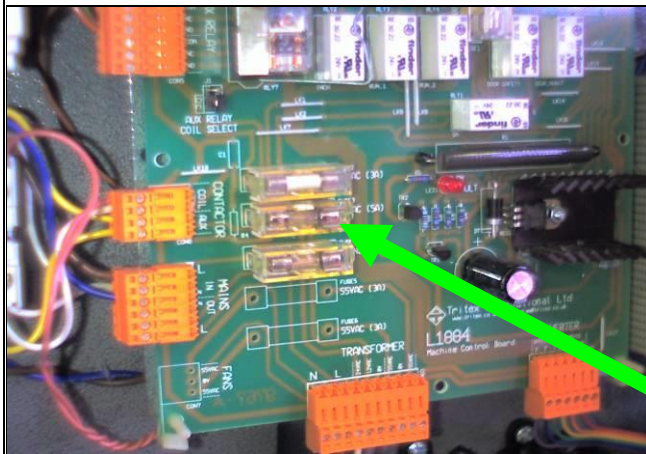
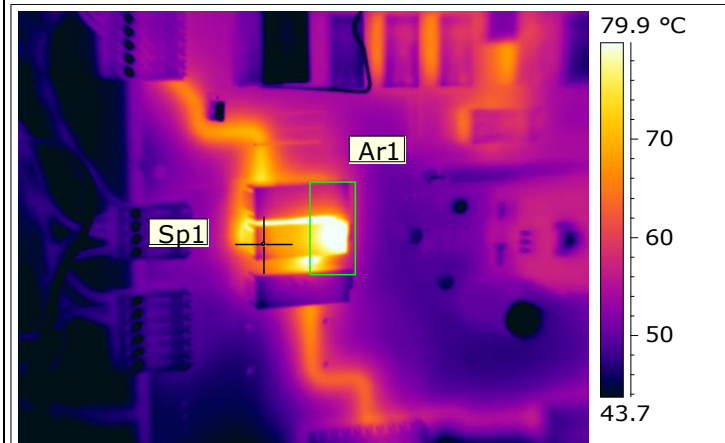
Location	Machine Room
Equipment	Sewing Machine F6 Control Panel
Type	PCB Mounted Fuse Carrier

Difference Ar1 - Sp1	32.4 °C
Fault Rating	Priority 2

Elevated temperature noted on end of fuse carrier on machine PCB unit.

Temperature differential across a fuse carrier would not be expected and indicates an internal issue.

Discussion with machine operator highlighted that the machine stops intermittently and this fault could well be the cause of this.

Recommendation is to replace the fuse carrier and fuse.

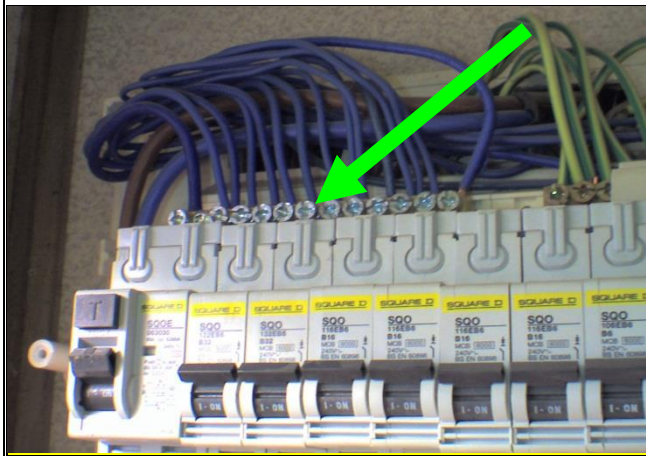
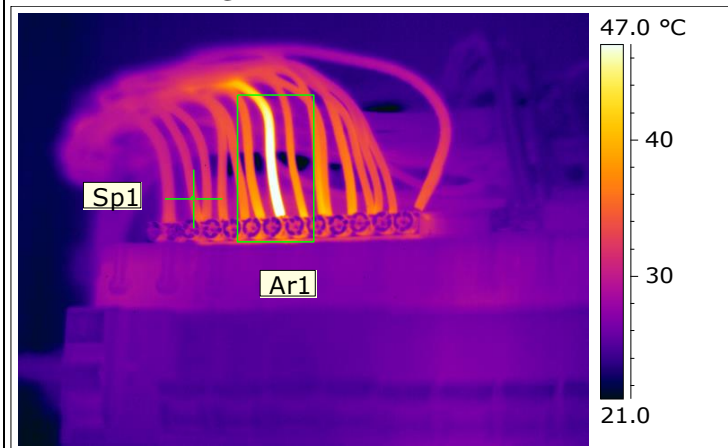
Location	Main Office
Equipment	Distribution Board
Type	Neutral Connection

Difference Ar1 - Sp1	23.3 °C
Fault Rating	Priority 2

Elevated temperature noted on neutral connection on distribution board.

Likely cause of heat rise is a poor or loose connection.

Recommendation is to inspect, clean and remake off this connection.

Note: Repair work was carried out at the time of the survey. See next page for analysis following completion of the repair.

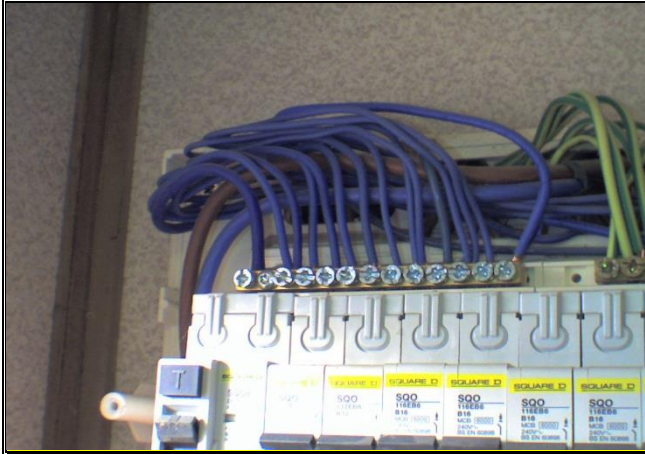
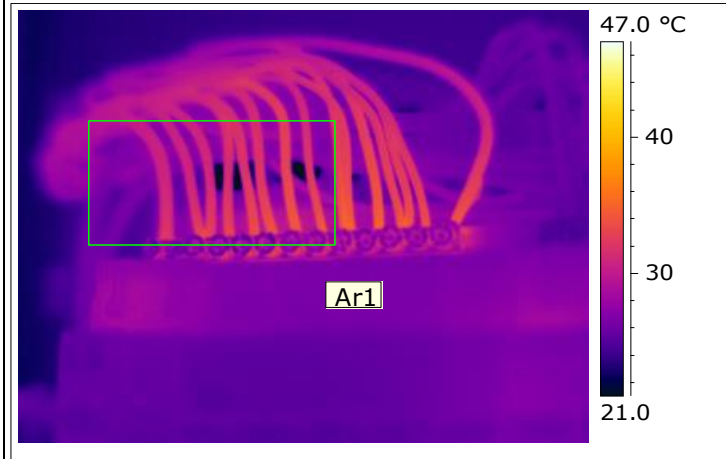
Location	Main Office
Equipment	Distribution Board
Type	Neutral Connection - RESOLVED

The thermal image shows that following the repair, the temperatures have returned to normal and the fault has disappeared.

No further work required.
