Mechanical Thermographic Survey

SAMPLE REPORT

Pixel Thermographics Ltd

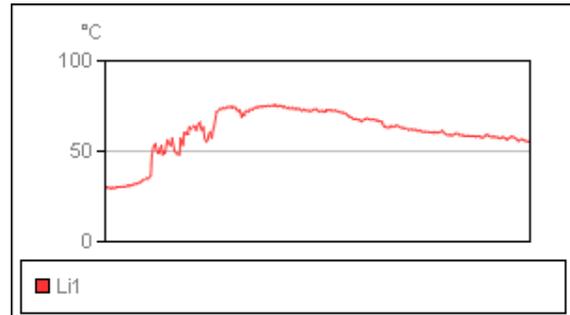
Location	A Plant Tin Return System (Oven Side)
Equipment	Prior to Moulder
Type	SEW Motor Gearbox

Elevated temperature noted on motor surfaces.

It was noted that this lane at the time of the survey was permanently loaded with trays which were not being loaded into the prover.

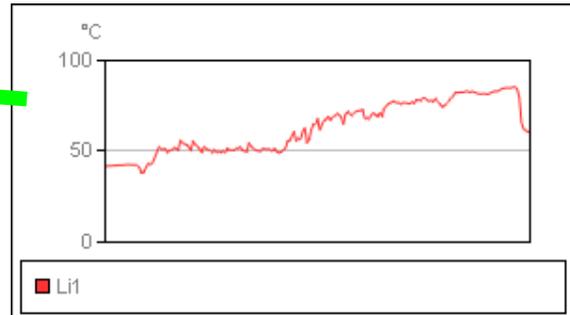
Location	A Plant Oven
Equipment	Main Circulation Fan (Inlet End)
Type	Fan Motor

Elevated temperature noted on NDE bearing housing on this drive.

Recommendation is to check bearing performance on this motor – utilise vibration analysis.

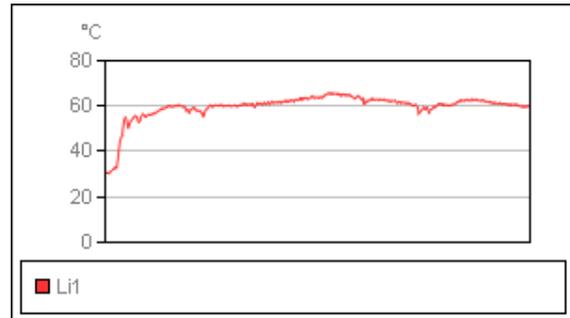
Location	A Plant Tin Return System
Equipment	Tin Cleaner
Type	SEW Motor Gearbox

Elevated temperatures noted on motor gearbox surfaces.

Likely cause of heat rise is poor air movement / cooling across the unit.

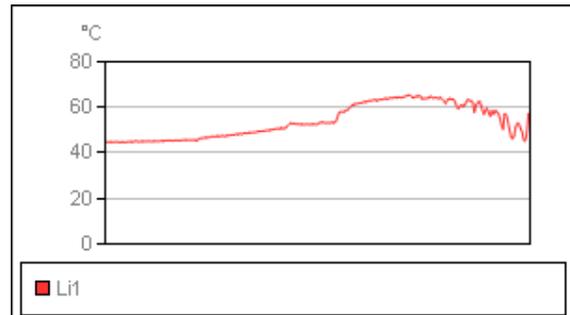
Location	A Plant Tin Return System
Equipment	Conveyor Under LEV Extract
Type	SEW Motor Gearbox

Elevated temperatures noted on motor gearbox surfaces.

Likely cause of heat rise is poor air movement / cooling across the unit.

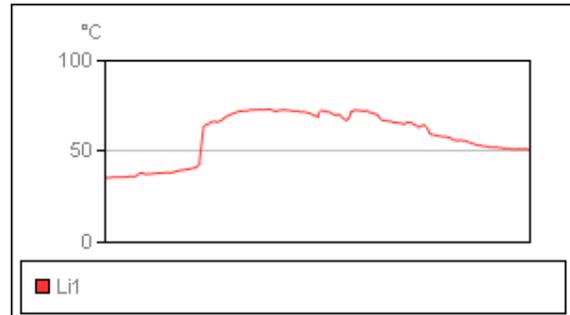
Location	A Plant Lid Return System
Equipment	Lid Take Off Drive
Type	SEW Motor Gearbox

Elevated temperatures noted on motor gearbox surfaces.

Likely cause of heat rise is poor air movement / cooling across the unit.

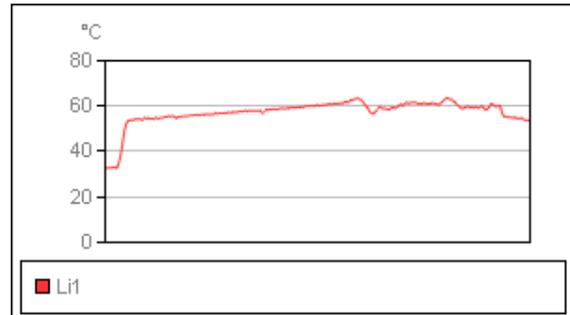
Location	A Plant Crustless Slicer
Equipment	Infeed Conveyor
Type	SEW Motor Gearbox

Elevated temperatures noted on motor gearbox surfaces.

Likely cause of heat rise is poor air movement / cooling across the unit.
