Thermographic BREEAM Compliance Survey

SAMPLE REPORT

Pixel Thermographics

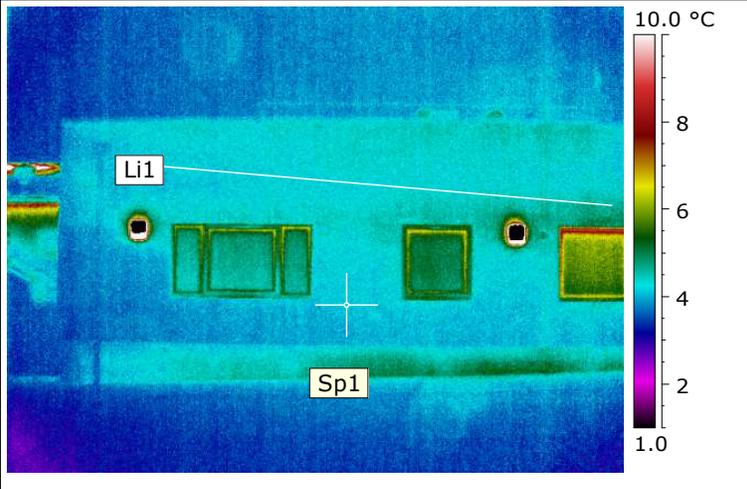
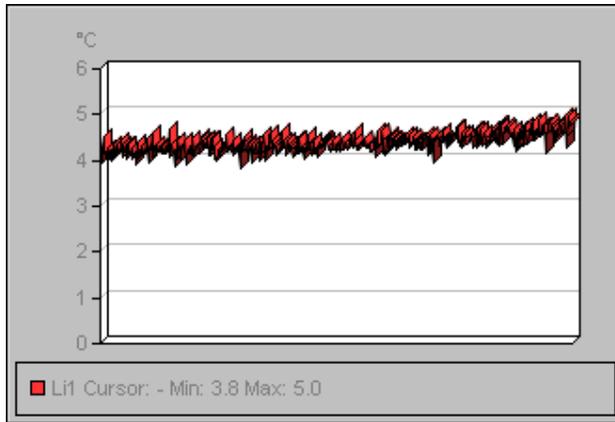
West Elevation
1:100

No insulated surfaces exceed the threshold temperature.
No evidence of thermal bridging.
No air leakage noted.

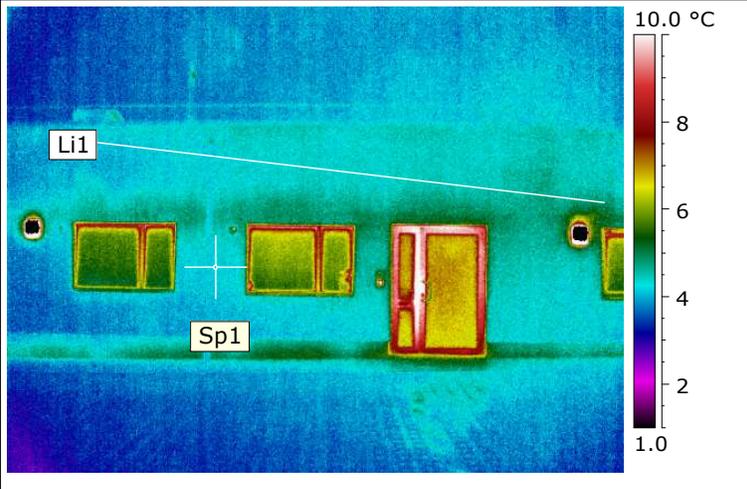
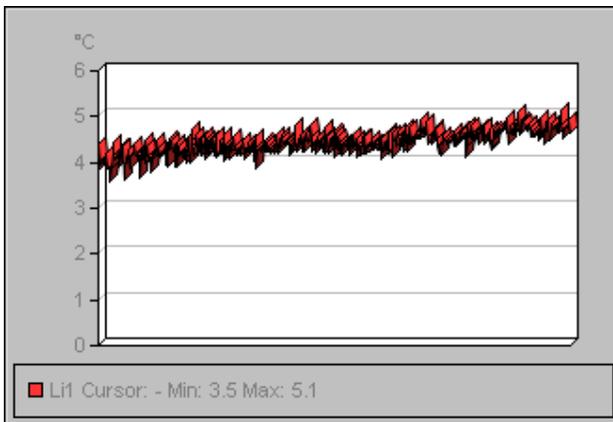
West Elevation

No insulated surfaces exceed the threshold temperature.
No evidence of thermal bridging.
No air leakage noted.

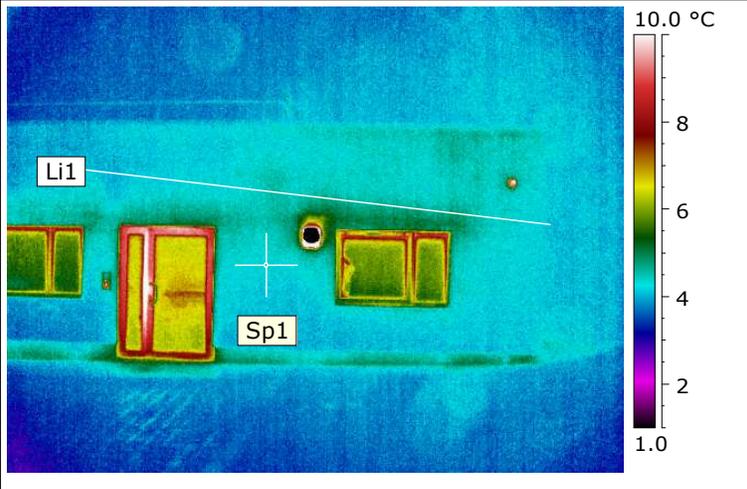
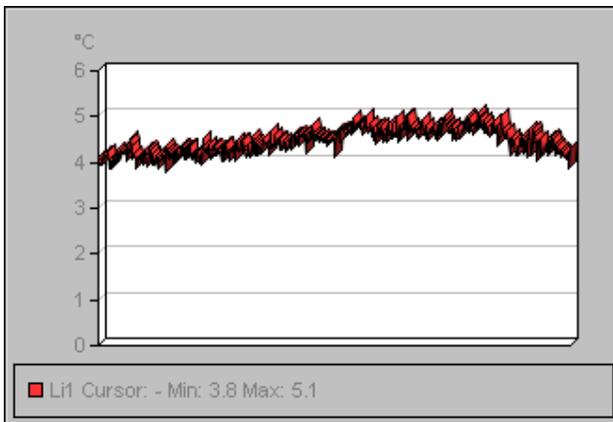
West Elevation

No insulated surfaces exceed the threshold temperature.
No evidence of thermal bridging.
No air leakage noted.

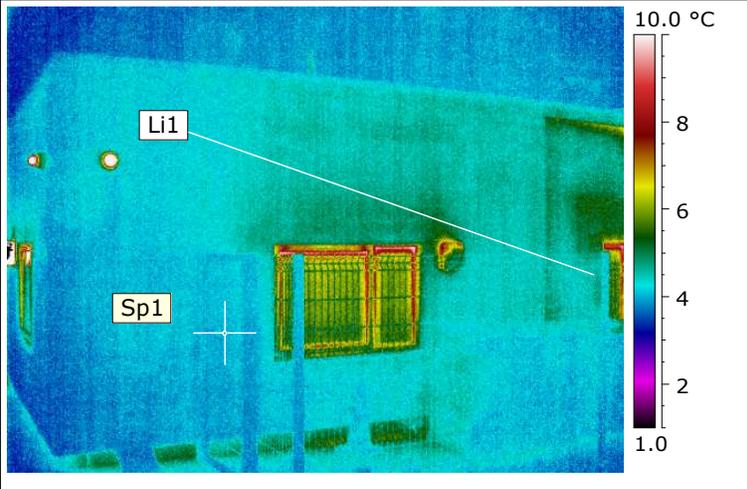
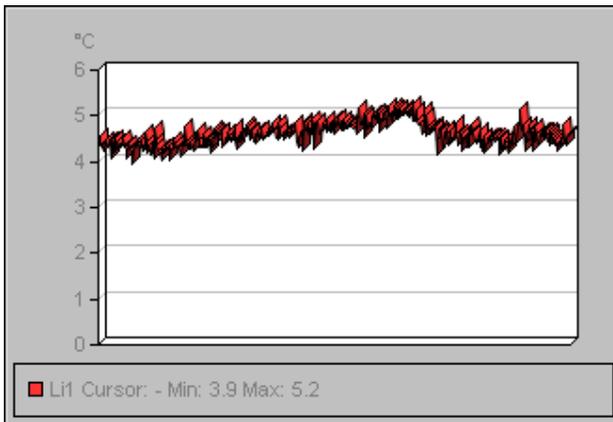
South Elevation

No insulated surfaces exceed the threshold temperature.
No evidence of thermal bridging.
No air leakage noted.

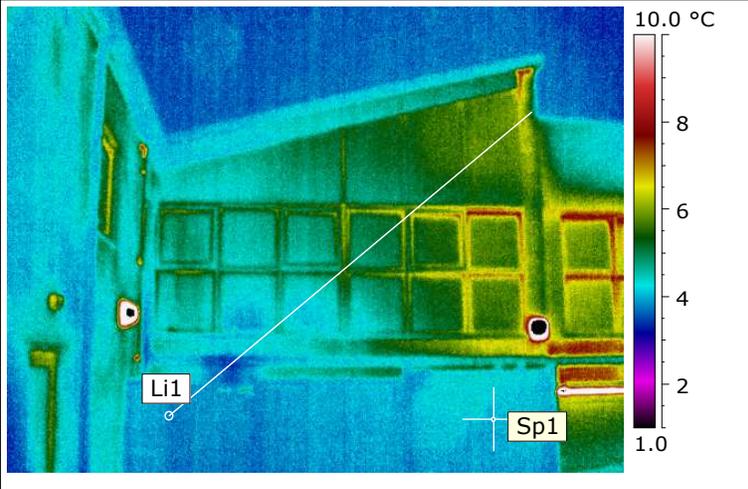
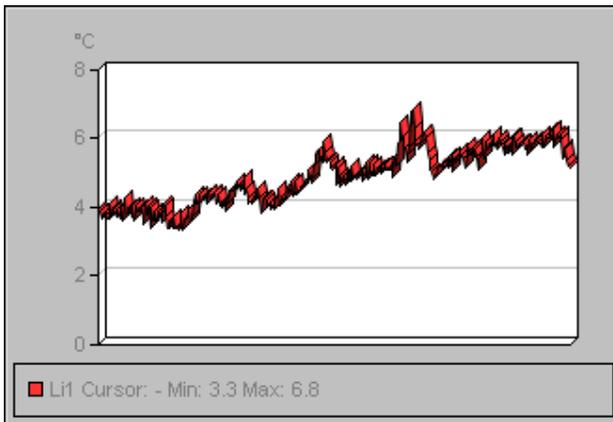
South Elevation

No insulated surfaces exceed the threshold temperature.
No evidence of thermal bridging.
No air leakage noted.

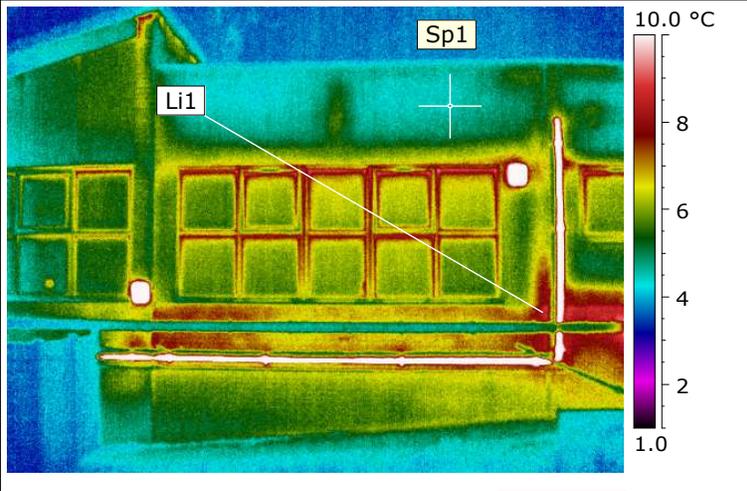
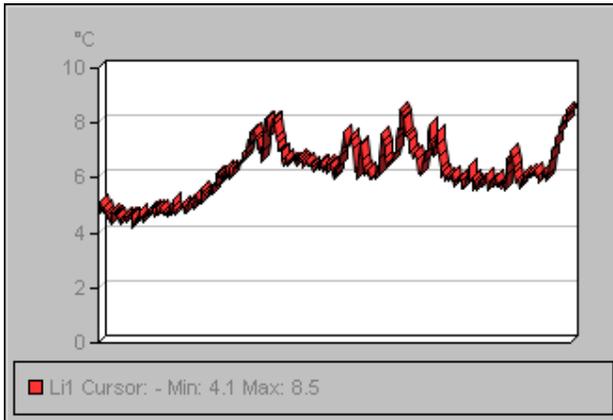
South Elevation

No insulated surfaces exceed the threshold temperature.
No evidence of thermal bridging.
No air leakage noted.

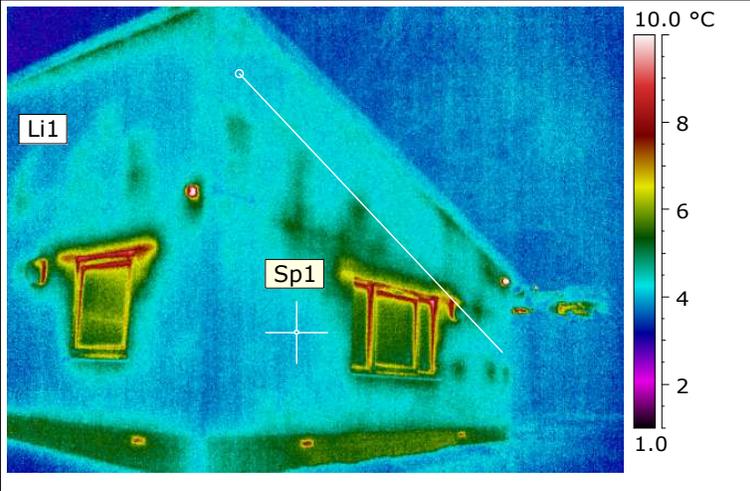
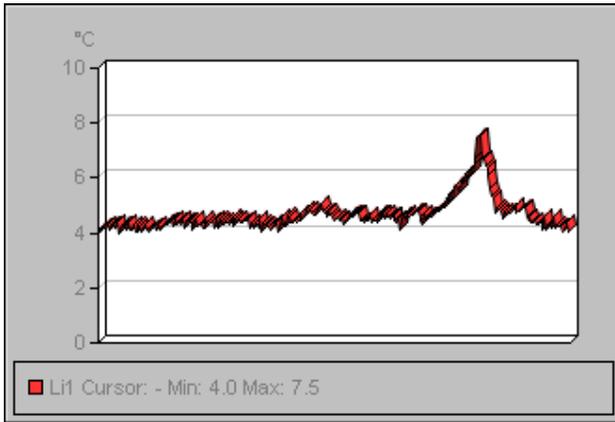
South Elevation

No insulated surfaces exceed the threshold temperature.
No evidence of thermal bridging.
No air leakage noted.

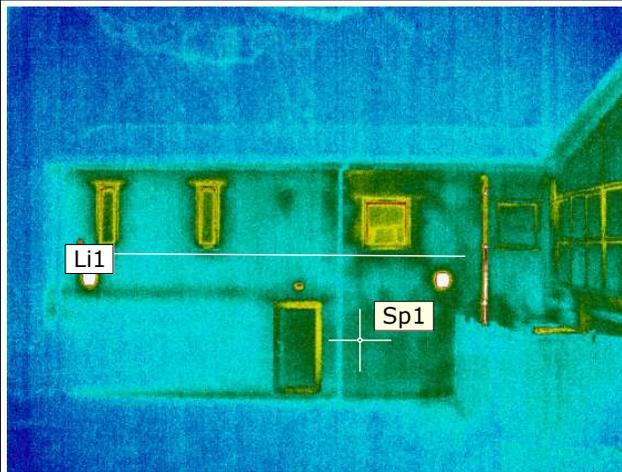
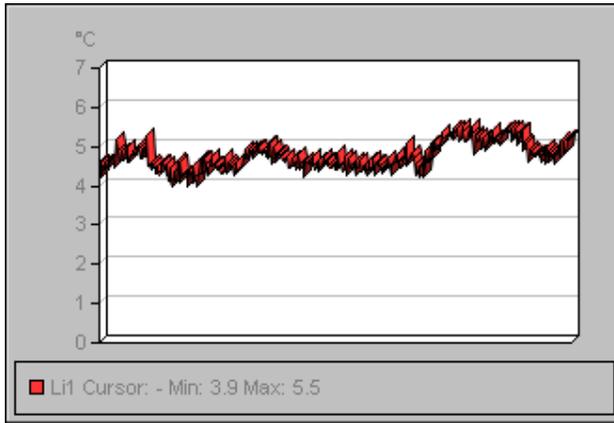
Internal East Elevation

No insulated surfaces exceed the threshold temperature.
No evidence of thermal bridging.
No air leakage noted.

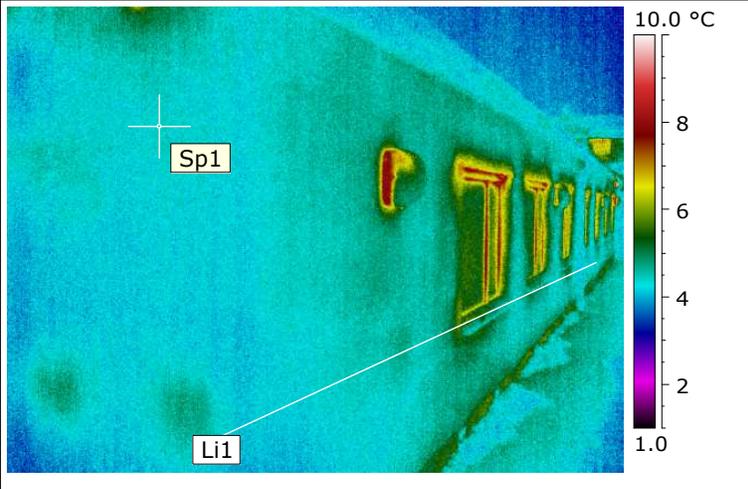
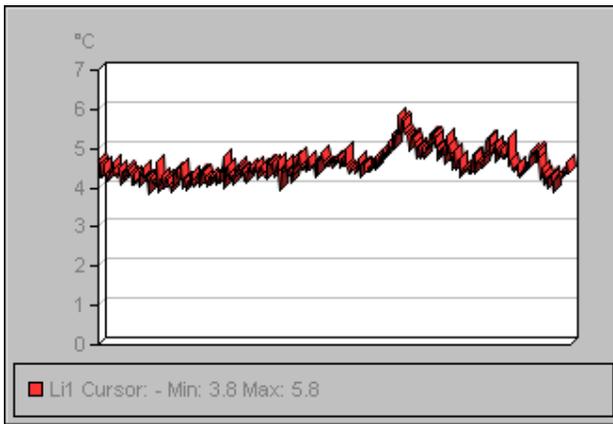
East Elevation

No insulated surfaces exceed the threshold temperature.
No evidence of thermal bridging.
No air leakage noted.

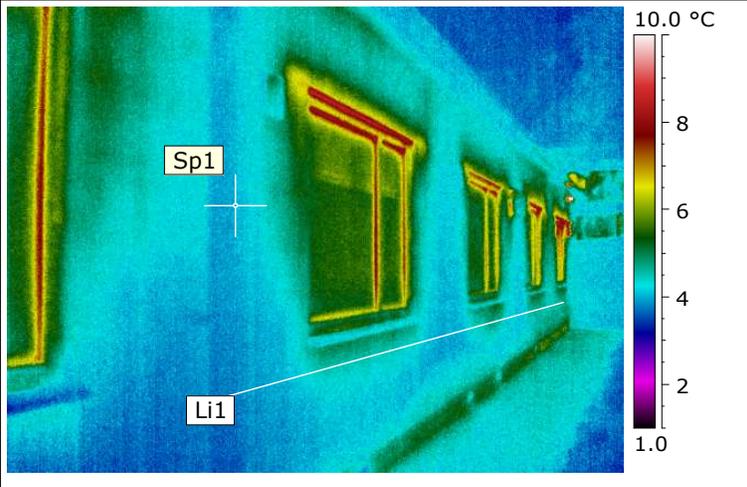
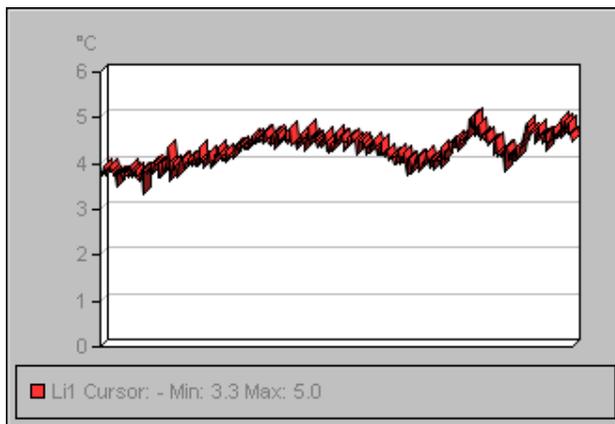
East Elevation

No insulated surfaces exceed the threshold temperature.
No evidence of thermal bridging.
No air leakage noted.

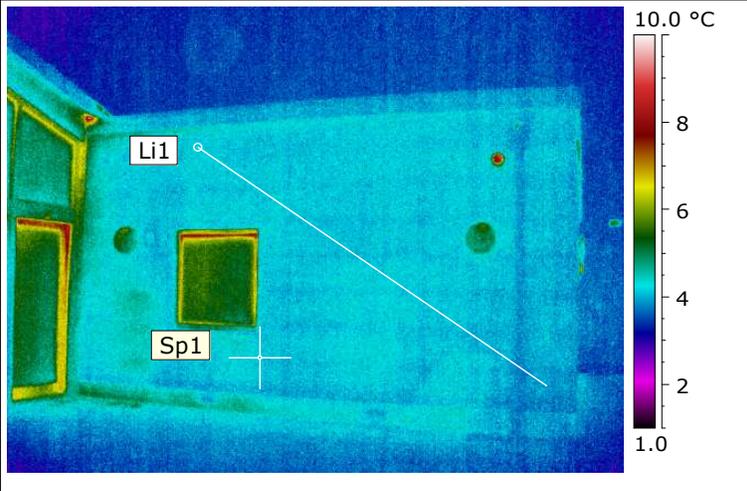
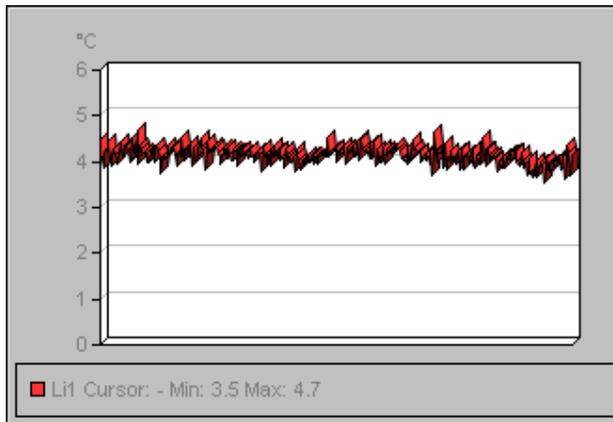
No insulated surfaces exceed the threshold temperature.
No evidence of thermal bridging.
No air leakage noted.

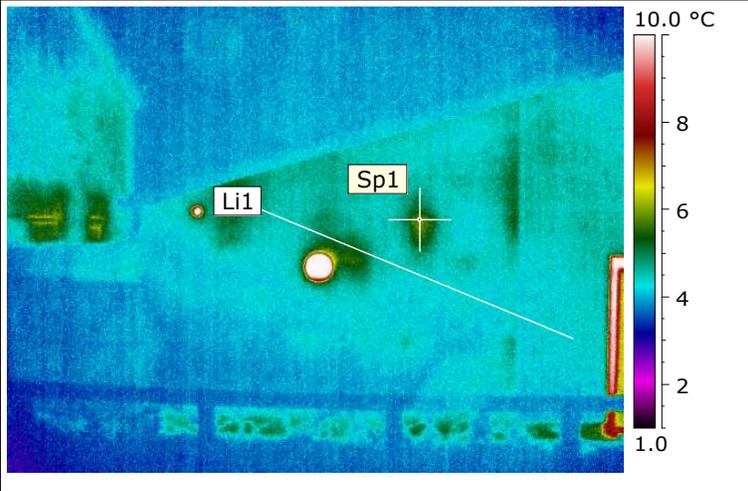
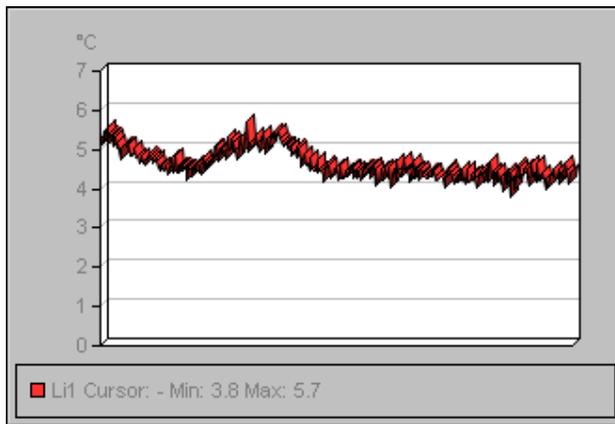
North Elevation

No insulated surfaces exceed the threshold temperature.
No evidence of thermal bridging.
No air leakage noted.

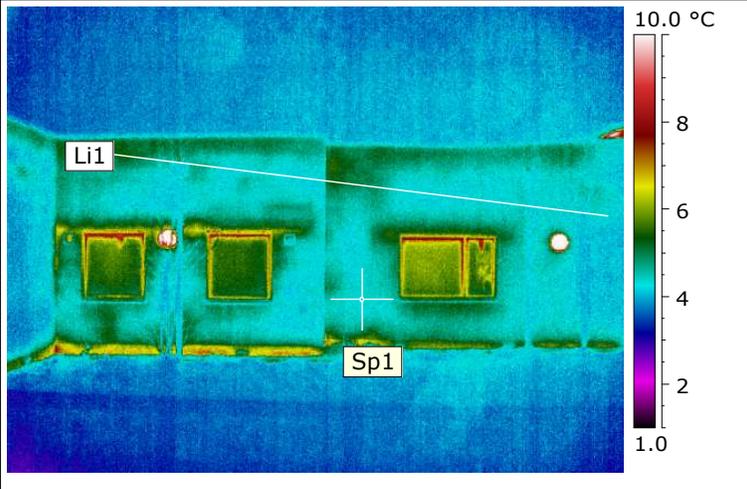
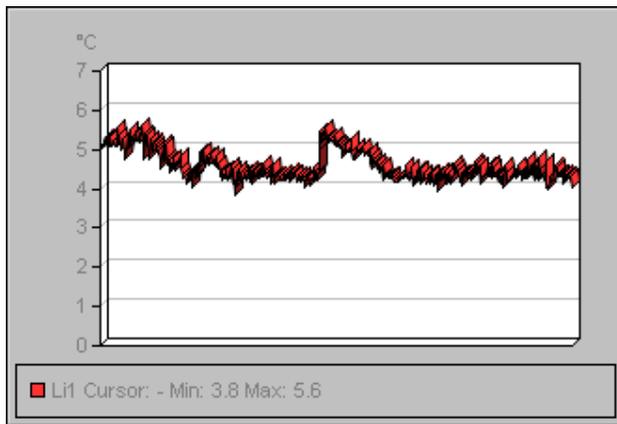
North Elevation

No insulated surfaces exceed the threshold temperature.
No evidence of thermal bridging.
No air leakage noted.

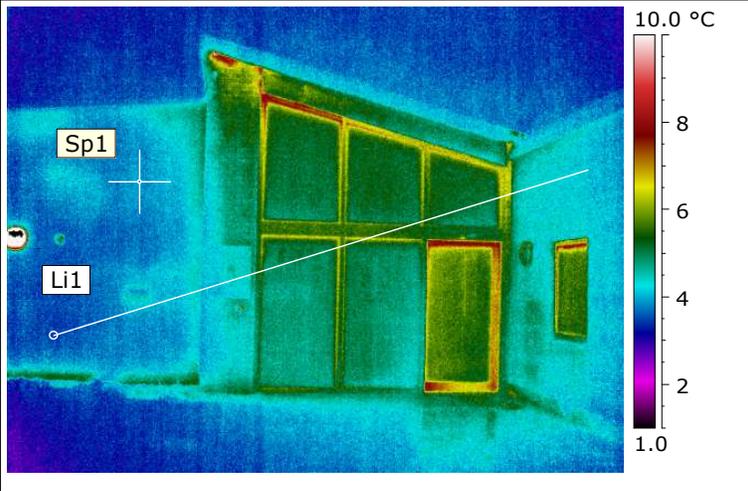
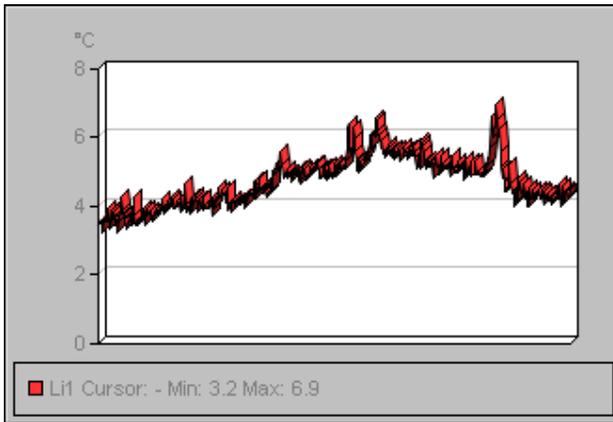
North Elevation

No insulated surfaces exceed the threshold temperature.
No evidence of thermal bridging.
No air leakage noted.

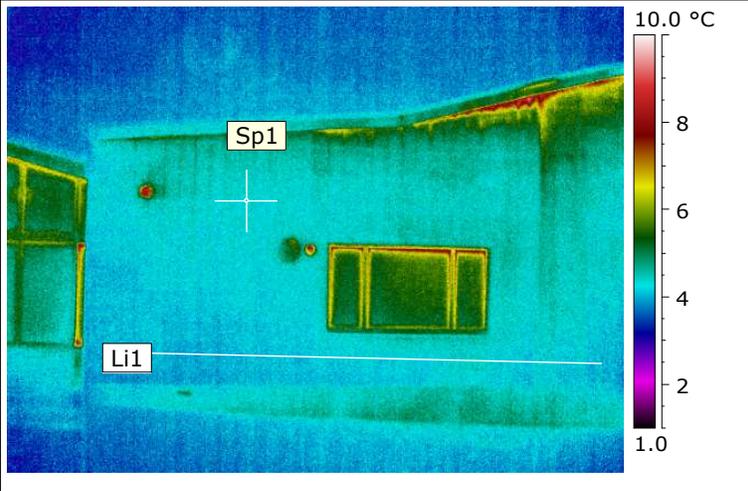
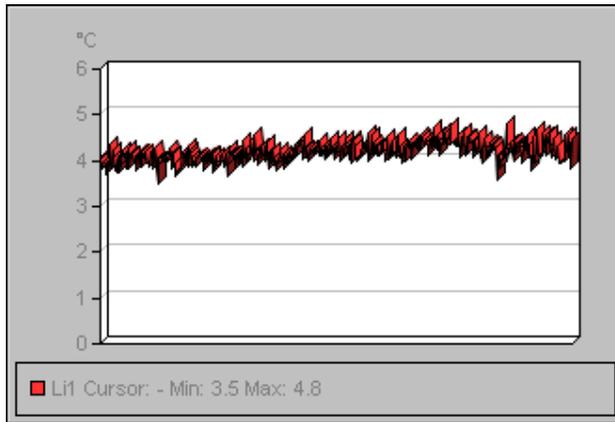
North Elevation

No insulated surfaces exceed the threshold temperature.
No evidence of thermal bridging.
No air leakage noted.

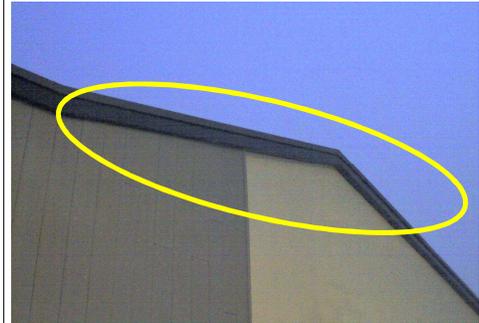
North Elevation

Thermal image highlights air leakage from soffit area of roof.
Investigation required to ascertain the source of heat within this roof void.
